Casualty Investigation Report CA 094

CEC PACIFIC

Crane Failure on 26th July 2005 at Zanzibar

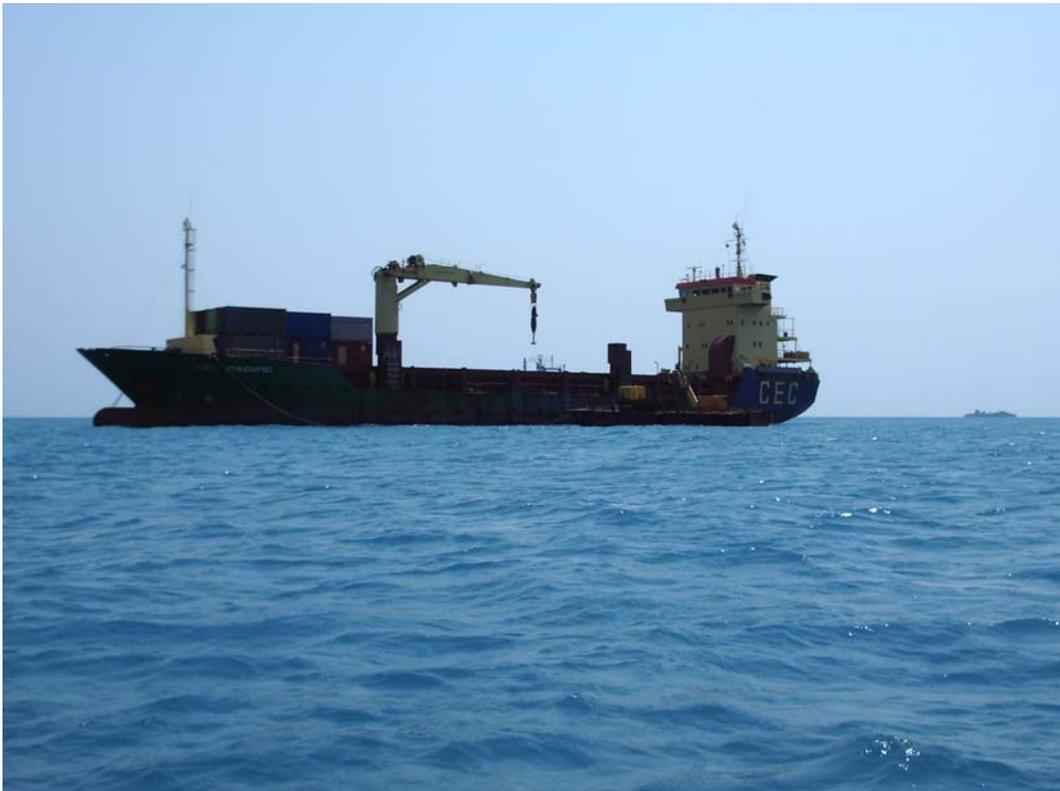
CEC PACIFIC AFTER NUMBER 2 CRANE FAILURE

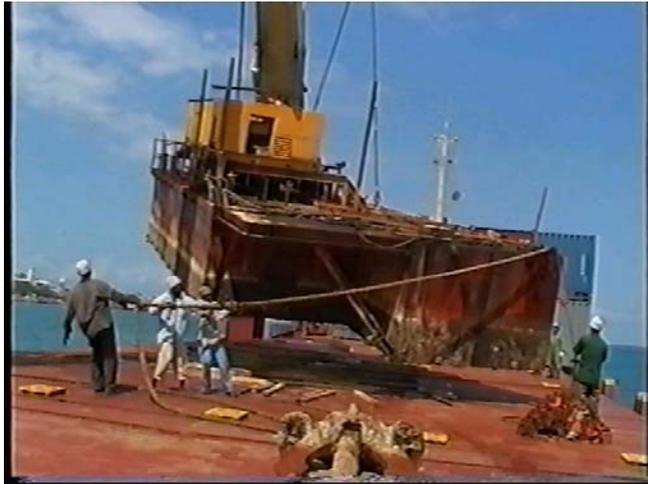
- 2.17 Once the barge was approx 20cm above the hatch cover the forward end of the barge swung slowly to port while the aft end swung slowly to starboard.

Stern of barge starting to swing to starboard

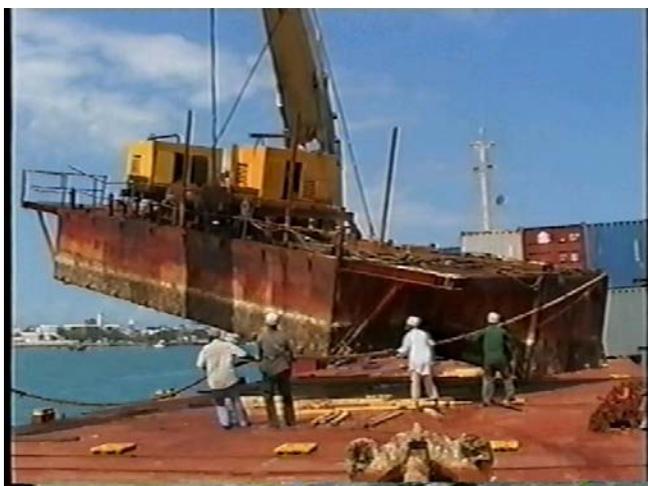
Forward end of barge twisting outboard

- 2.21 The forward end of the barge continued to twist outboard and as it did so the vessel's list to port increased until the angle of list was approximately 10 degrees. It was at this time that both cranes started to be dragged outboard by the combination of list and the weight of the barge.

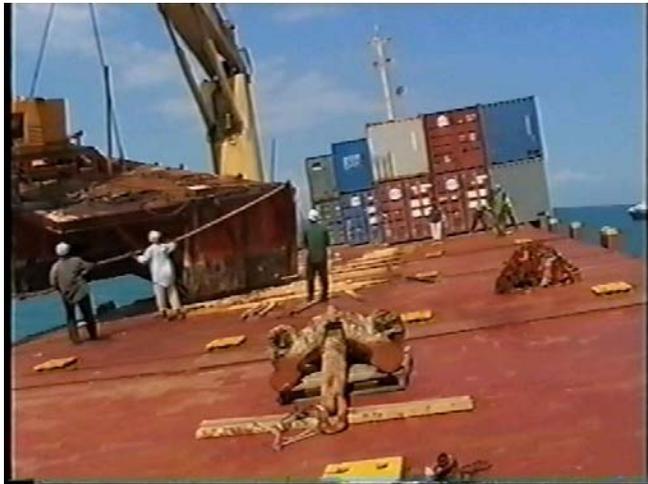
Vessel listing to port as barge swings over the side rail

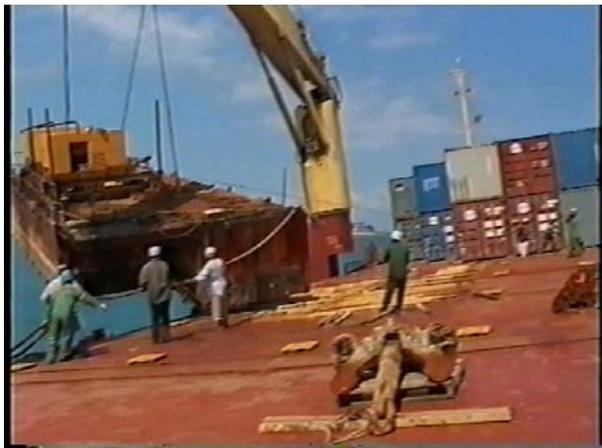
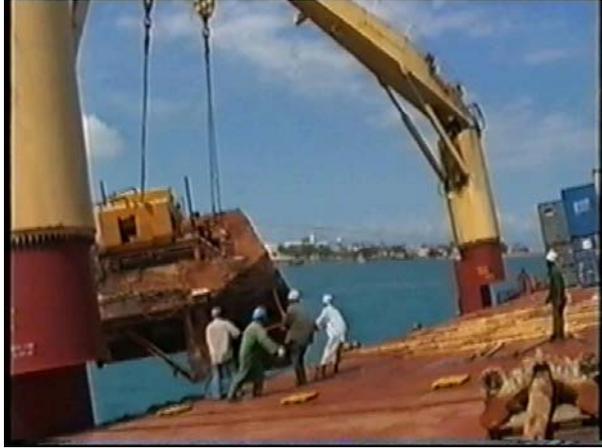
- 2.22 Tag lines were used to try and control the swing and consisted of narrow diameter mooring ropes (approx 45mm). The only places that they could safely be wrapped around were the pad eyes on the side of the hatch coamings. There was a minimum of three men on each line and from the video coverage of the incident it can be clearly seen that there was no effective use of these tag lines.

Vessels list increasing as cranes being dragged outboard by the weight of the barge. Note forward tag line, tight but not holding

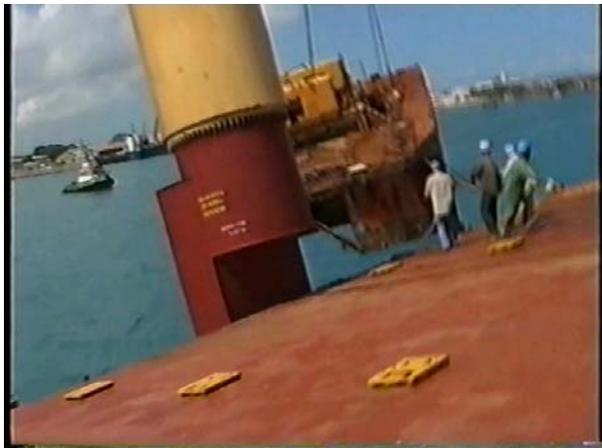
Moments before cranes ordered to slack the barge into the water

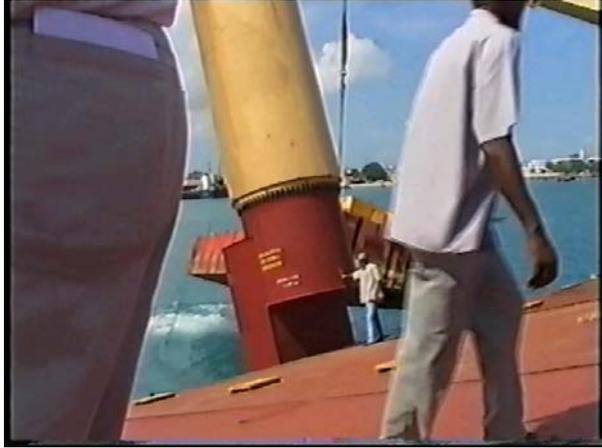
Last image before No 2 crane detached. No.1 crane slacking to water.

- 2.26 Once all the weight was off No. 1 crane due to the barge being lowered into the water, more weight was transferred on to No. 2 crane. The weight on the crane proved too great causing the slew bearing to fail catastrophically.
- 2.27 No 2 crane sheared at this bearing and toppled into the sea with the driver still in the cab.

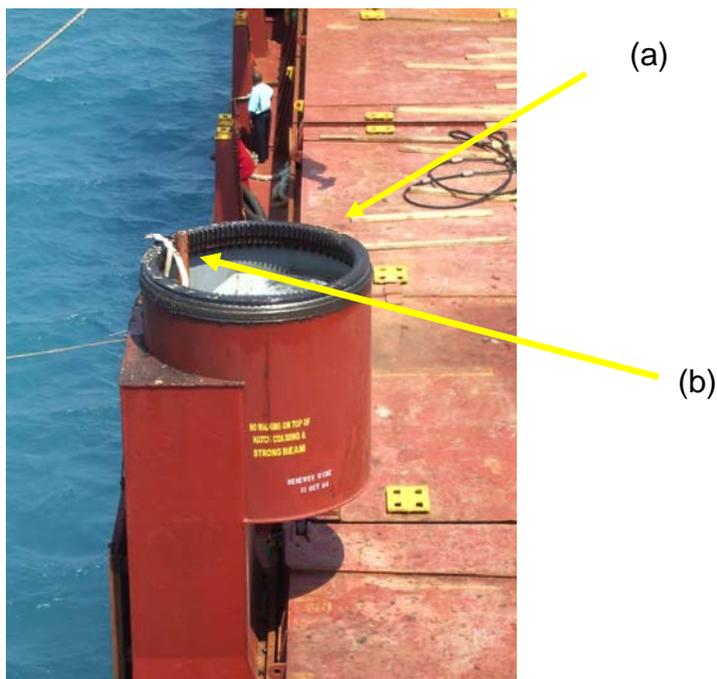
Number 2 crane pedestal after the incident

- 2.28 The crane sheared off the pedestal at the slew ring (see images above). Investigation of the incident demonstrated that this was the single point of failure on the crane. The driver was able to exit the cab via the pedestal while submerged, but before the crane hit the seabed sealing off this escape route.
- 2.29 No 1 crane driver, at the same time exited his crane via the usual route inside the pedestal for fear of his crane also falling into the sea.
- 2.30 No. 2 crane driver was back at work the following day on light duties having sustained minor bruises.

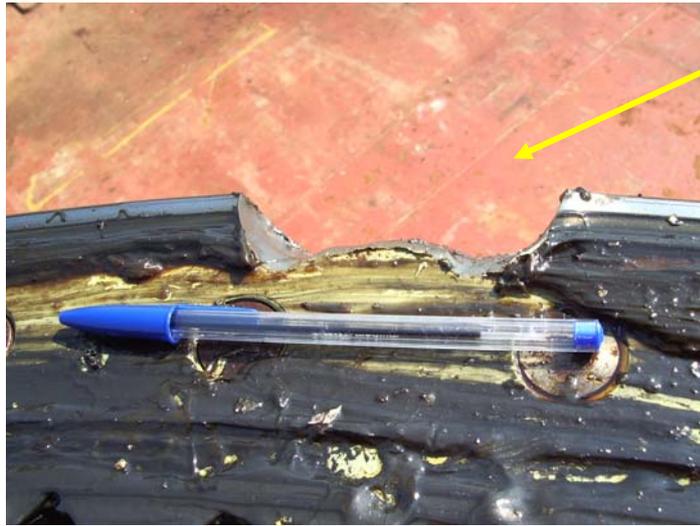
Damage to slew gear showing area through which bearings had torn

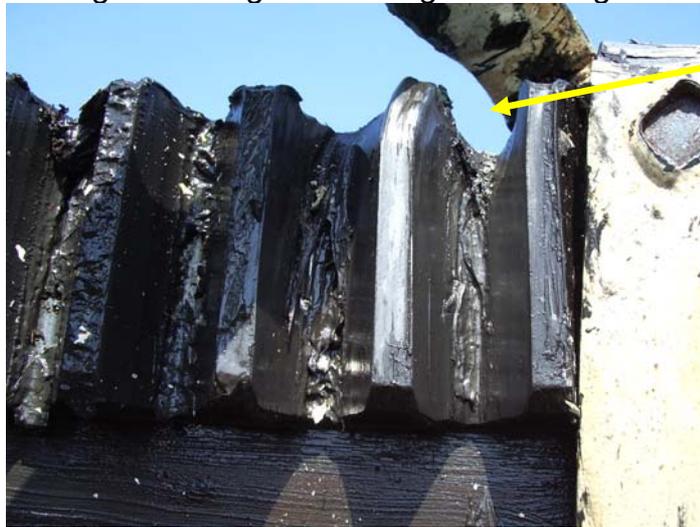
Damage to slew gear showing bent slewing gear

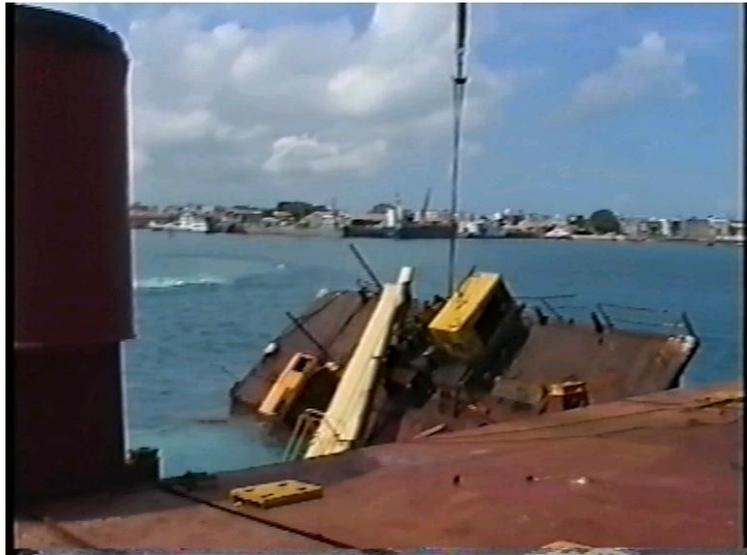
Final resting place of Number 2 crane in the sea, supported on the barge

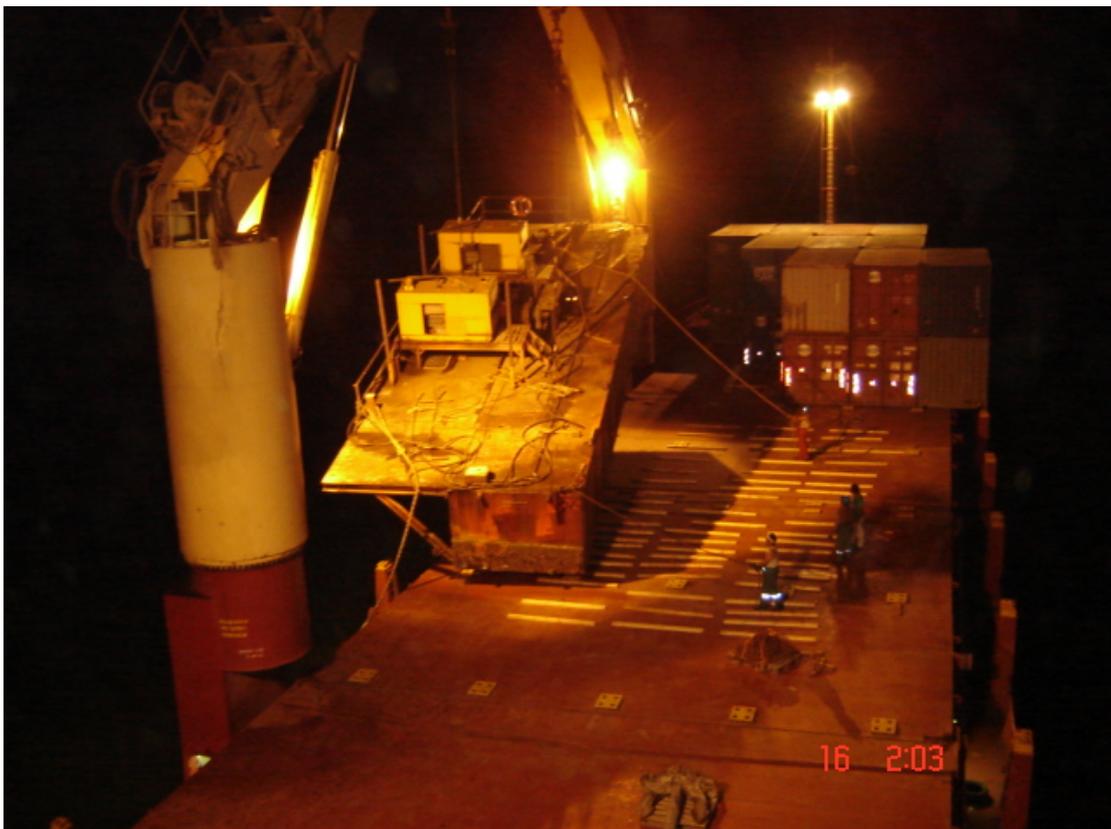
Crane No. 1 was attached to lifting point 2 using a double strop while Crane No. 2 was attached to lifting points 1 and 3 using two strops. The barge was successfully brought on board although it was noted by several of the ships staff that the load was twisting back and forth during the process. The barge was landed on the hatch cover stern first due to the fact it was trimmed at an angle of approx 25 degrees. See photograph on the next page.

Loading the barge on board at Tio

board. There is no explanation for the motion of the barge during loading, but it is considered possible that water in the barge might have been moving about as it was lifted, causing variations in the centre of gravity position. This may have produced this twisting effect which was also evident as it was lifted during discharge. The evidence of water and extra weight, being in the barge, is not available but this observed movement is a strong indicator of its possible presence.

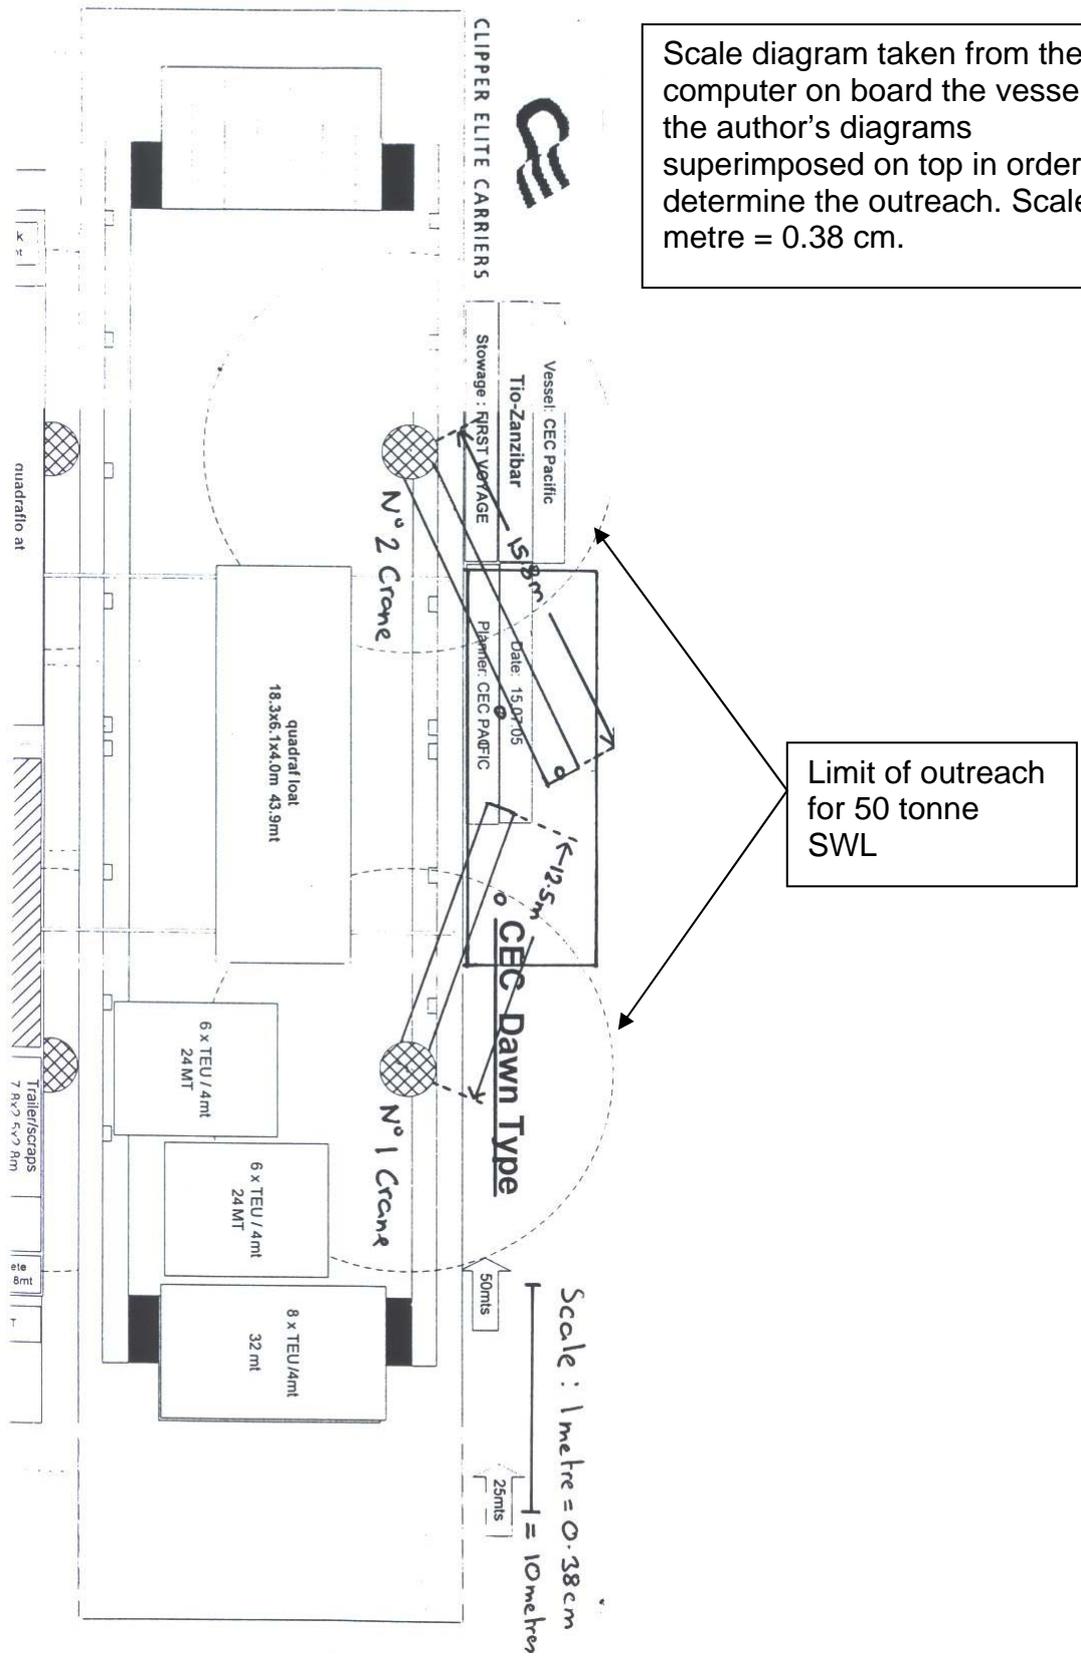
Scale diagram taken from the load computer on board the vessel with the author's diagrams superimposed on top in order to determine the outreach. Scale 1 metre = 0.38 cm.

- 5.13 Using the manufacturer's scale from the crane handbook above:
- No. 1 crane outreach 12.5 m. SWL at this point = 29 tonnes.
Actual weight on crane = 34.8 tonnes. **20% overload.**
 - No. 2 crane outreach 15.8m. SWL at this point = 26 tonnes.
Actual weight on crane = 33.9 tonnes. **30% overload.**
- 5.14 After three attempts at lifting the load there should have been enough evidence for the crew to suspect that the barge was over weight and beyond the limits of the cranes. However, any concerns the crew may have had about the weight of the barge were not acted upon or followed up. In planning for the discharge of the barge no consideration appears to have been taken about the barge being over the declared weight, and possibly outside the limit of the cranes.

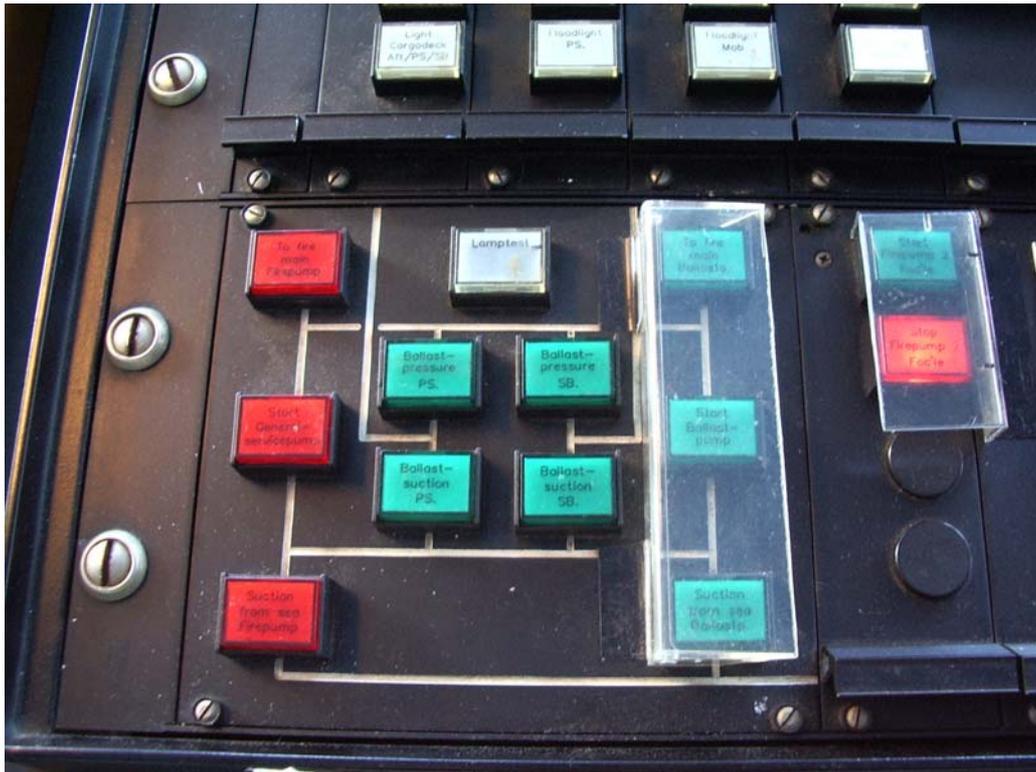
- 11.3 On the bridge the remote ballast transfer controls are located over to the port side of the forward console (see image on following page). The inclinometer is set on the aft bulkhead nearer to the centre line of the vessel and behind the console. This would mean that when operating the ballast controls the operator, in this case the Master, would constantly have to look over his shoulder to view it. In reality the Master would be looking forward to determine which way the vessel was listing and would have full control of ballast operations during heavy lifts. A visual appreciation of the heel angle against a horizon is, in any case, equally effective in a dynamic situation such as the load or discharge operation.

Remote ballast control panel on the Bridge

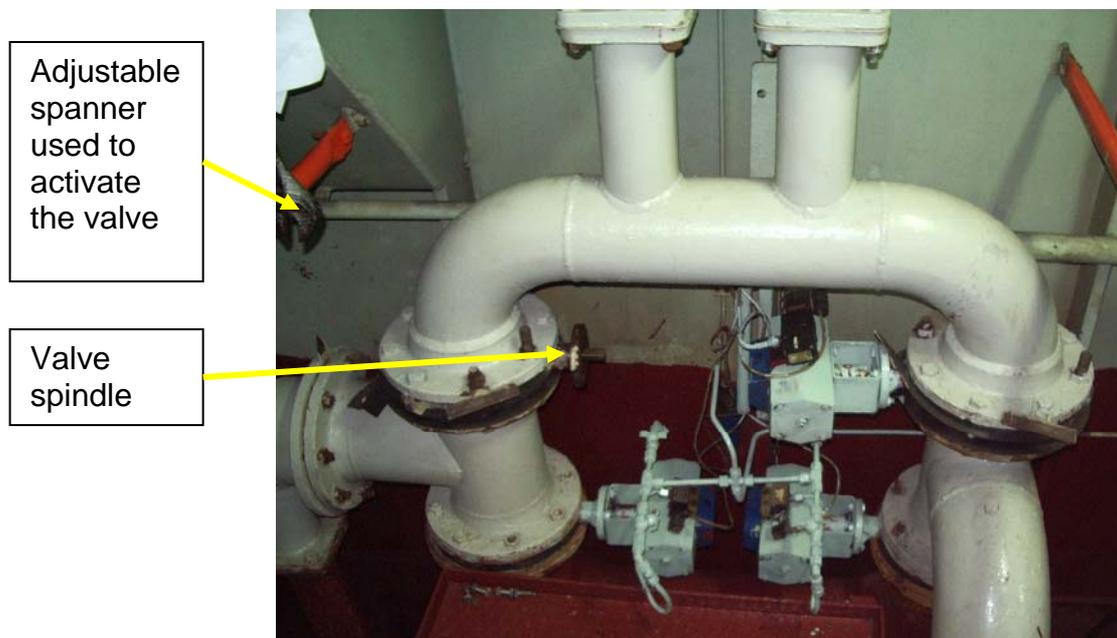
had been removed would need to be replaced (the current arrangement is that this has been removed and the spindle is turned with an adjustable spanner, see image below). Some of the indicator bulbs on the bridge panel would also need to be replaced and the system fully restored and tested to remote operation.

- 11.6 As the spindle requires an adjustable spanner to operate the valve this demonstrates that the system is not “as designed” and should not be operated in this way. The current arrangements mean that the engineer has to activate the pneumatic valves from the mimic board in the ballast flat and then remember to activate the one valve that has had its actuator removed by hand.

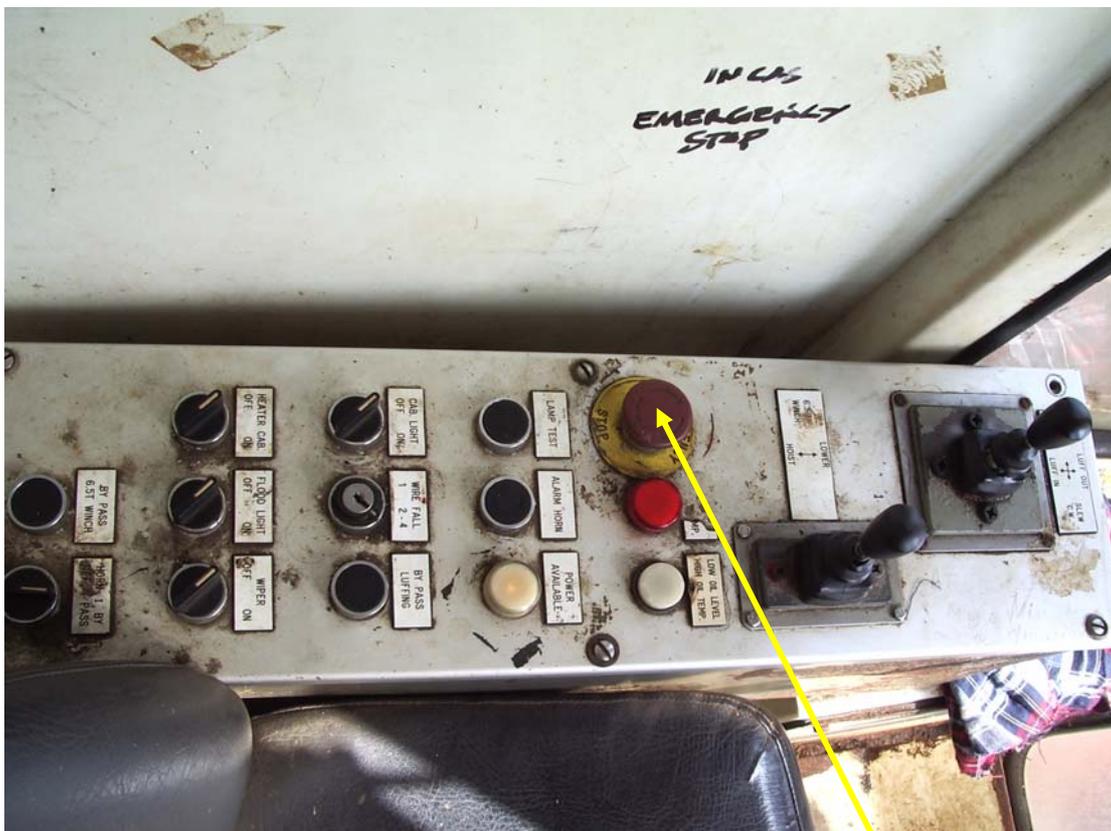
No. 1 crane controls showing emergency button.

- 12.2 When this button is pressed all power is cut to the crane and can only be restored by switching it back on in the Engine Room.
- 12.3 On hearing the metal on metal sound and seeing things go out of control the crane driver did what he believed to be the correct line of action and also as per the instructions in the cab, see picture above.
- 12.4 It can be concluded that the crane toppled off the vessel as a direct result of the majority of the barges weight transferring to a single crane when the power to this crane had been switched off. Had the crane not been locked then the situation may have been different. In most

situations when machinery or situations are appearing to get out of control the normal cause of action is to press the Emergency Stop button, however on this occasion pressing the Emergency Stop button exacerbated the situation. The only way, in this situation, of reducing the stress on the crane would be to lower away the load to the water. As the Emergency Stop button prevented the lowering mechanism, this was not possible. Even if it would have been possible to restart the crane (This has to re-started from the switchboard room in the Engine Room) it would have been unlikely that there would have been enough time to lower the barge into the water before the crane became catastrophically overloaded.
