# **Isle of Man Ship Registry**

Casualty Investigation  
Report No. CA103

**Isle of Man Registered "FICUS"**

Grounding

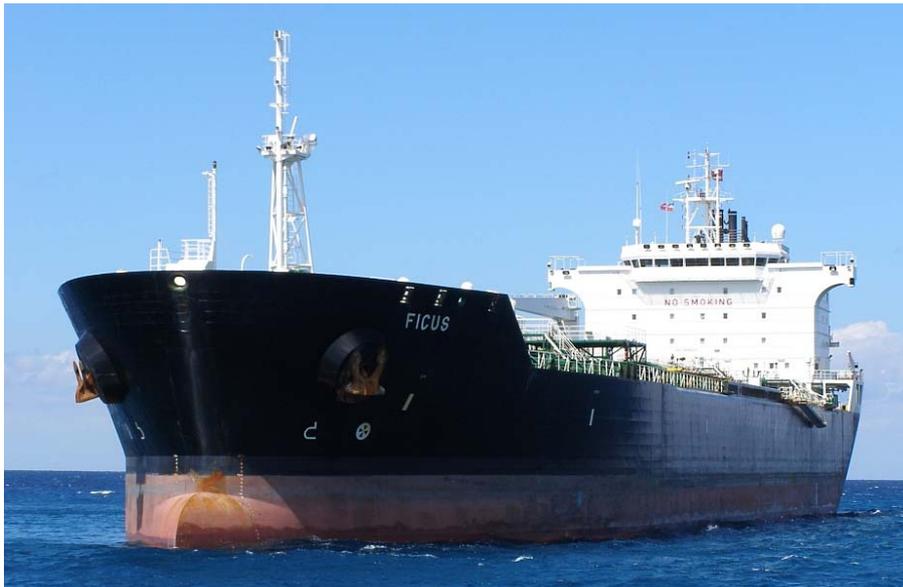
*Photo taken whilst the vessel was aground*

On the 27th February 2008 at 09:11 local time the Oil/Chemical Tanker “Ficus” grounded in shallow waters off Goulding Cay, New Providence Island, Bahamas during a large alteration of course. The vessel was altering course for the final leg of the Passage Plan before picking up the pilot at Clifton Pier, New Providence Island, Bahamas.

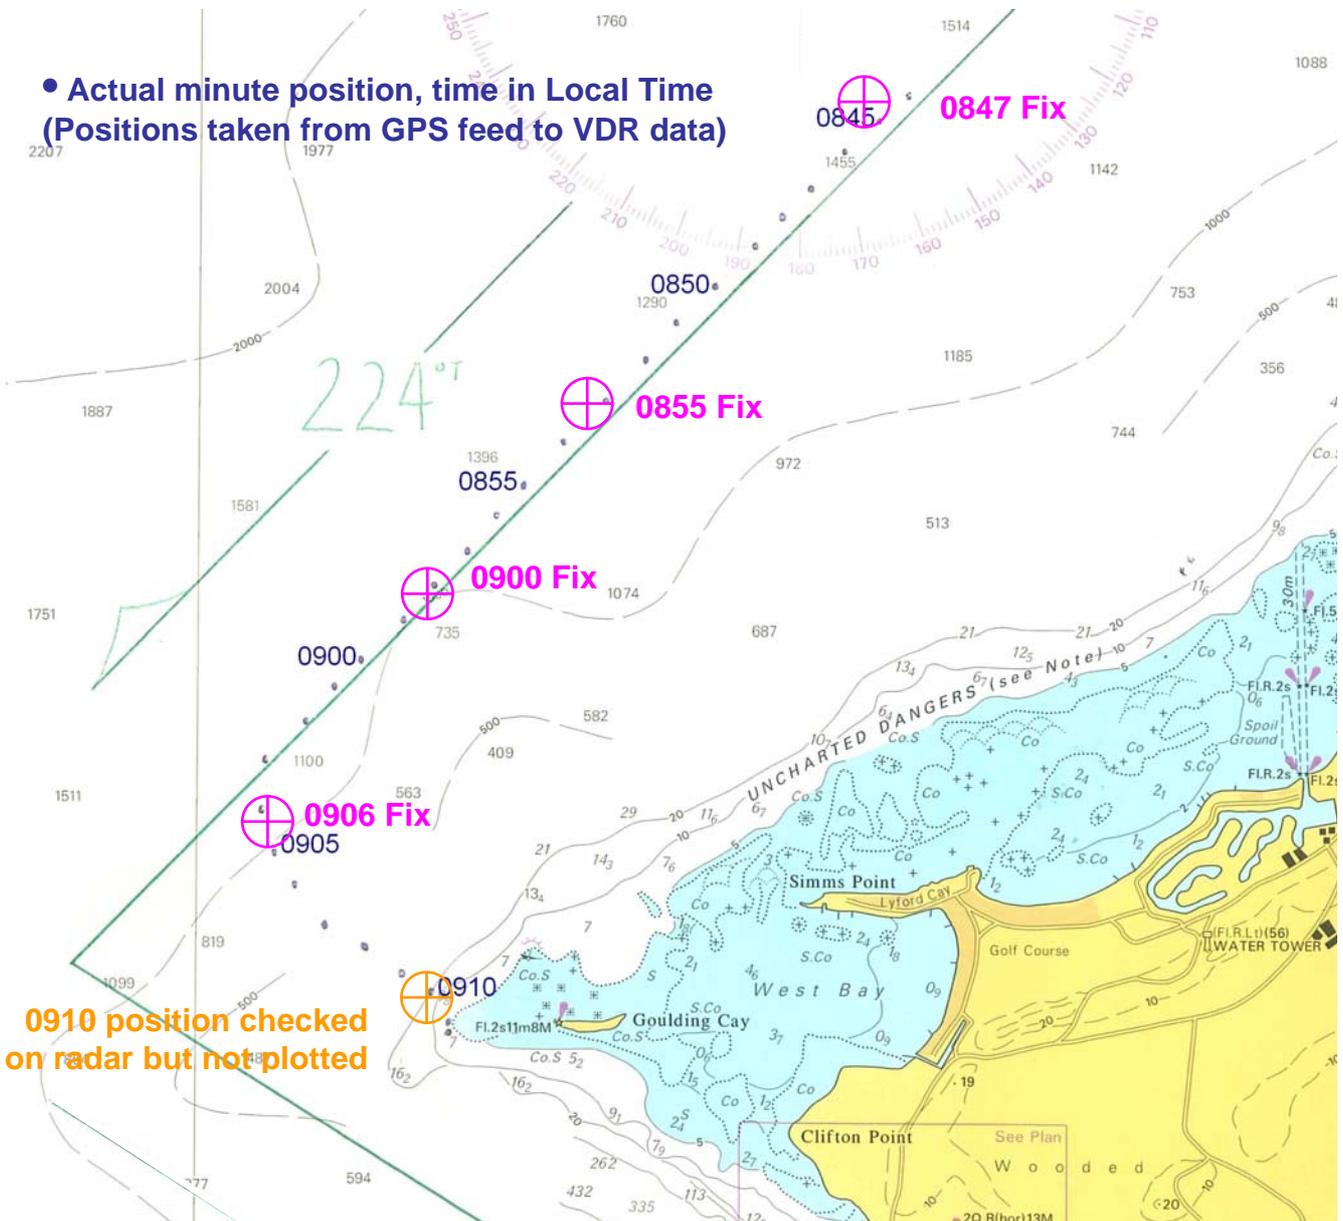
### 1.5 Vessel Tracks Leading Up To The Grounding

The chart extract below shows a minute by minute account of the vessel's actual track starting at 0844LT and ending at 0912LT. The chart extract also shows the positional fixes taken by the OOW(8-12) that were plotted on the chart.

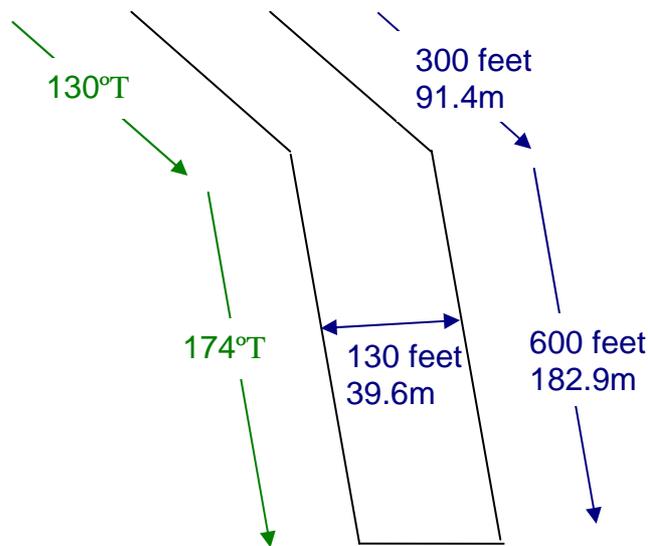
### Damage to the Seabed

The nature of the seabed where the Ficus grounded was predominantly a "limestone shelf" with some coral growth. A divers assessment of the affected area showed the line of grounding to be approximately:-

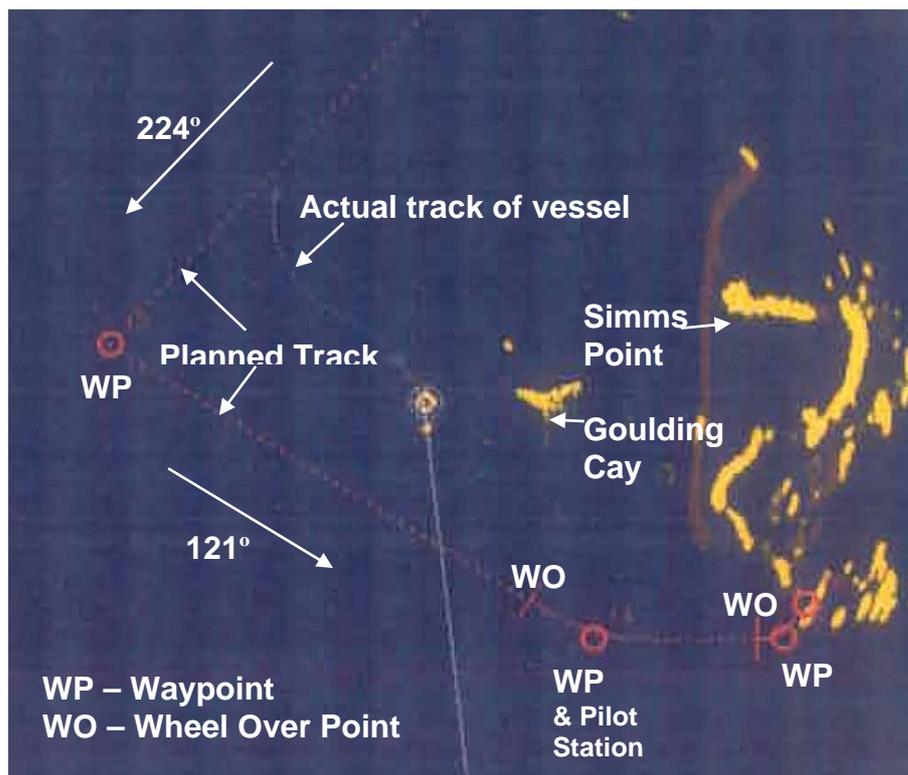
The following Radar screen shot shows how the track is displayed to the OOW on the Radar Screens.

*Picture taken following the grounding where the pilot station is shown the next waypoint.*

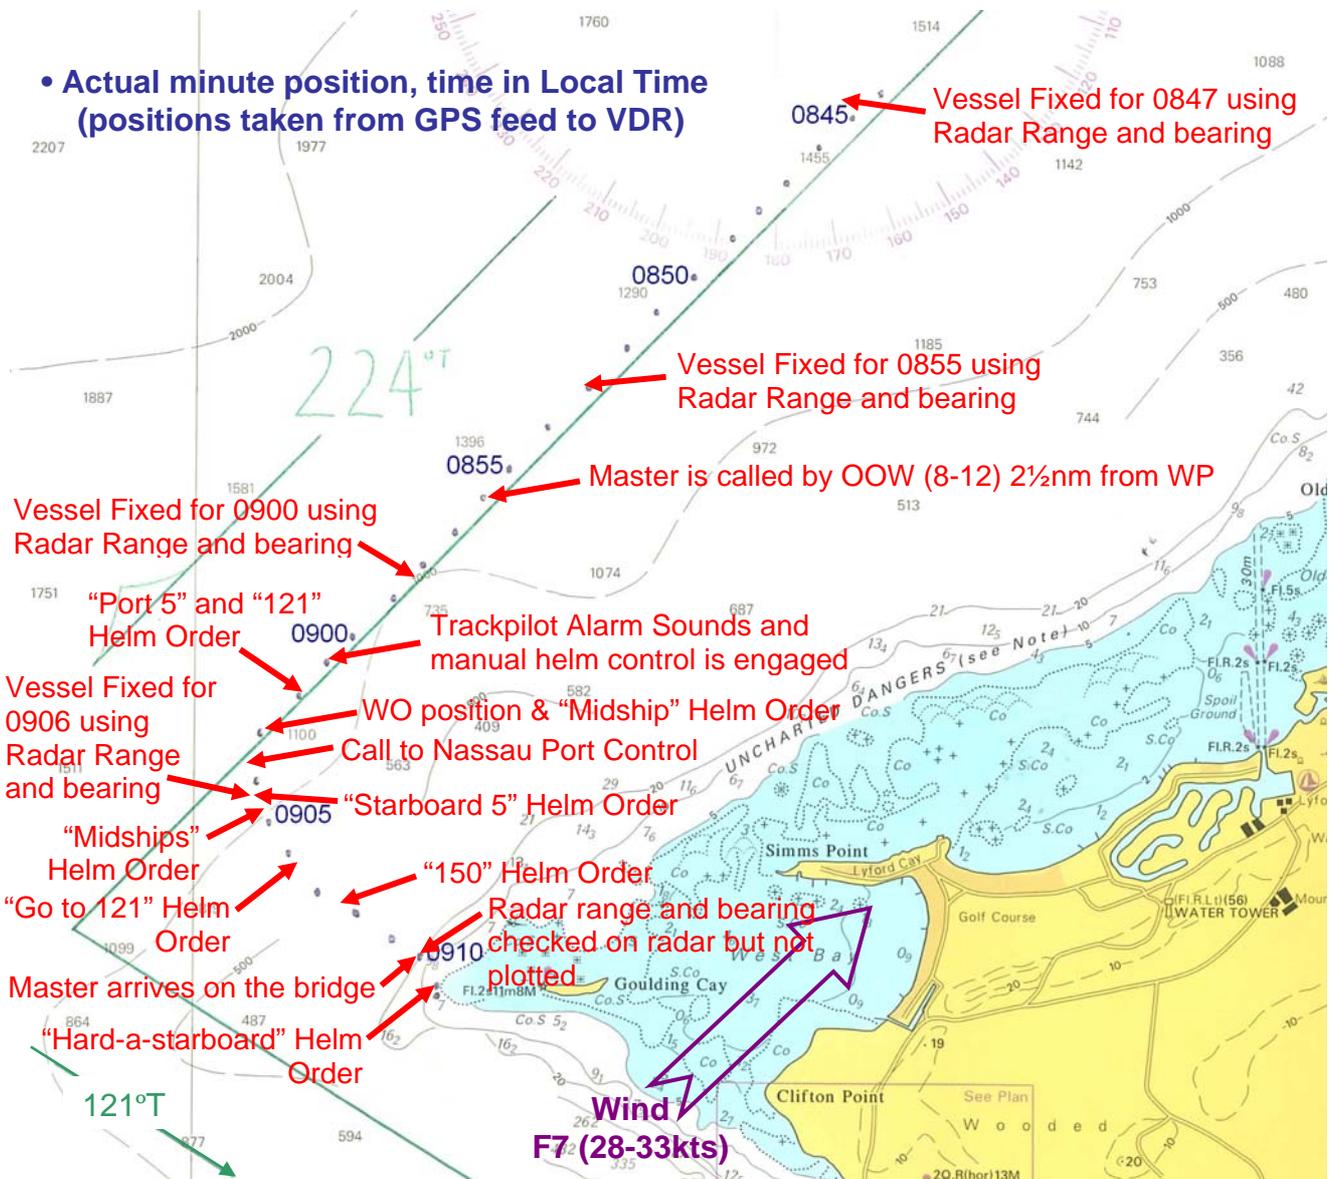
The chart extract of BA1489 below shows the significant events immediately prior to and during the course alteration leading up to the grounding of the vessel.

At 0901LT the ECDIS alarm sounded which indicated to the OOW that the vessel was 2 minutes away from the Wheel Over position as calculated by the ECDIS for alteration to the next course. On the basis of this alarm the OOW (8-12) decides he will alter course using manual helm control. The OOW(8-12) immediately instructs the Lookout(8-12) to take the wheel and be the helmsman. The helmsman’s role is to carry out helm or course orders as directed by the OOW. The vessel’s position was last checked at 0858LT and marked on the chart as “0900”.

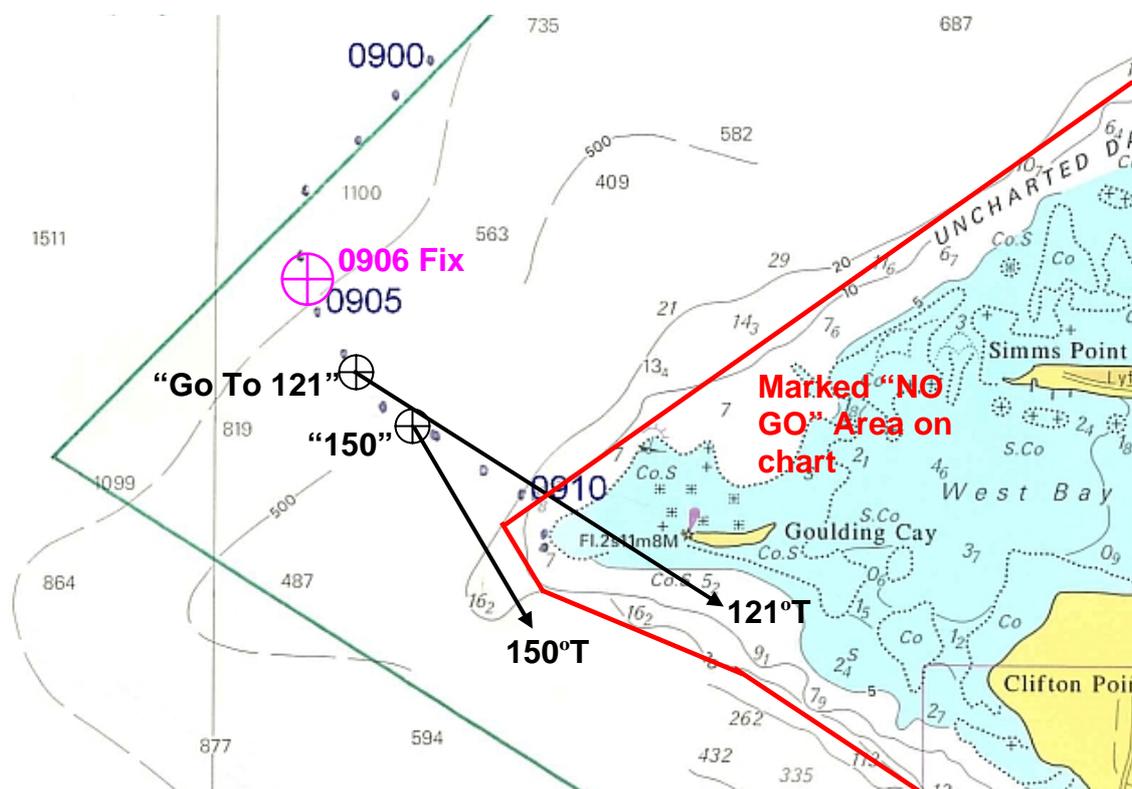
The following chart extract of BA1489 shows the implications of steering a course of 121°G. It is clear the OOW(8-12) has lost his situational awareness at this point with respect to the safe navigation of the vessel and in particular the position of the vessel. By steering a course of 121°G the vessel's track will be taken directly through the "No Go" areas marked on the chart and the shallow waters that would lead to the vessel grounding.

The chart extract of BA1489 above shows the implications of steering a course of 150G. The "150" order indicates that the OOW(8-12) is attempting to steer clear of the "No Go" area by a narrow margin. The "150" order was not based on a plotted position and it is likely that the course decision was arbitrary based on looking at either the radar, 'zoomed' in ECDIS chart or out of the bridge window. A more decisive and significant alteration of course was needed at this point in order to steer the vessel to safe waters and to counteract any effects of the South Westerly Force 7 wind.

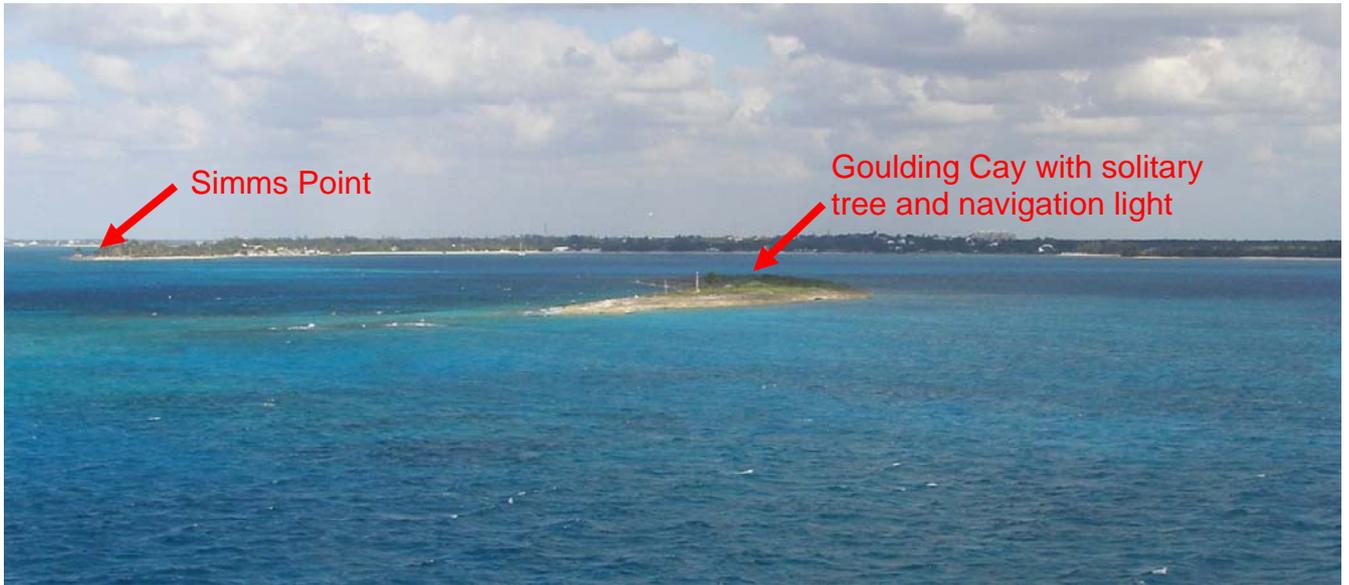
Goulding Cay and Simms Point Looking approx East by North

*Picture taken from vessel whilst aground.*

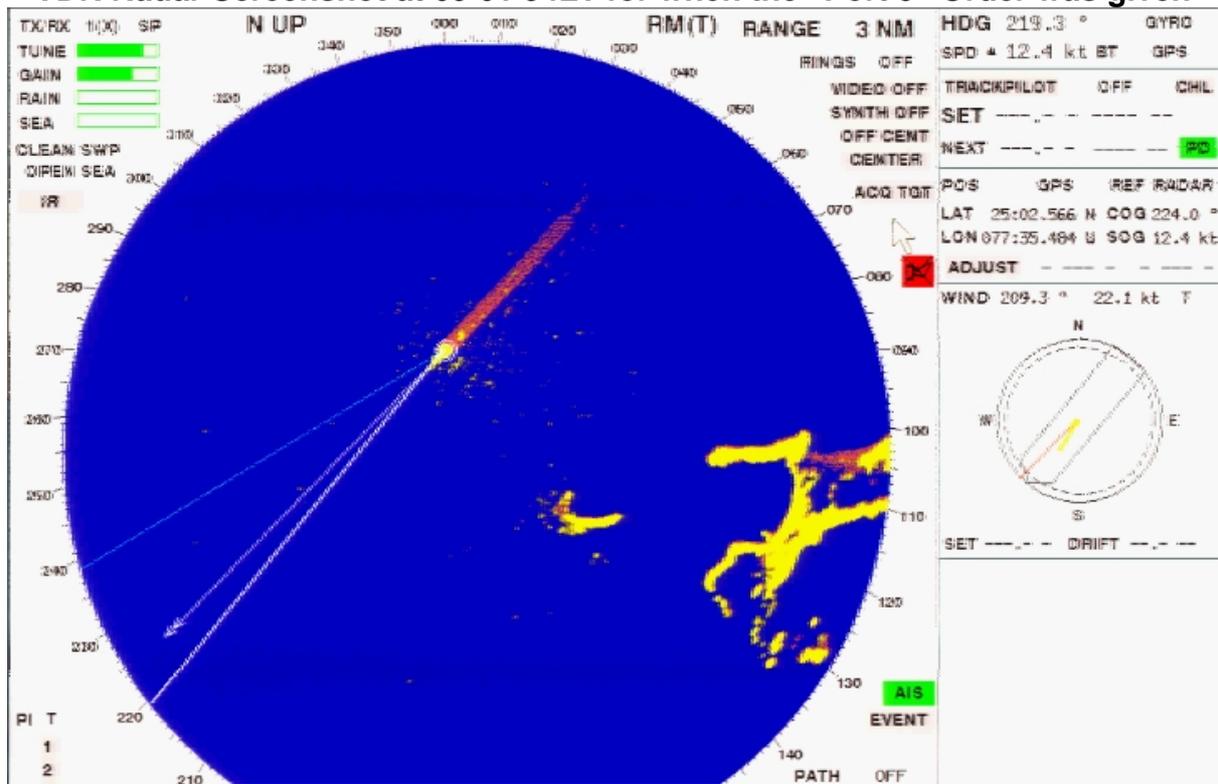
Annex 3A

VDR Radar Screenshot at 09 01 34LT for when the "Port 5" Order was given

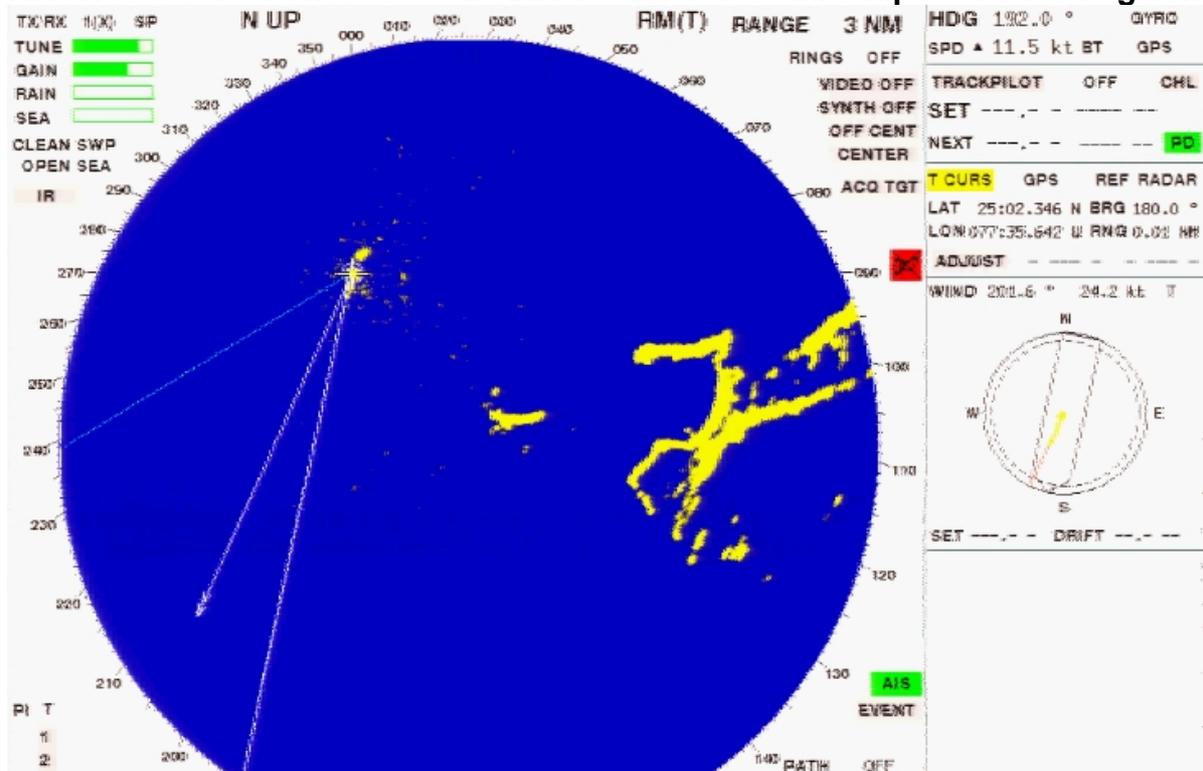
Annex 3B

VDR Radar Screenshot at 09 02 52LT for when the "Midships" order was given.

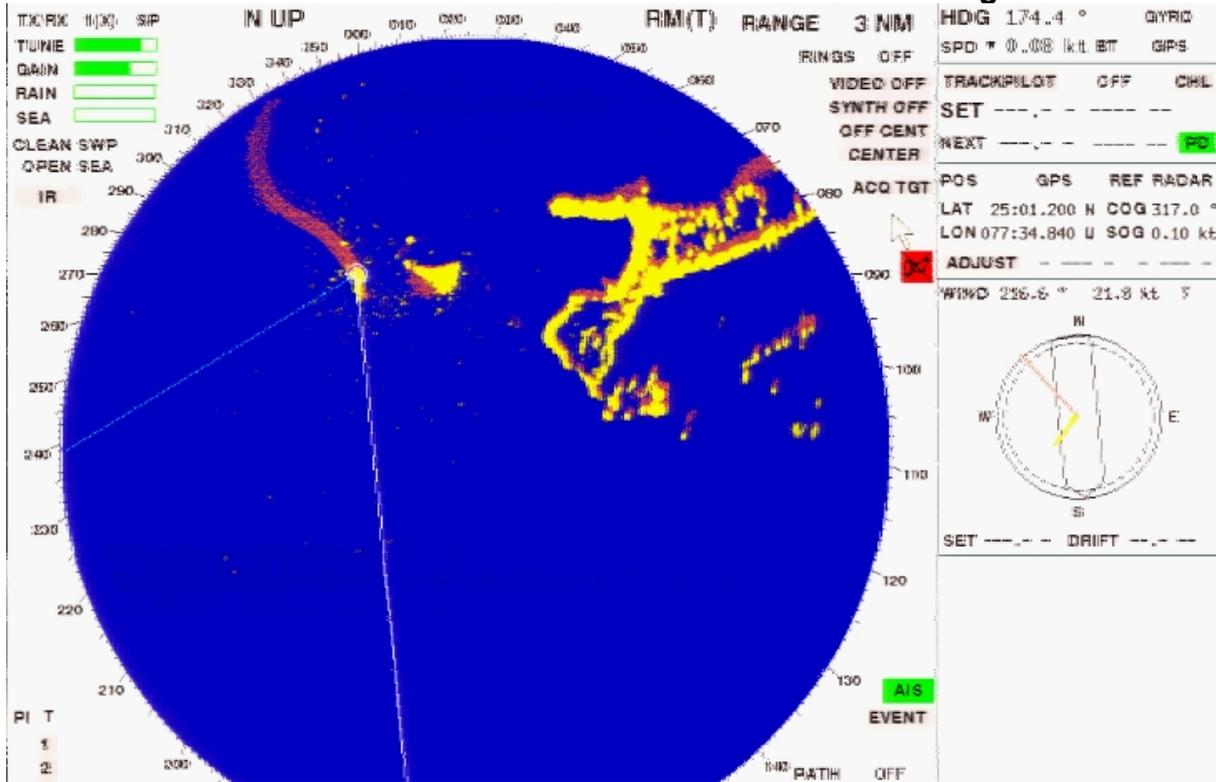
Annex 3G

VDR Radar Screenshot at 09 11 30LT for when the vessel grounded

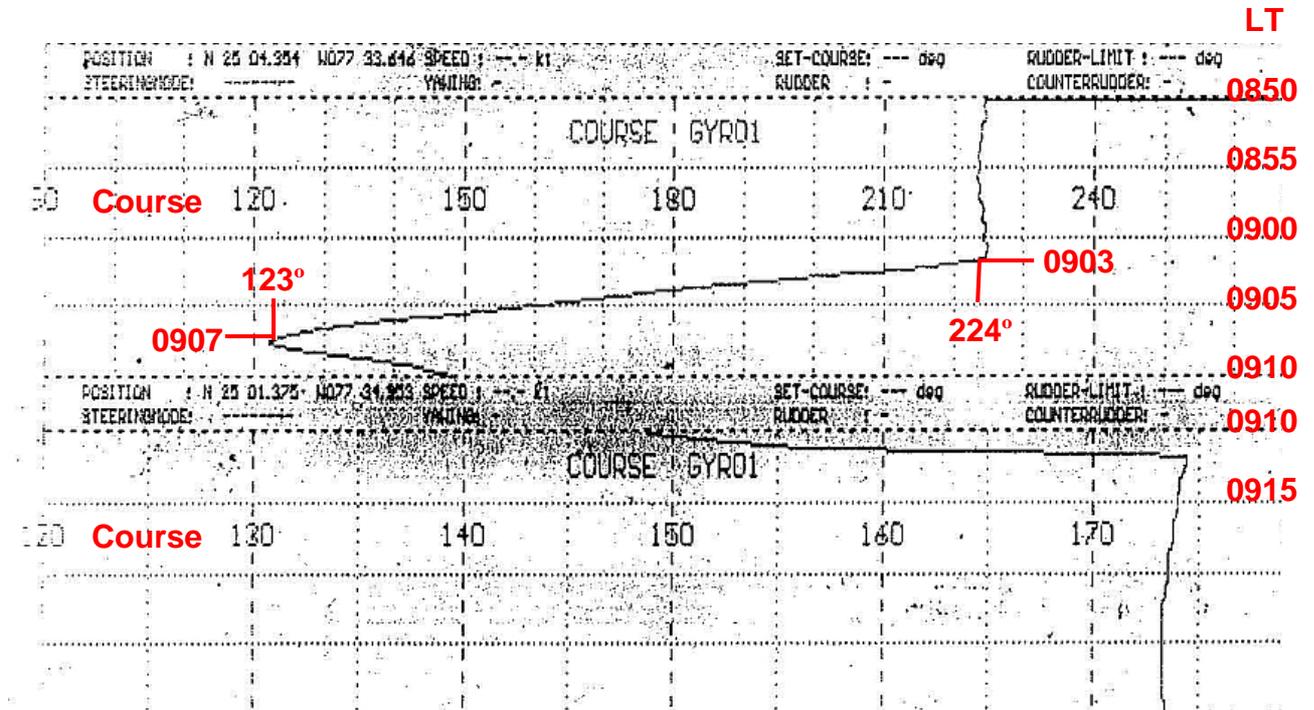
### The Course Recorder

The line representing the change of heading between 0903 and 0907 is approximately a straight line. During this period the change of heading is approximately 101° (224°-123°). Therefore the average rate of turn can be calculated as approximately 25°/min.

Please note that rate of turn at any one point may be higher or lower than 25°/min.
