Casualty Investigation Report CA 91  
Loss of the Isle of Man registered Ship  
Jökulfell

On 7<sup>th</sup> February 2005

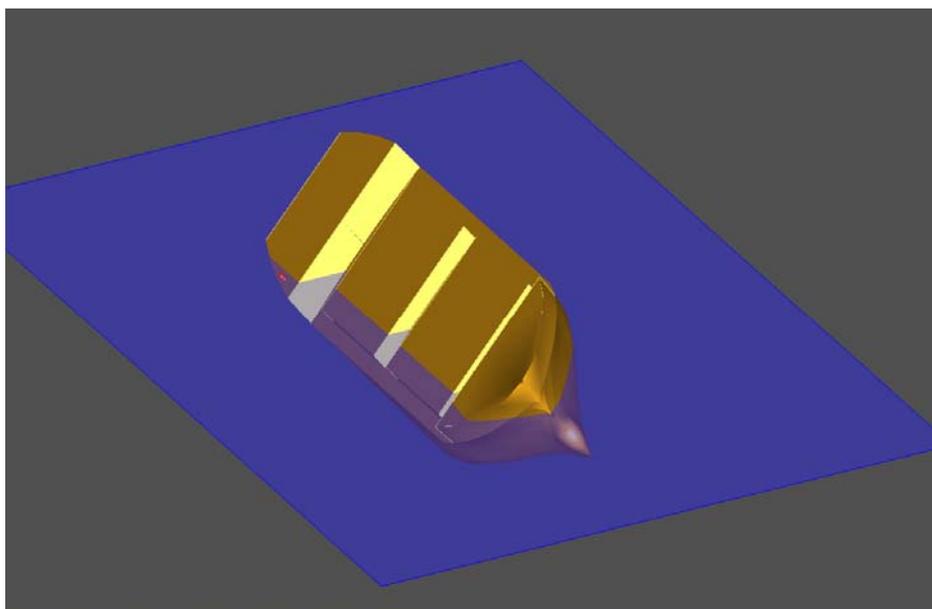
- ◆ While there is no mention in the ship's trim and stability book of downflooding angles<sup>11</sup> the analysis shows that flooding through the engine control room vent will occur at 39.2 degrees. This equates very closely with the observed events on board. While they were in the control room at about the time that the large rolls occurred the Second Engineer and the Electrician saw water coming in through the vent. There is no mention of water in the control room when the three men first went in.

Computer simulation of Jökulfell at 39 degrees – engine room vent in waterline, viewed from ahead

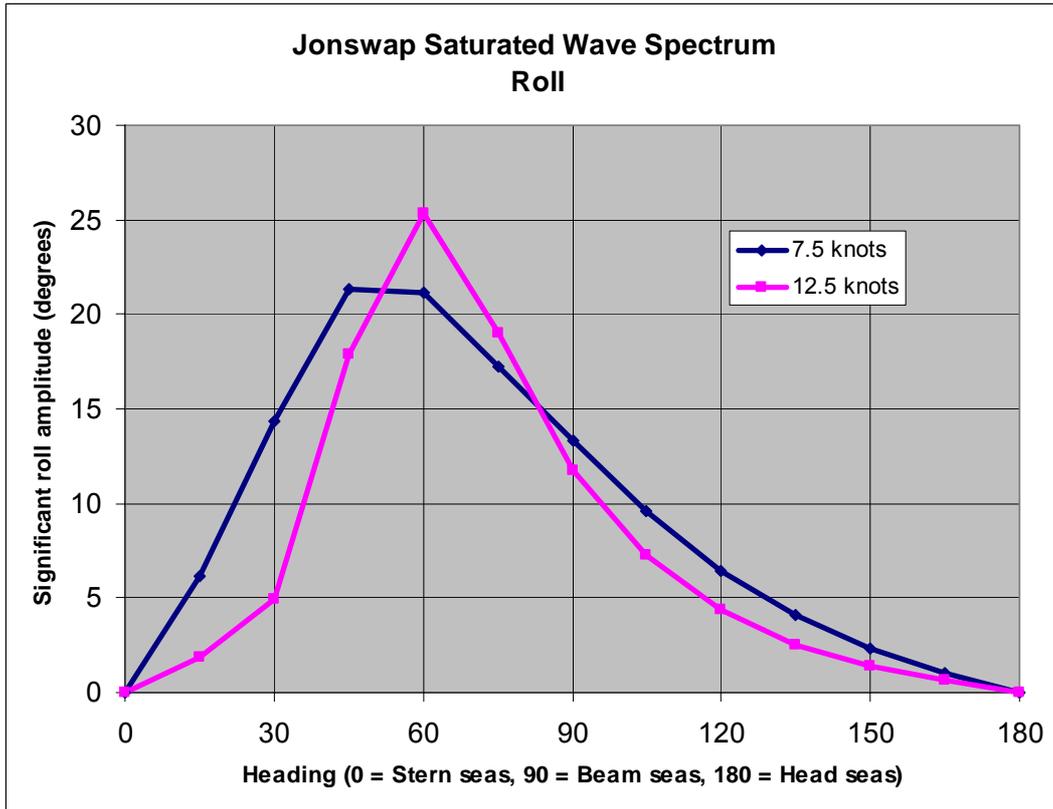
- ◆ Assuming a typical saturated wave spectrum<sup>13</sup> and a ship speed of 12.5 knots the graph of roll amplitude against heading (referenced to the wave direction) shows a dramatic significant roll amplitude peak of 25 degrees at a heading that puts the waves 30 degrees abaft the ship's beam (60 degrees from directly astern). A change of 15 degrees in relative heading has the effect of reducing the peak roll amplitudes by 7½ degrees. A change in heading of 30 degrees reduces the peak amplitudes by half or more.

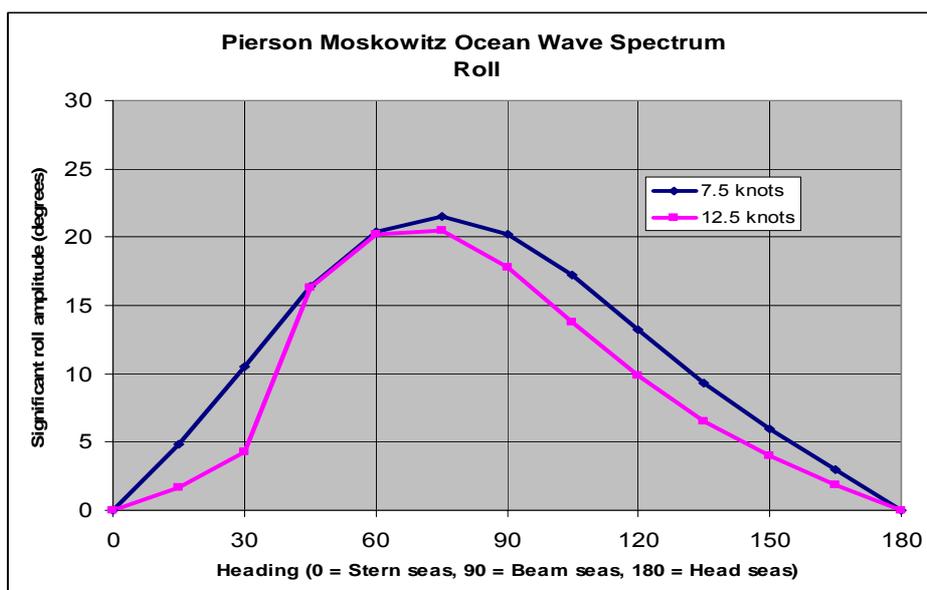
- ◆ Assuming, by comparison, a typical Ocean Wave spectrum<sup>14</sup> a similar graph shows significant peak roll amplitude of 22 degrees occurring at an angle of 45 degrees abaft the beam. (see over).

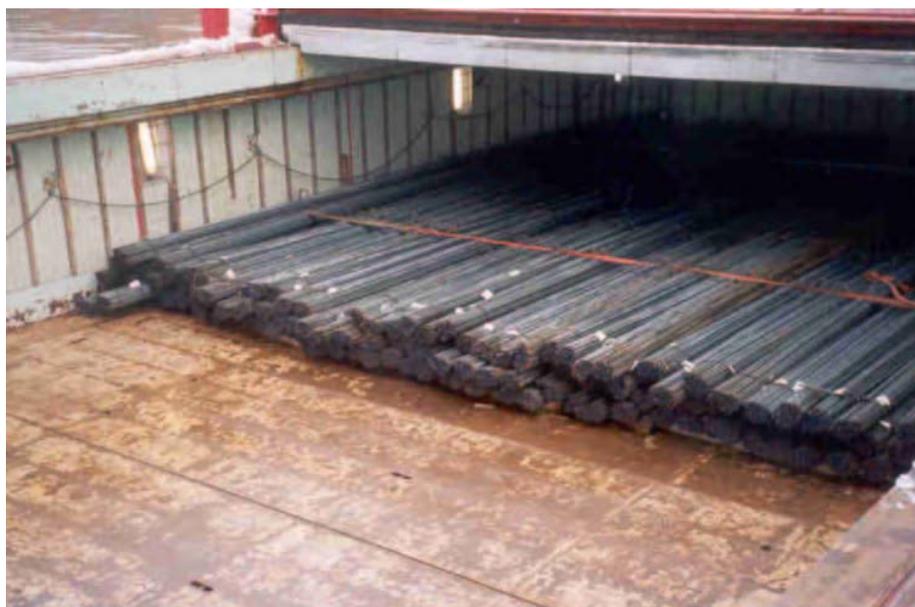
Actual stow of reinforcing bars in either No.1 or No.2 Upper T'ween Deck aboard Jökulfell before departure and before loading the construction cargo. One of the sets of webbing lashings is clearly visible.

3.37. In the case of Jökulfell the reinforcing bars were stowed such as to avoid excessive loads, with friction enhancing materials, (the dunnage), without gaps (the bundles tended to mesh quite tightly together and the regular tightening of lashings assisted in this). They were protected from chafing etc, by the dunnage, protected from harm by using webbing lashings, and stowed without gaps in a level layer from ship's side to ship's side.

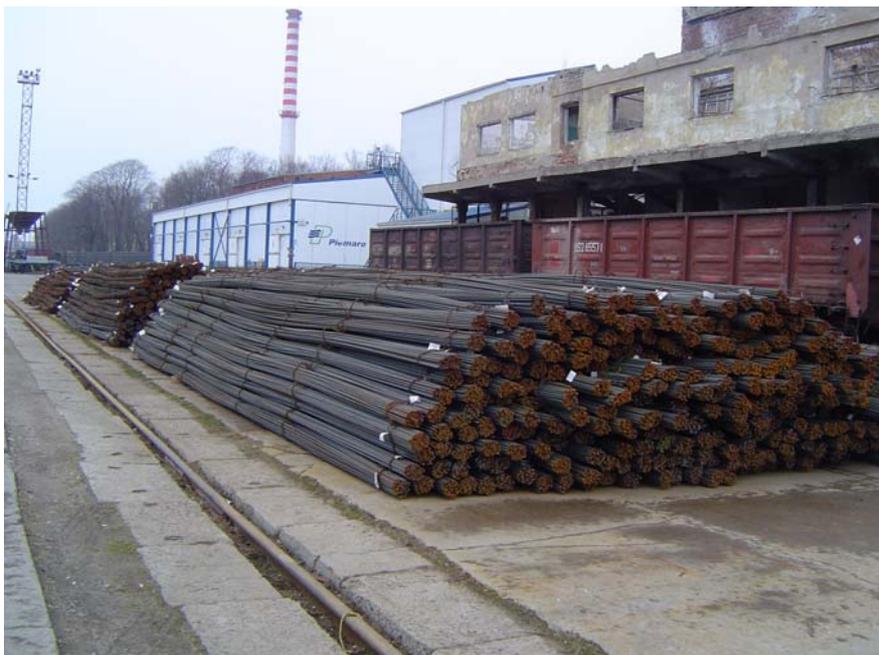
Part of Jökulfell's cargo of reinforcing bars on the quayside ready for loading.

3.38. The picture above shows a part of the cargo of reinforcing bars for Jökulfell stacked on the quayside ready for loading. It is notable that the “block” of bundles has a very steep vertical face with no lashing or support. This clearly indicates that this cargo is not easily moved. It has a strong tendency to stay locked in place. This does not remove the need for proper securing but when these bundles are stowed two or three high fully across the width of the space and against both sides it is the case that the space has to be tilted to a considerable angle to induce movement. It is also obvious, however, that once in motion; a large number of bundles will readily roll over each other.

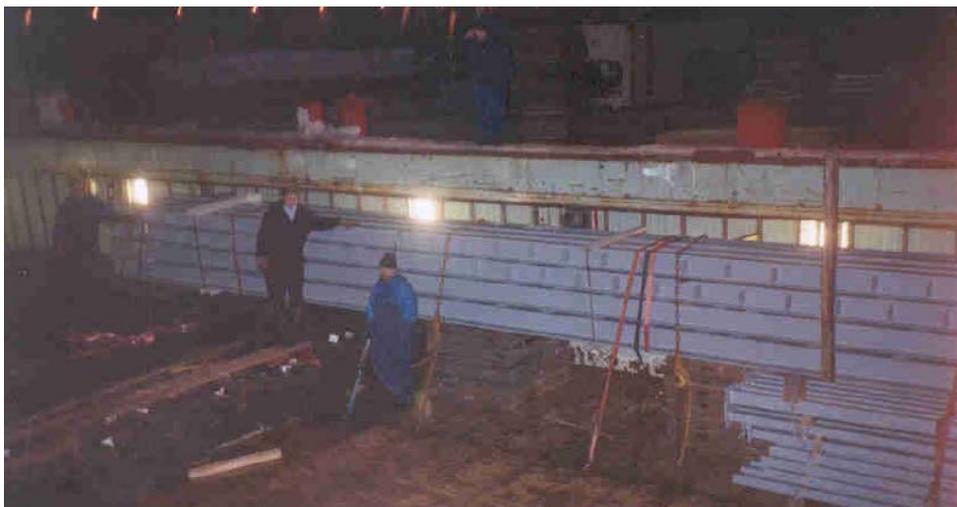
Part of the Construction cargo being loaded in one of the Upper T'ween decks. Note the supporting pallets and the fact that the construction cargo is stowed over the top of the reinforcing bars stow on this deck as well as the number of lashings in place.

- 3.42. Some parts of the reinforcing bar stows were “overstowed” by the large pieces of construction equipment. These were placed on wooden pallets to raise them in areas where there were no reinforcing bars and allow them to be positioned in part on top of the bars. There were not enough items of construction cargo to place elements over the top of all the reinforcing bar stows. The photograph above shows a part of one of the construction items being positioned and it is clearly seen to have one end resting on top of the stow of reinforcing bars at one side.
