Isle of Man Ship Registry

Casualty Investigation
Report No. CA107

Isle of Man Registered “Ostende Max”

Collision

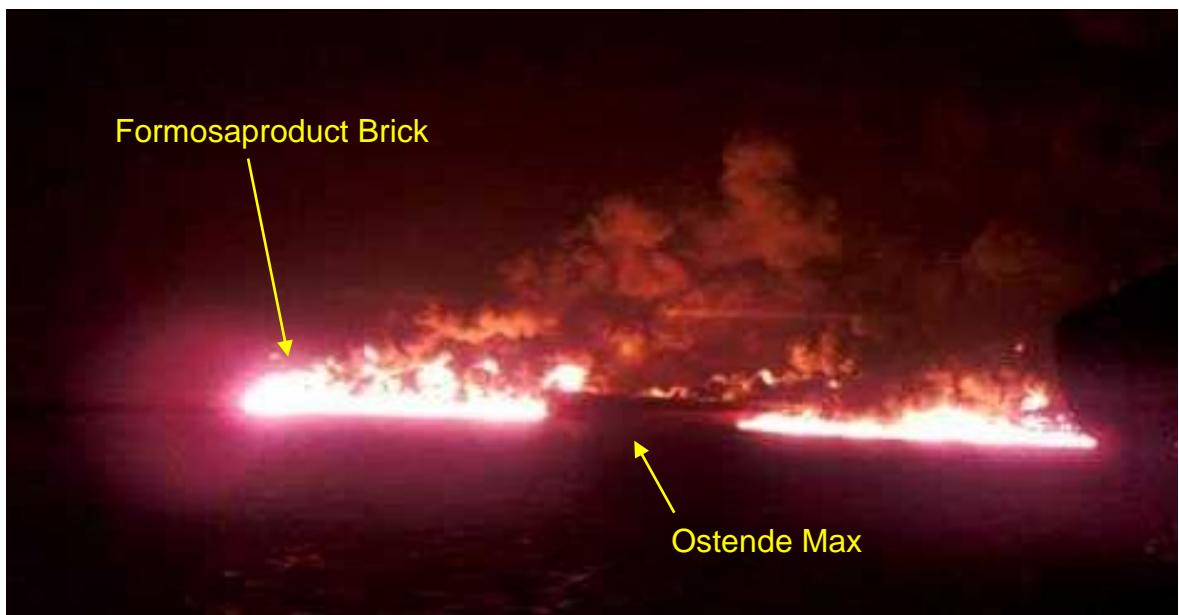
A massive explosion occurs on the FPB as a cargo tank ruptures. Naphtha cargo spills from the FPB and ignites. The ignited spill engulfs the sea surrounding the Ostende Max. The Ostende Max and Formosaproduct Brick suffer significant structural damage. The hull paintwork of the OM is set alight. A small fire occurs on the foc'sle deck of the OM.

The picture below is from a film clip taken by a passing ship which shows the scene shortly after collision post separation of the vessels.

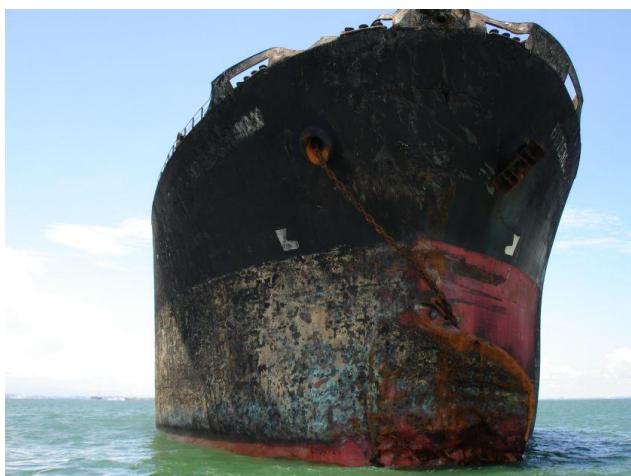
- 2144** The OM is over flown by a Malaysian helicopter assessing the scene.
- 2223** The OM informs the Technical Managers that the hold, ballast and bilges are OK with damage to the forepeak and bulbous bow.
- 2339** The Master calls Klang VTS and informs them that he is standing by to assist the vessel on fire and also requests permission to proceed with the voyage.
- 2342** The Master is informed that he must remain at the scene and that he should anchor the vessel or drift. He is also asked if it is possible to receive the 14 rescued crew from the FPB. This question is not understood.

Ostende Max
Fire and Structural Damage

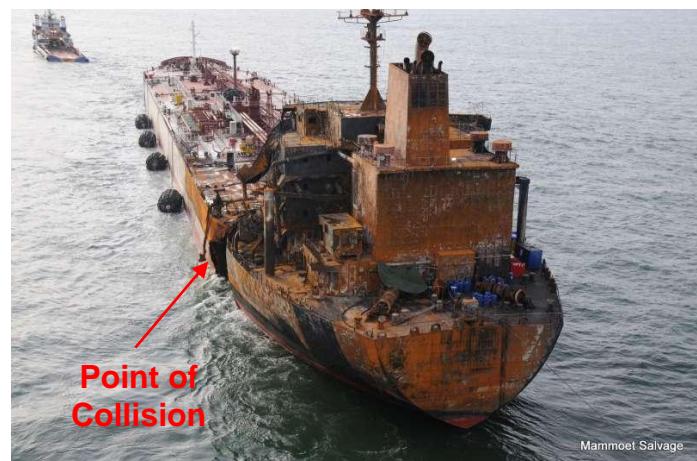
The FPB continues to drift, the aft cargo area and accommodation block fire is eventually extinguished as the exposed naphtha cargo is consumed by the fire and also by the rescue vessels in attendance.

Formosaproduct Brick
Fire and Structural Damage

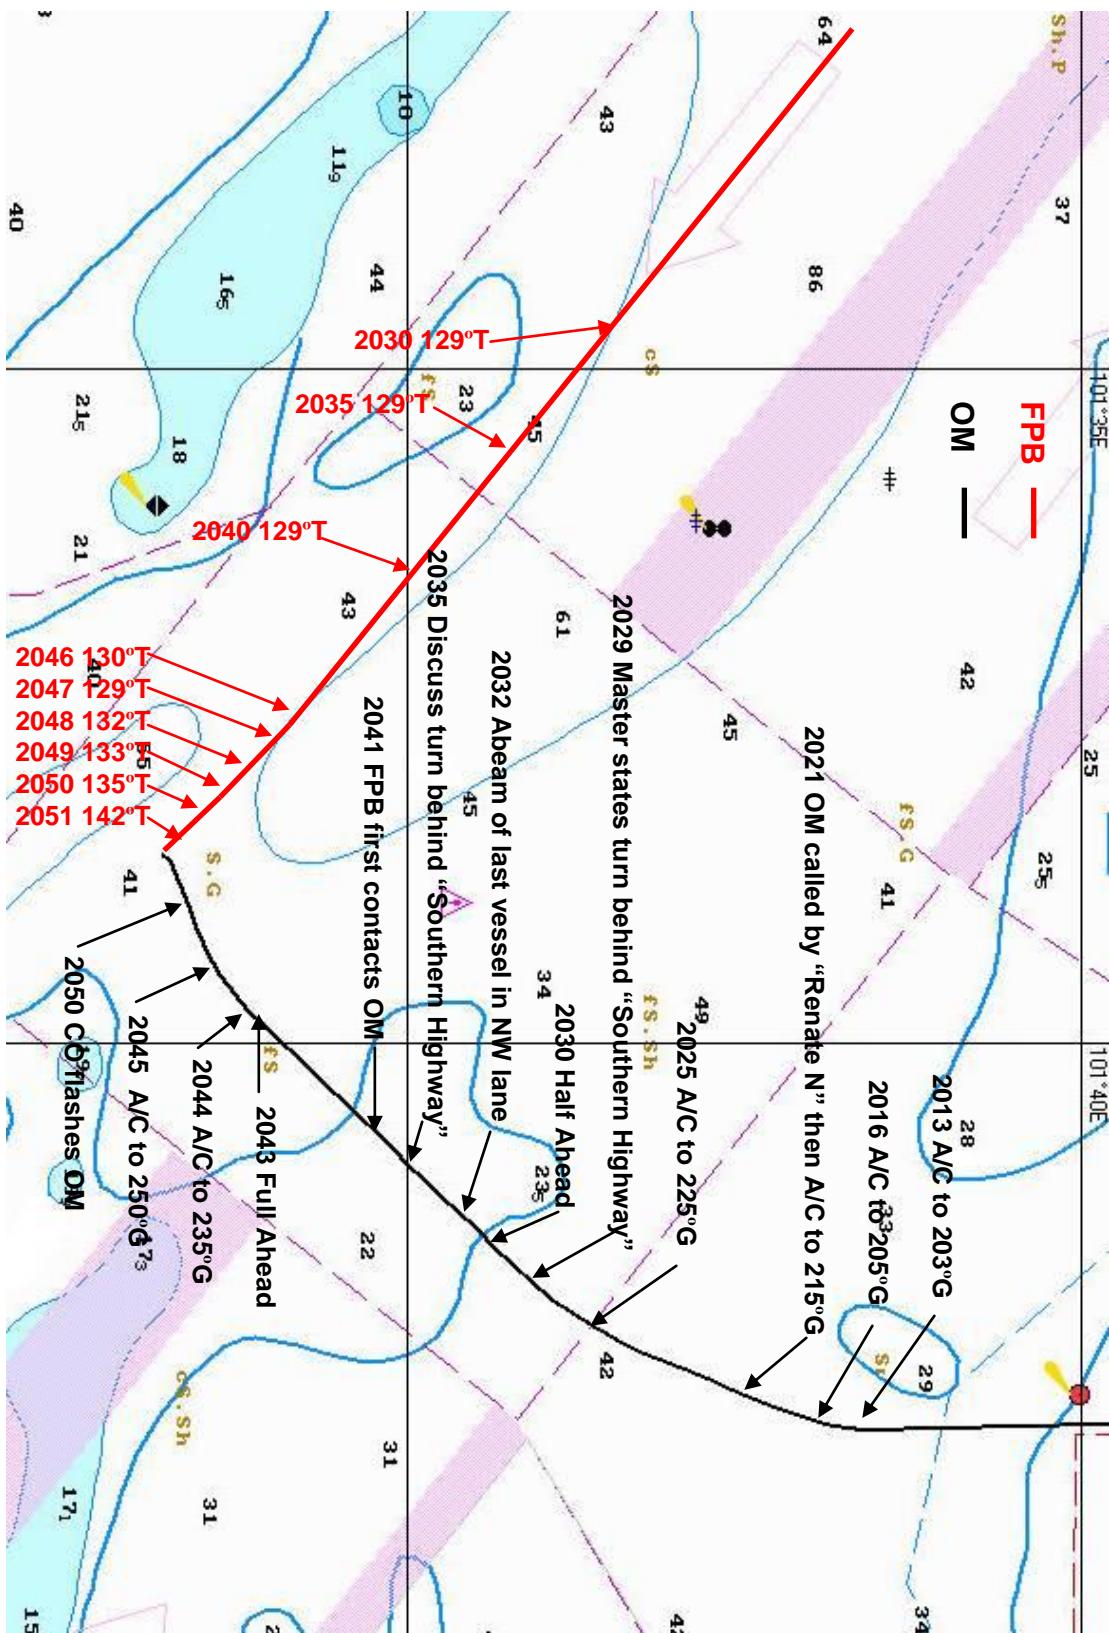
The chart extract below shows an approximate account of each vessel's track leading up to the collision at 2052LT.

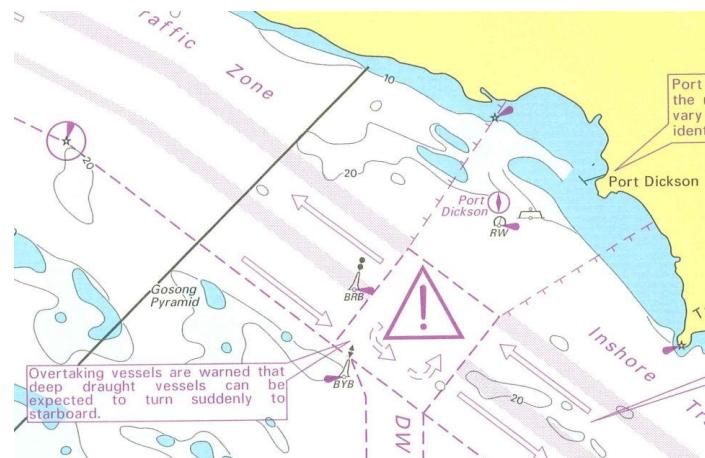
Extract from BA Chart 5502 "Mariners Routing Guide Malacca and Singapore Straits" reproduced by kind permission from the UK Hydrographic Office.

On Chart 5502 the Precautionary Area to the south west of Port Dickson has arrows indicating the recommended direction of traffic flow. The arrows indicating the recommended direction of traffic flow are not indicated on BA3946.

Section 2.9 on Chart 5502 states "A Precautionary Area comprises an area within the defined limits where vessels must navigate with particular caution and be in a maximum state of manoeuvring readiness, crossing traffic is likely to be encountered in these areas. Vessels proceeding in the TSSs, when approaching a precautionary area shall proceed with caution taking note of the local warning system...".

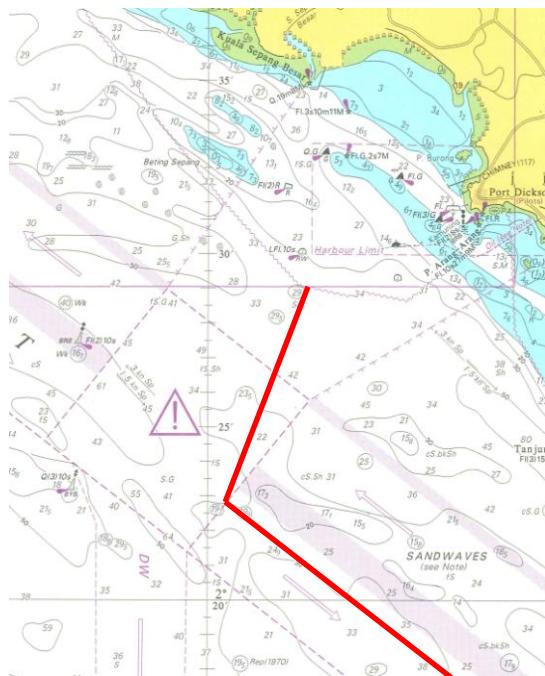
A
Ostende Max's Intended Track

Diagram A below shows the Ostende Max's intended track for joining the SE bound lane. Diagram B shows how the recommended route could have been incorporated into the Ostende Max's Passage Plan.

The Ostende Max's Voyage Plan did not consider vessels arriving at Port Dickson from the SE lane using the recommended traffic flow and instead opted for the most direct route to plan. The Ostende Max was called by the vessels "Renate N" and "Formosaproduct Brick" who initially enquired as to the Ostende Max's intentions with regards to joining a TSS lane.

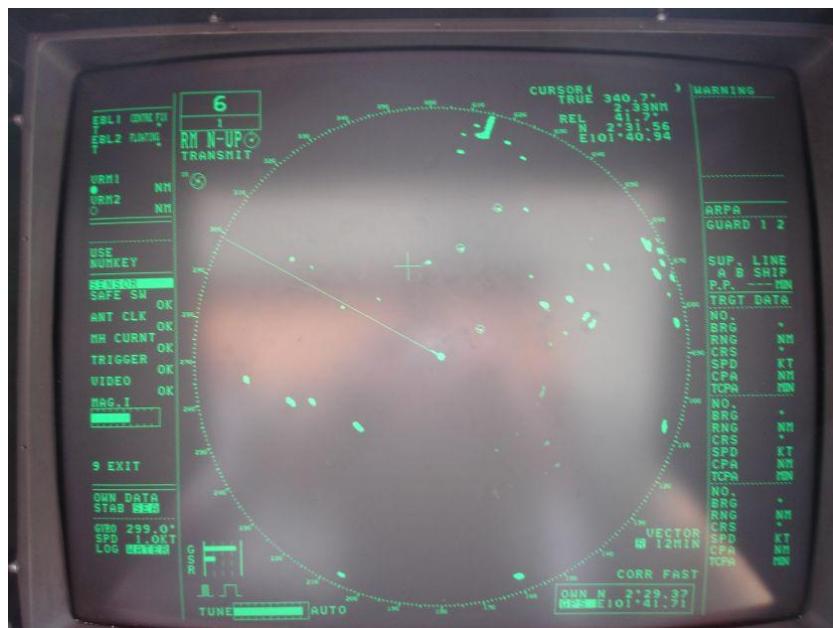
(photo taken at anchor post collision)

The 3O and CO stated that they did not "trust" the radars in general because of 'intermittent' targets and had reported this to the Master. The Master and 2O stated there had been no problems with the radars recently and no defects with them outstanding. Records were available for each radar's service history and daily testing according to the manufacturer's instructions. The radars were inspected on board following the collision and found to be operating satisfactorily.

The picture below shows the ARPA radar set up as it was (except off-centreing) when operated by the CO prior to the collision.

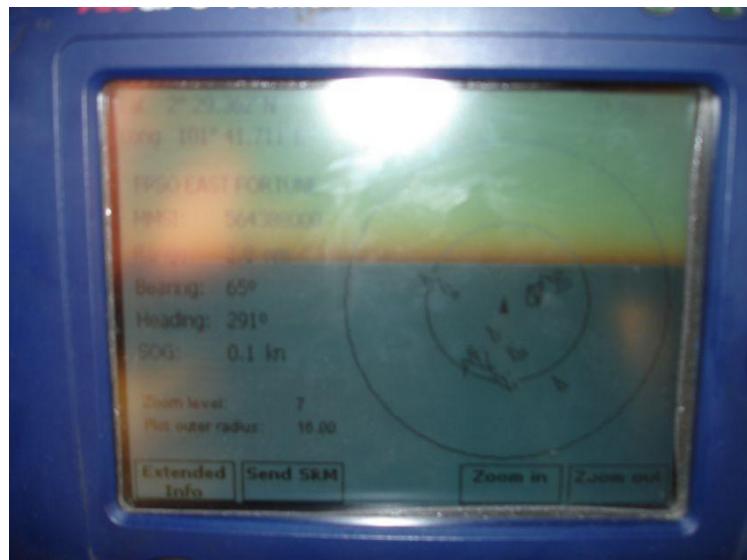
(photo taken at anchor post collision)

The vessel has an AIS unit installed and was operational. It was observed from the VDR AIS data that some targets were intermittent, particularly the vessel "Southern Highway". The following picture shows an actual screenshot of the vessel's AIS. Each vessel displayed could be interrogated for vessel details.

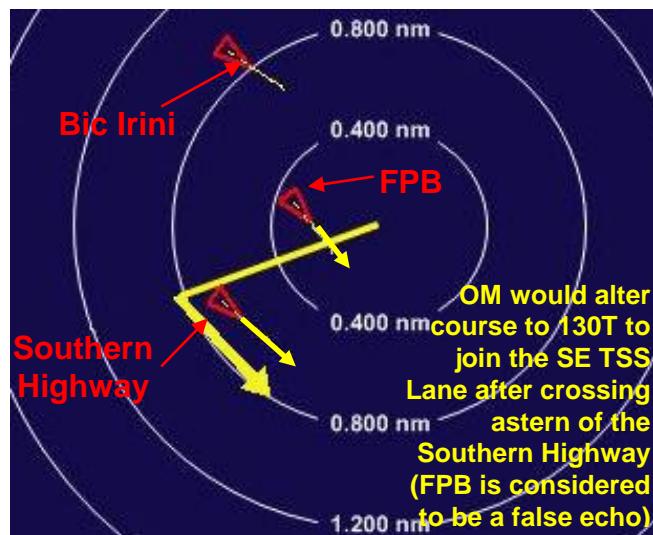
AIS Screenshot at 2051 for diagrammatic purpose

The OM was the give way vessel from 2020 after the Master instructed the OM's Bridge Team to turn after passing astern of vessels to starboard. Based on the developing situation the diagram below shows the OM's likely intentions with a view to passing astern of the Southern Highway and then altering course to port once clear of the Southern Highway's stern to join the SE bound TSS lane. The FPB is thought to be a false echo on the radar.

The OM had ample time and opportunity to properly assess the situation and to take appropriate action to keep well clear of the vessels on its starboard bow. This could easily have been achieved by comparing vessels observed visually to those vessels displayed on the radar. To comply with the Master's instructions there was ample sea room and time to make a bold alteration of course to starboard in good time and show the Bic Irini, Southern Highway and FPB the portside navigation light in order to pass the vessels at a safe distance before altering course towards the SE TSS lane.
