Isle of Man Ship Registry

Casualty Investigation
Report No. CA121

**Isle of Man Registered “Sally Ann C”
Enclosed Space Fatalities and Near Fatality**

13th March 2015

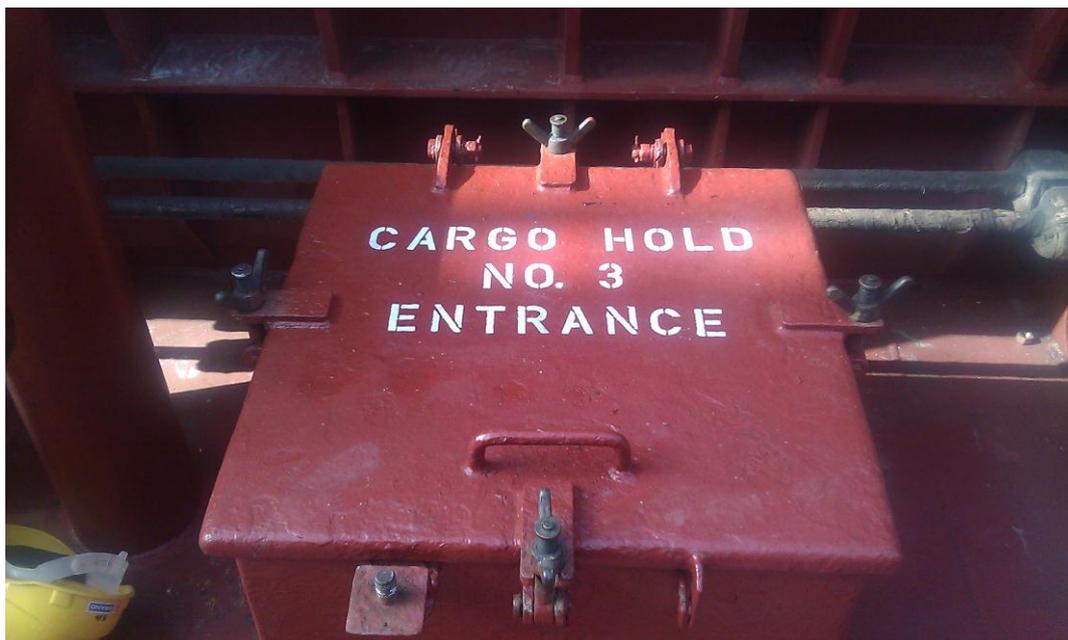
Entrance to Cargo Hold No.3 at the cargo recess area, located midships between No.2 and No. 3 cargo hatches (frames 95 to 101)

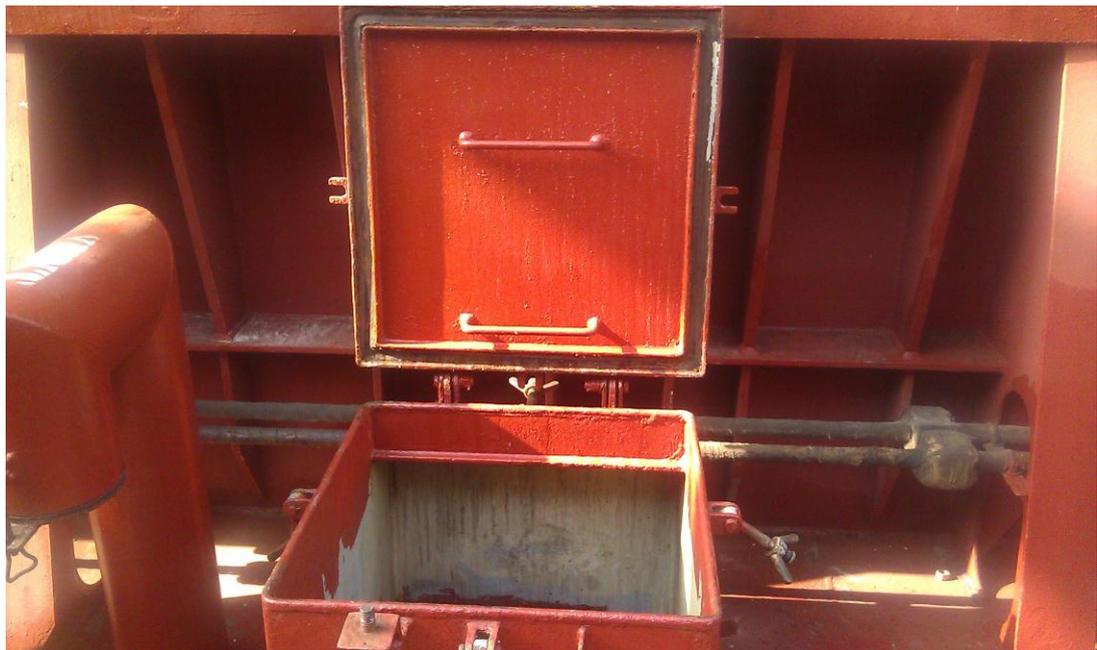
No.3 Cargo Hatch found in open position

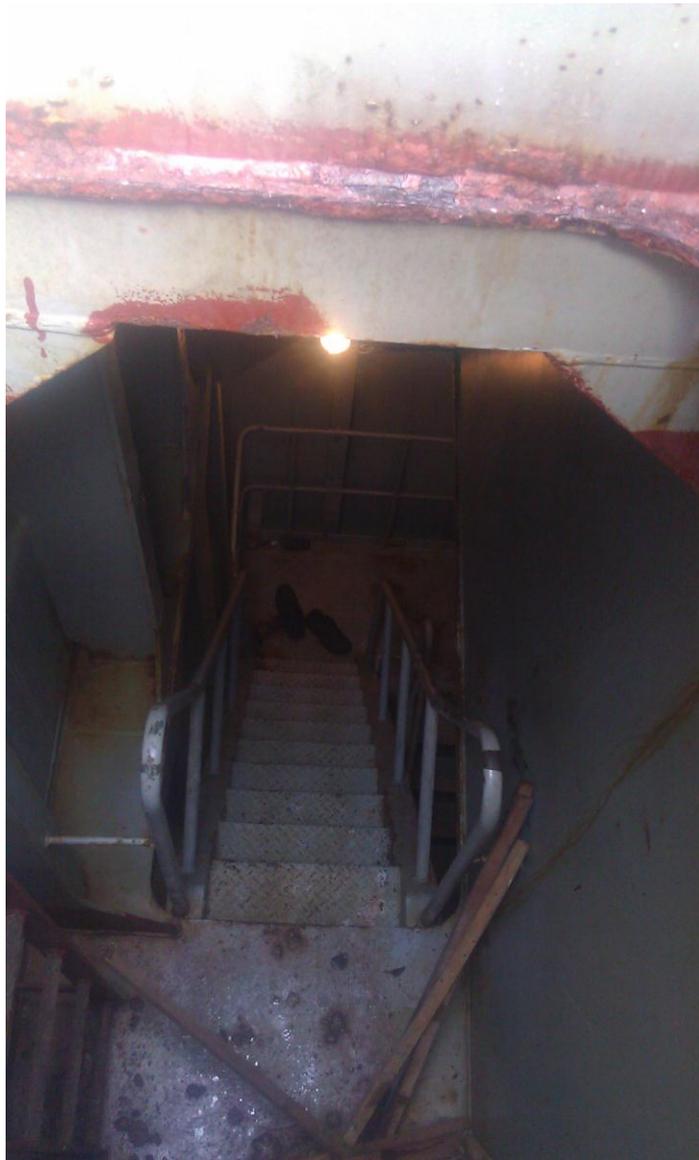
**No.3 Cargo Hatch
View from top looking down onto platform 2 at base of stairway**

Cont'd The O/S (No.8) who had gone forward to the focsle in search of the Chief Officer heard the radio conversation confirming the Deck Cadet and Deck Boy had found the Chief Officer inside the cargo hold access. He ran aft to join them at the incident scene and looked inside the cargo hold access noting the Chief Officer was lying apparently unconscious on platform No.2.

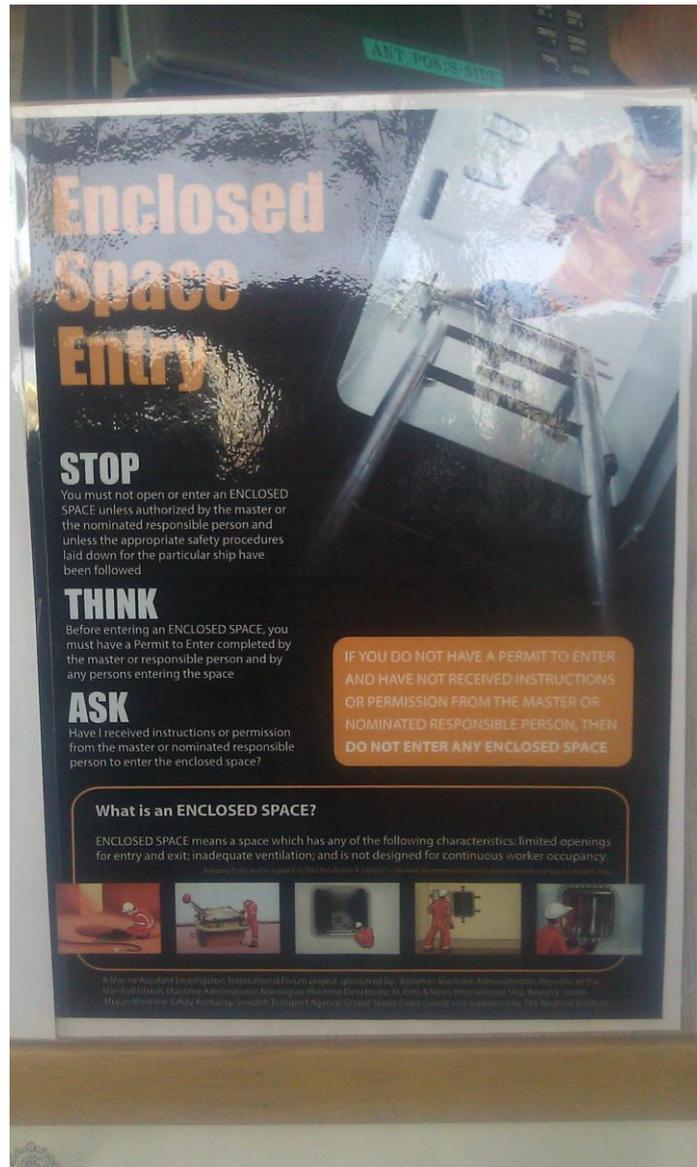
Additional comment; It seems the practice of enclosed space entry is well known BUT the definition of "enclosed space" needs to be highlighted

Copy of Enclosed Space Entry Poster found on board Sally Ann C

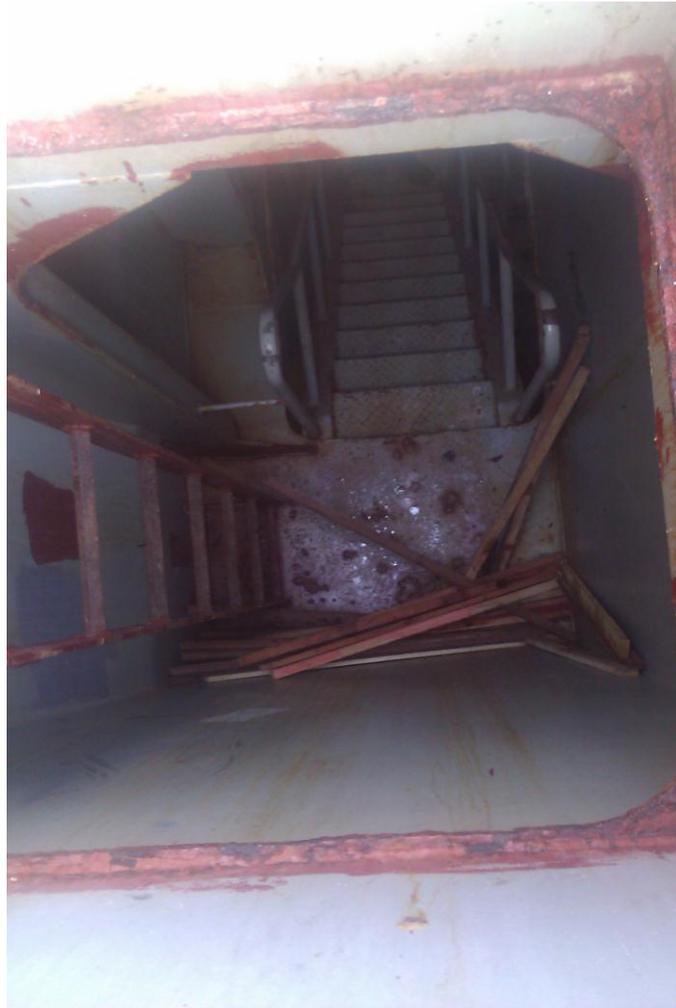
The ship's Master eventually gained access to No.3 cargo hold during the discharging of cargo and a broken security tag was found hidden amongst the dunnage lying on platform 1 at the base of the vertical ladder. It was subsequently identified as the missing security tag number 3008.

No.3 Cargo Hold Access showing Platform 1 at base of vertical ladder

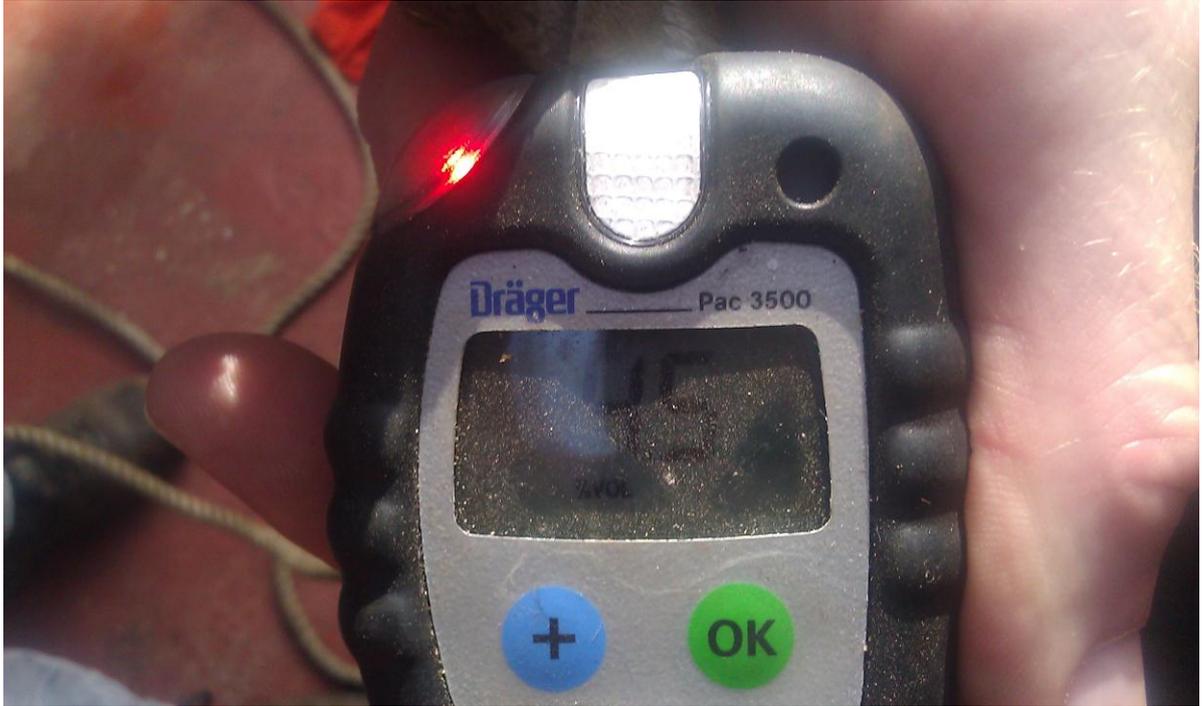
As part of the investigation a measure of the oxygen levels in No.3 cargo hold access and stairway were taken using another portable oxygen meter. The meter was lowered into the cargo hold access and within a couple of metres of its descent it went into alarm mode. The test was repeated several times and oxygen level readings noted. Note in the photograph below, one such reading indicated an oxygen level of 4.5%. The lowest observed reading was noted to be 3.5% of oxygen.

Oxygen content measured at No.3 Cargo Hold Access on 16th March 2015

It can be identified from the table above the Chief Officer was very quickly overcome upon entering the hold access space. He was asphyxiated due to the low levels of oxygen and presence of carbon dioxide. The fact he was more than likely inside the cargo hold access space for approximately one hour prior to his discovery, draws the conclusion he was probably dead prior to being found by the crew.

Similarly the very low levels of oxygen found under testing just inside the entrance to the space confirm why the Chief Engineer and 2nd Officer were overcome. When the C/E entered the hold access space in his attempt to rescue the C/O, and subsequently the 2/O in his attempt to rescue the Chief Engineer.

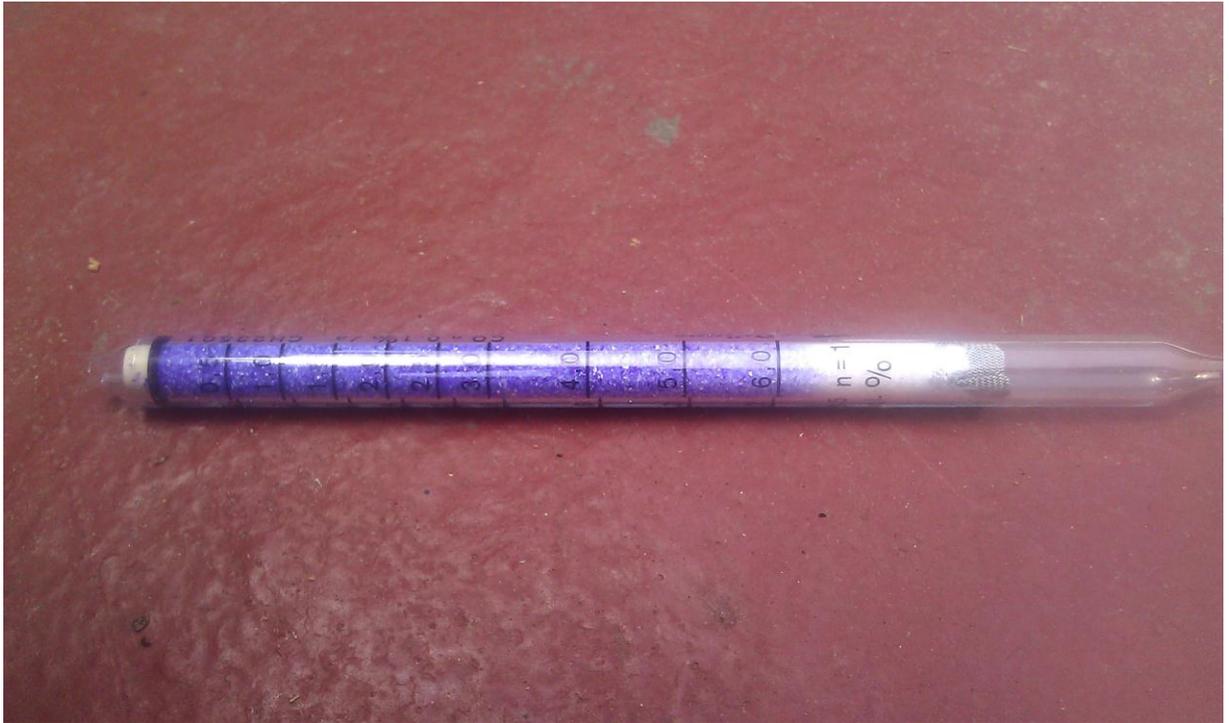
The results found the presence of carbon dioxide at approximately 7m below the access entrance. This is just underneath the second platform which is approximately 6.4m below the Upper Deck level. The depth of the hold access is measured at 9.991m.

Note the change in colour of the test tube crystals to a blue/violet colour and the extent of the graduated measurement indicated on the photograph at 6.0% by volume. This would indicate the lower part of the cargo hold access space to have a large concentration of carbon dioxide gas. The concentration of carbon dioxide gas at higher levels within the cargo hold access was not determined at this point in the investigation. A similar test for carbon monoxide resulted in a zero reading.

Draeger tube reading indicting presence of Carbon Dioxide
