Isle of Man Marine Administration
Oaseirys Lhuingys

Casualty Investigation Report CA 89

“Mirabella V”

Grounding

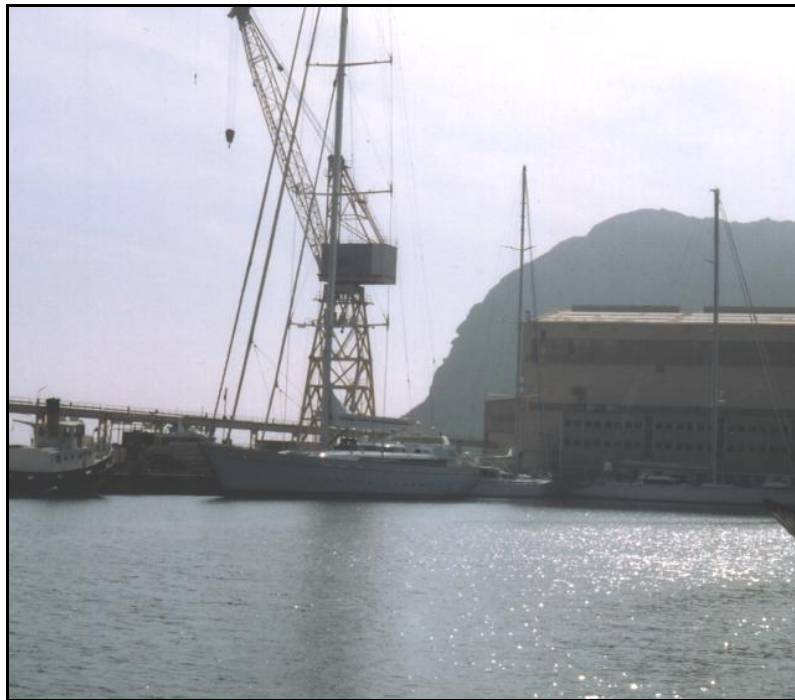
There were no injuries, nor loss of life. Pollution of the environment was insignificant. The yacht sustained structural damage to the keel, keel box, keel lifting mechanism, starboard rudder and transom flap.

Figure No. 1 Mirabella V alongside wharf at La Coitat under repair

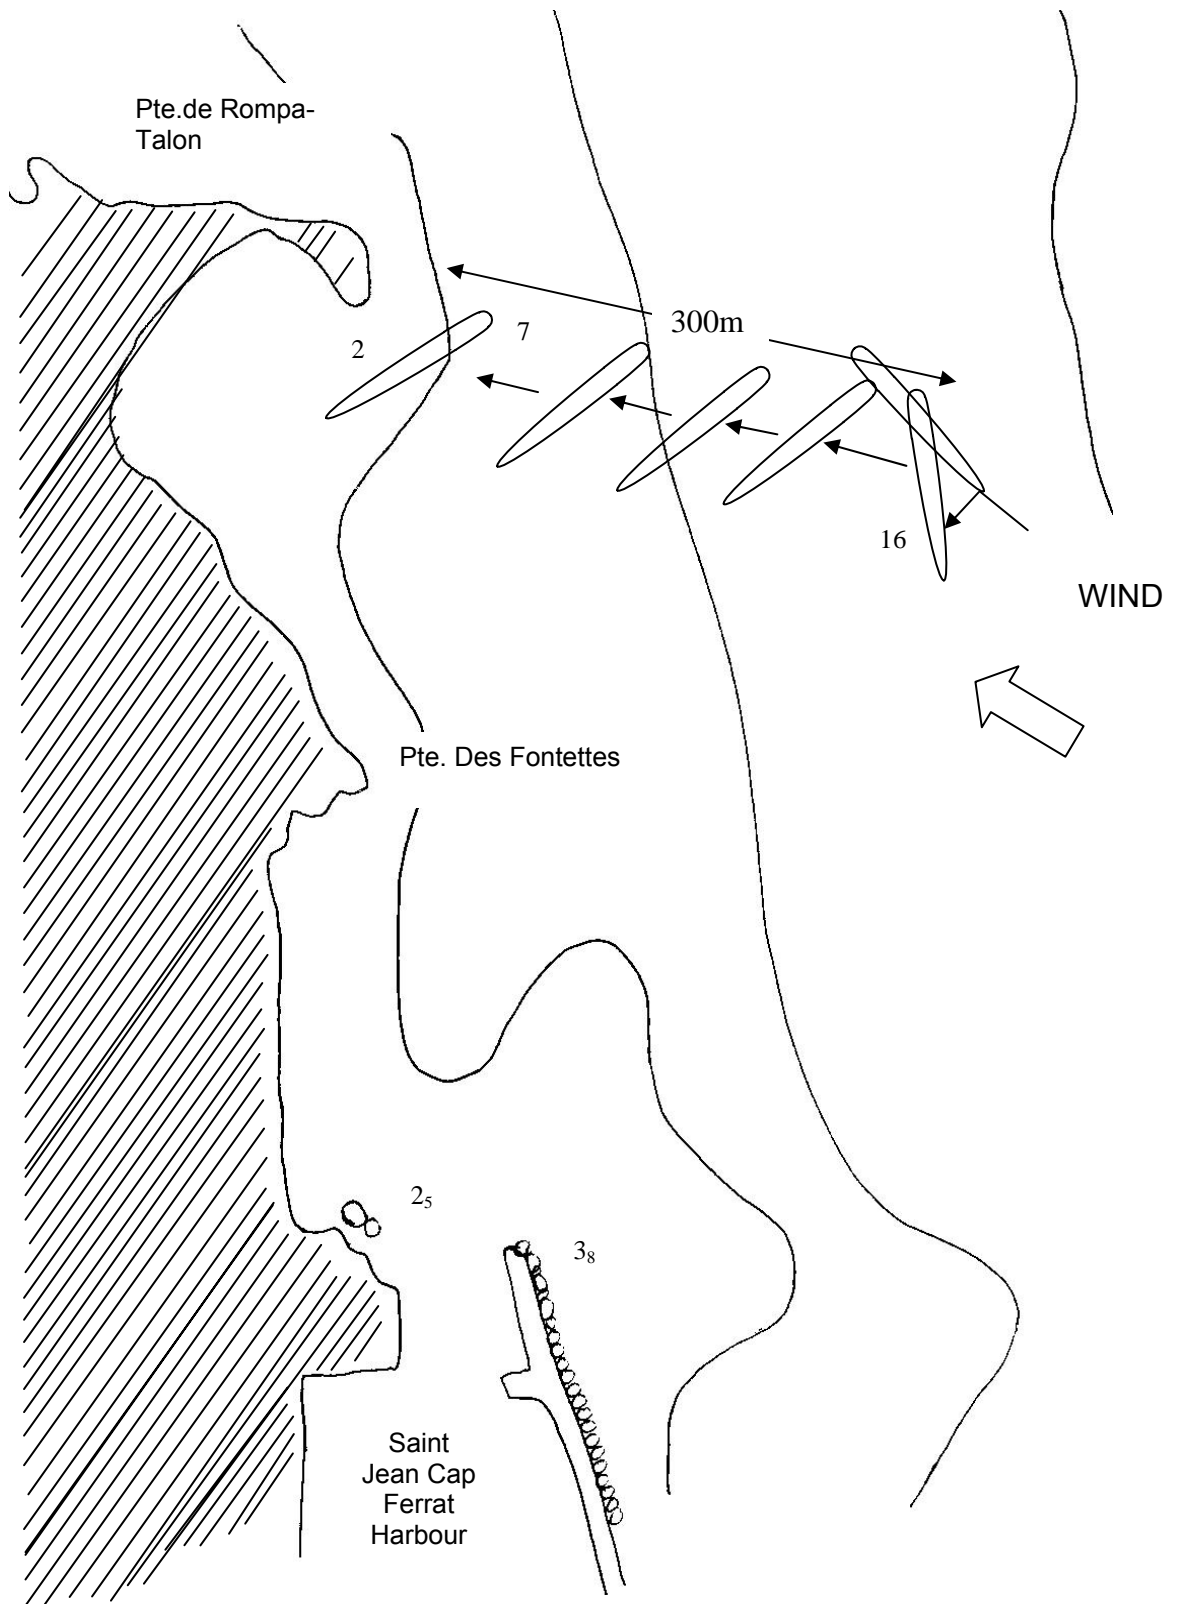
1.3.11.1 At this moment the anchor suddenly began to drag. The Master observed the bow 'falling away' to starboard towards the shore, until the heading of the yacht was beyond broadside to the wind. The Master realised immediately that the anchor was no longer holding.

As soon as the clutches were engaged the Master went full astern and put the steering gear hard to port. At this moment the yacht grounded. The yacht bounced several times along the rocks and then came to a halt with the wind and sea on the port beam.

Figure No. 3
The course and heading of Mirabella V as she dragged her anchor

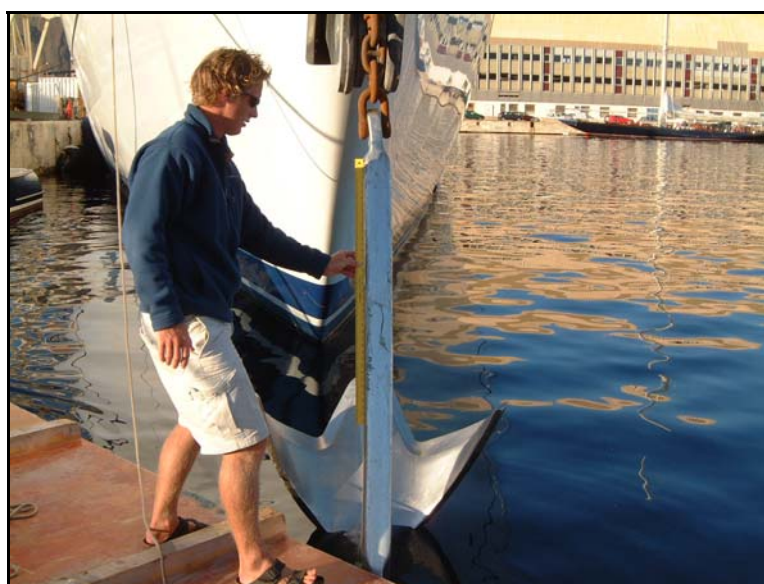
- 2.2.6 It is concluded that the tendency of this yacht to swing at anchor, coupled with a short scope of cable deployed, in all probability caused a lateral load on the anchor shank.

2.3.4 After the incident the anchor shank was found bent.

Figure No. 4
Anchor shank deflection against a straight edge

- 2.3.5 The damage to the anchor suggests that it was in sufficiently good holding ground and firmly secured in the seabed. The holding capacity of the anchor was clearly used to its full extent, taking the equipment to its failure limit.
- 2.3.6 The nature of the damage indicates a very high transverse pull bending the shank.
- 2.3.7 It is possible that this high transverse pull would have been cyclical, induced by the yacht swinging around the anchor. This would have the tendency to work the anchor from side to side, breaking it out from its holding position.
- 2.3.8 It is concluded that the anchor was pulled out from its holding position by a large transverse pull on the anchor shank as the yacht swung about her anchor.

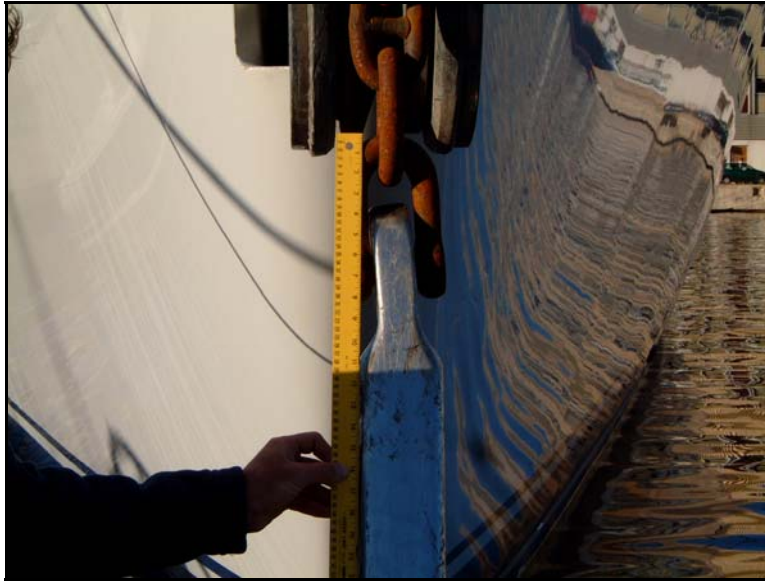
Figure No. 5

Deflection at end of anchor shank against a straight edge

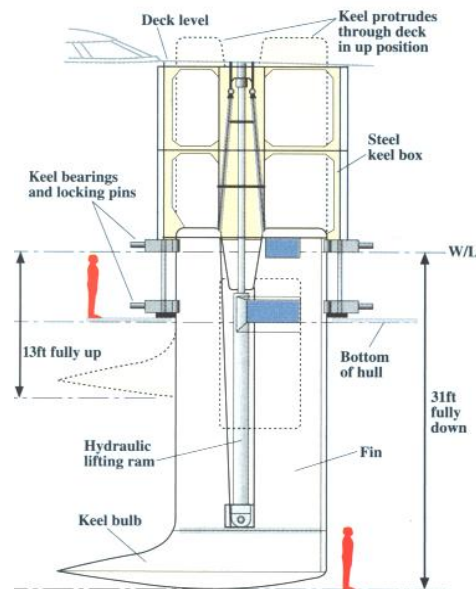
Figure No. 7
Diagram of lifting keel arrangements

- 2.7.2 The bulb of the keel, extending well below the bottom of the hull was the first part of the yacht to ground. The first couple of bumps sheared the bolts connecting the load bearing cassette around the top of the hydraulic lifting ram. The keel bulb then sat on the bottom with the yacht sliding up and down on the aerofoil section of the keel, with the motion of the waves. The benefit of this was that it kept the main hull of the yacht floating above the rocks, relatively undamaged and prevented the yacht from being driven further ashore. If this foil keel had been of the solid type, the weight of the yacht bouncing up and down on it would have pushed it through the bottom of the hull, causing one or two compartments to become flooded.

- 2.7.4 It is concluded that the yacht did not ground because of a failure in the hydraulic lifting system for the keel.

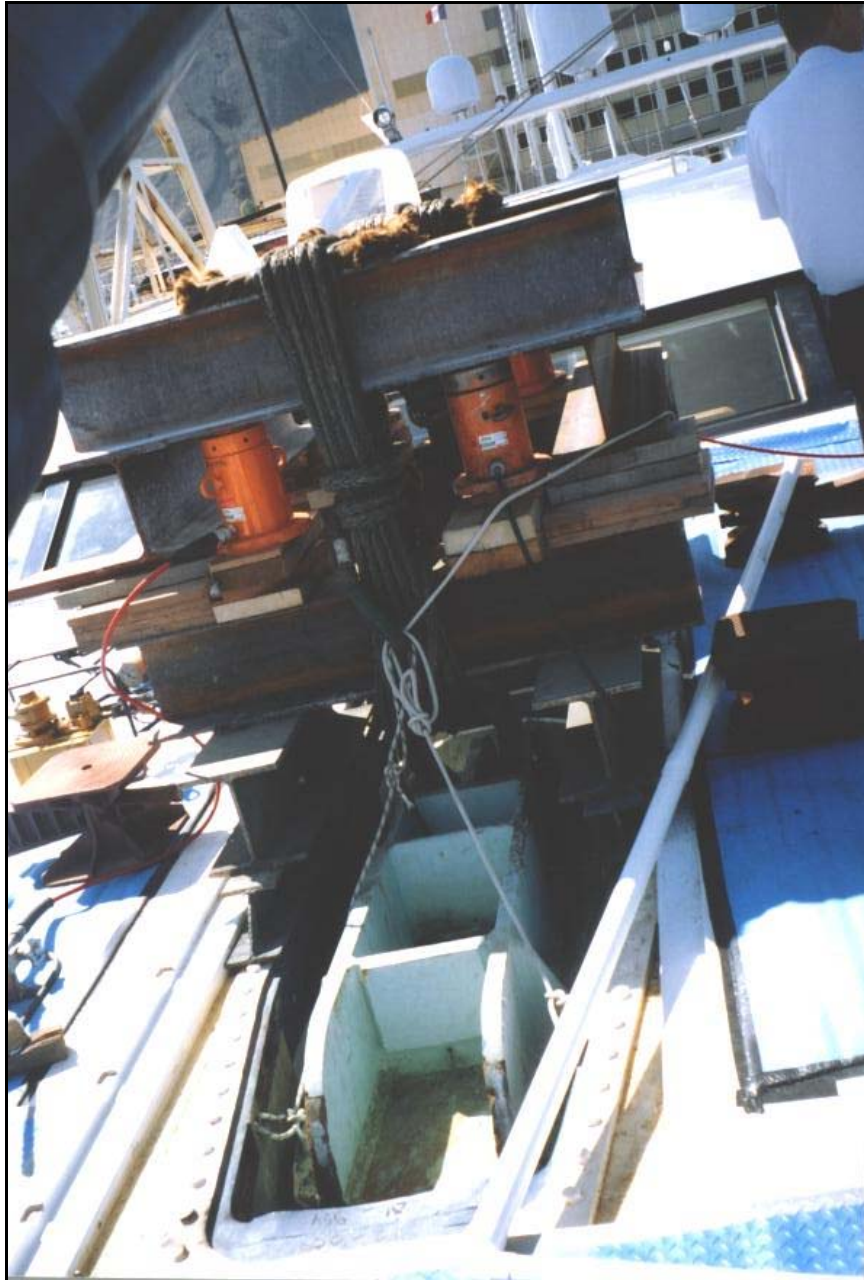
- 1.3.15.3 The Chief Engineer went to the wheel house to try to lift the keel using the computerised control system. However, the lifting mechanism for the keel was showing many alarms. The Chief Engineer tried to override the alarms manually but was unable to do so. By this time the keel had dropped down onto the seabed and the yacht was heeled over by the waves/wind. The Chief Engineer looked forward out of the wheelhouse and observed the keel load bearing cassette lifting. This unit joins the top of the keel lifting ram to the keel box. It had been sheared off, and was lifting as the seabed took the weight of the keel.

7. Temporary repairs made to keel lifting mechanism
