Casualty Investigation Report CA 86

Sinking of Isle of Man registered fishing vessel

PL 17 "TETSUKO"

Isle of Man Government Marine Administration

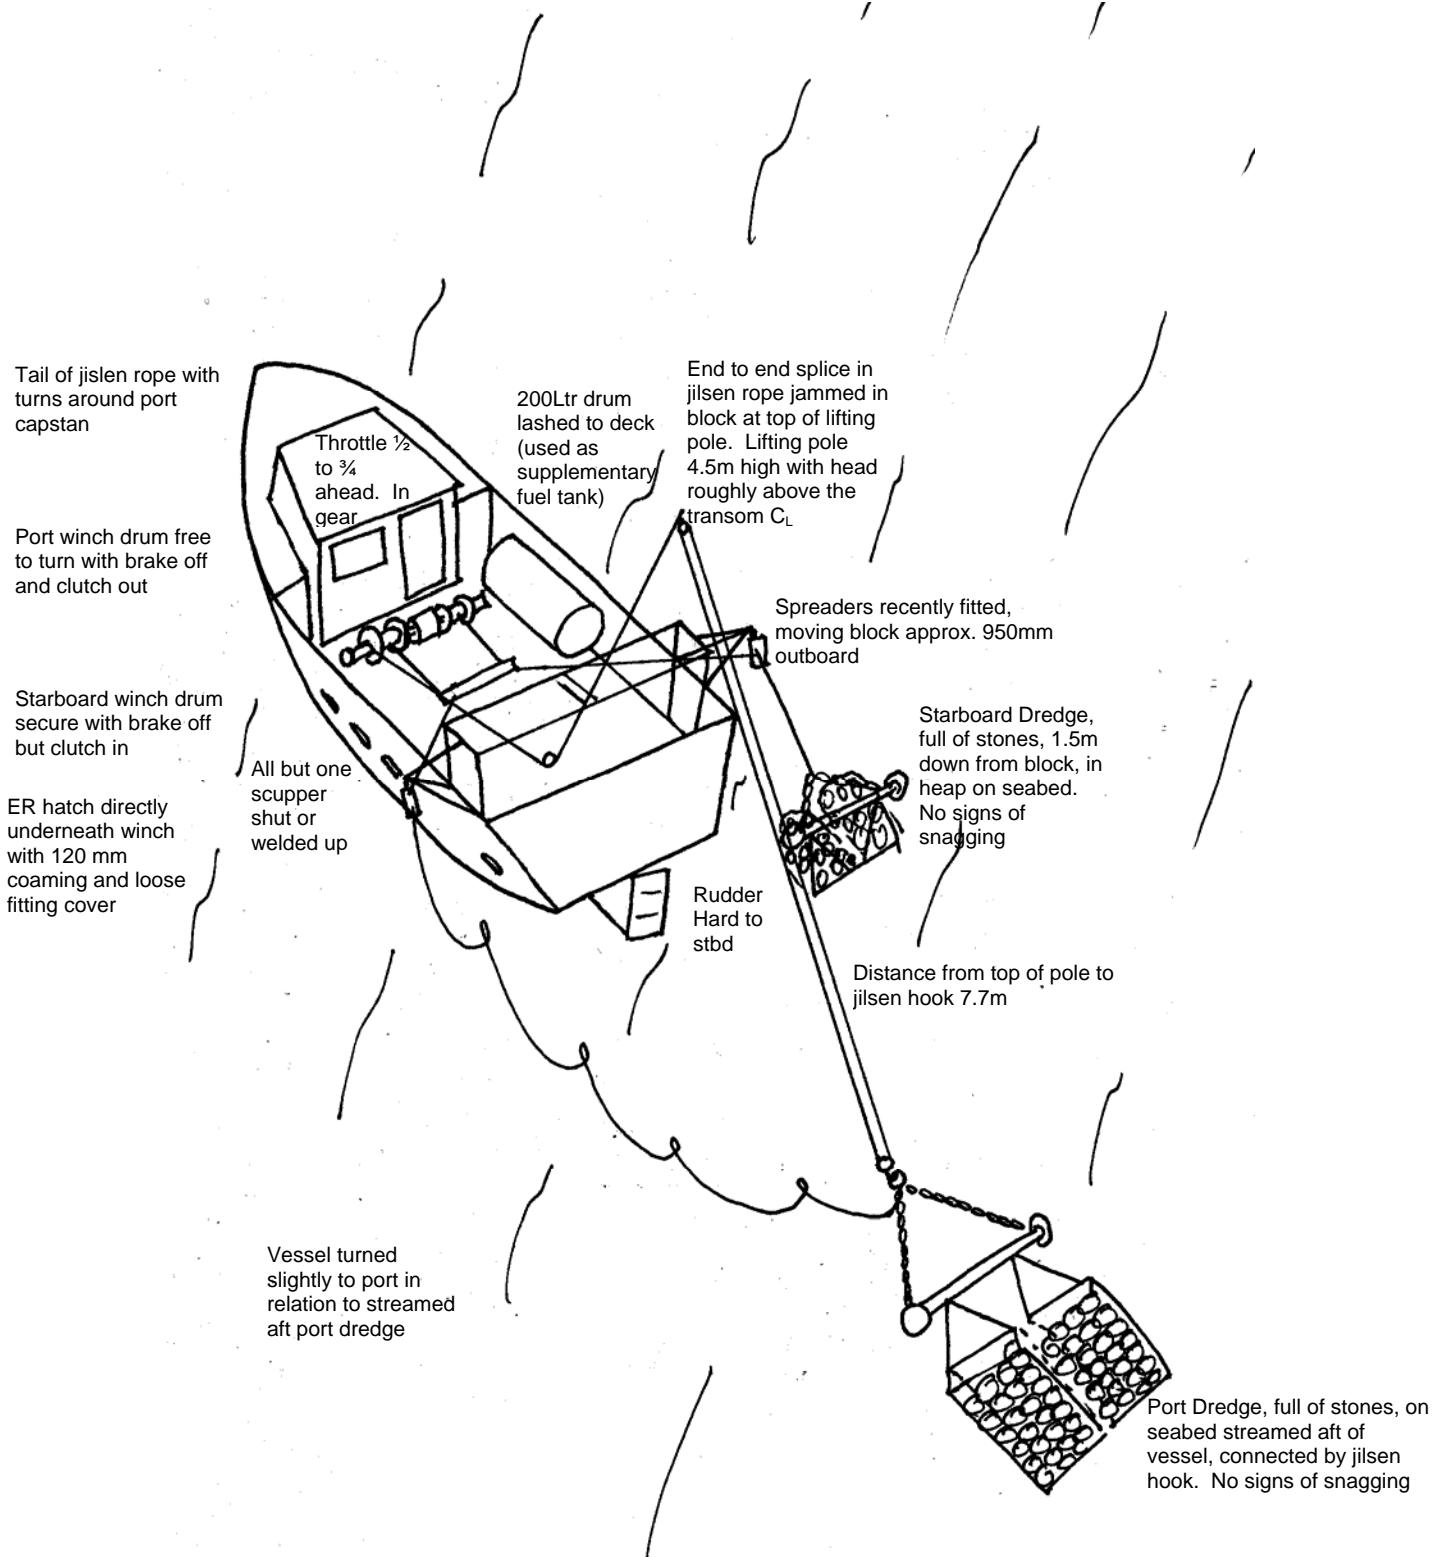
FIGURE 1

HOW THE *TETSUKO* WAS FOUND ON THE 15TH FEBRUARY 2004
FISHING VESSEL IS LYING ON THE SEA BED, LEANT OVER ON HER STARBOARD BILGE

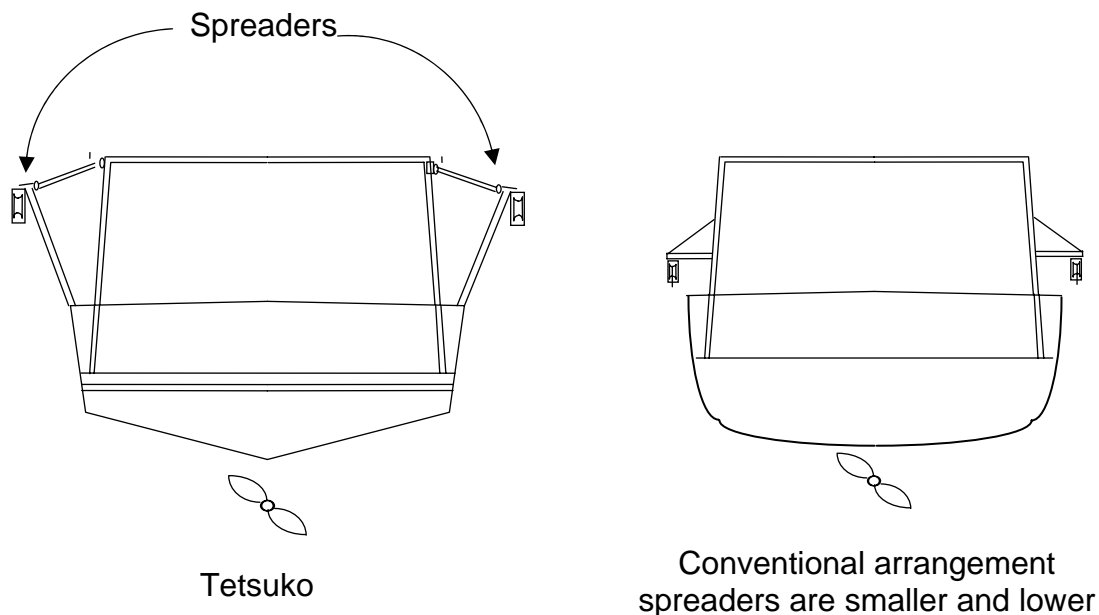
The spreader beams fitted to the gantry raised the suspension point of the dredges upwards and outwards. Both the amount of extension over the side (approximately 950mm) and the height above the deck raised the centre of gravity of the vessel, when the scallop dredges were suspended from them. This would have a detrimental effect on stability. The sizes of the spreaders fitted to the *Tetsuko* were bigger and higher than on other vessels of a similar size.

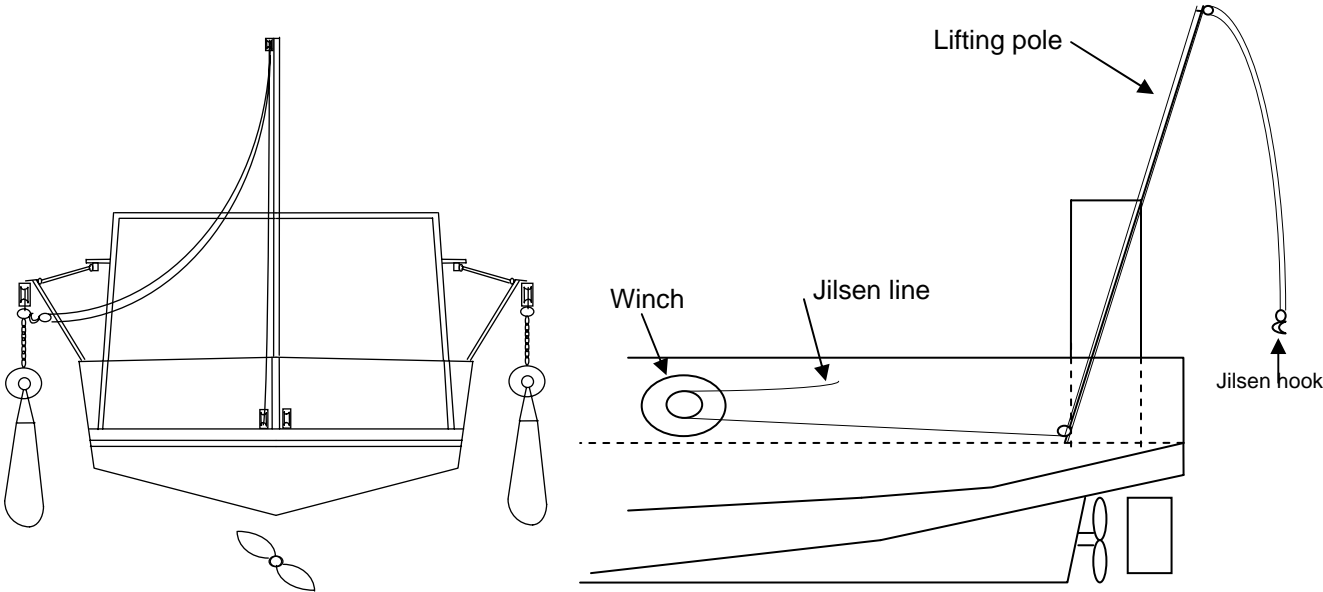
Tetsuko fitted with single aft central Lifting Pole 4.5m high

The height of the lifting pole for the recovery of fishing gear was 4.5m above the deck. This is far in excess of that required to lift the scallop dredges on board. Once the weight is taken on the pole then the centre of gravity effectively moves to the point of suspension, at the top of the pole, with consequent rise in the vessel's centre of gravity and a reduction in stability. In addition, such a large weight suspended from such a height would swing like a pendulum, adding dynamic loading as the vessel rolls.

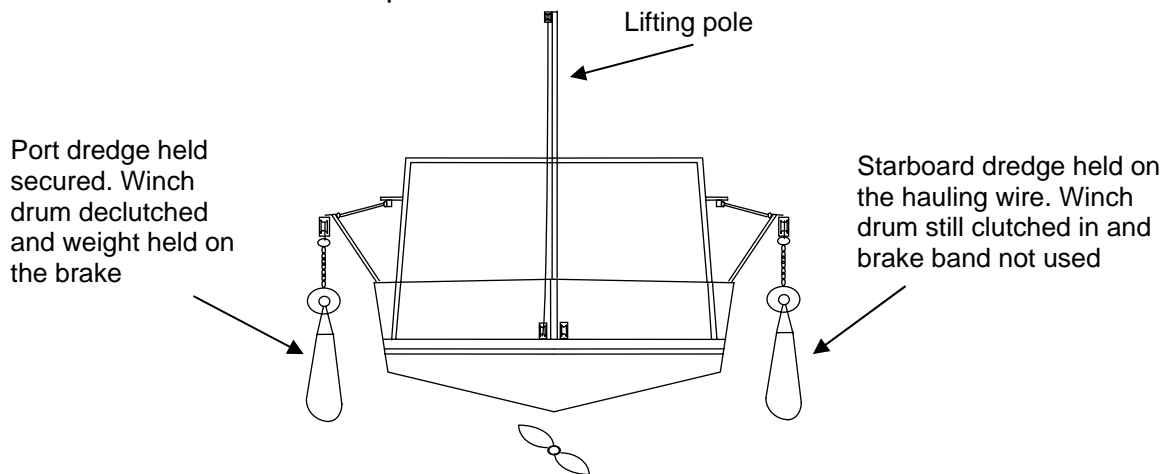
2.3.2.5 It is probable that the starboard brake was not capable of holding the starboard dredge (full of stones). Therefore, the starboard clutch was left in and the starboard dredge held on the hydraulics.

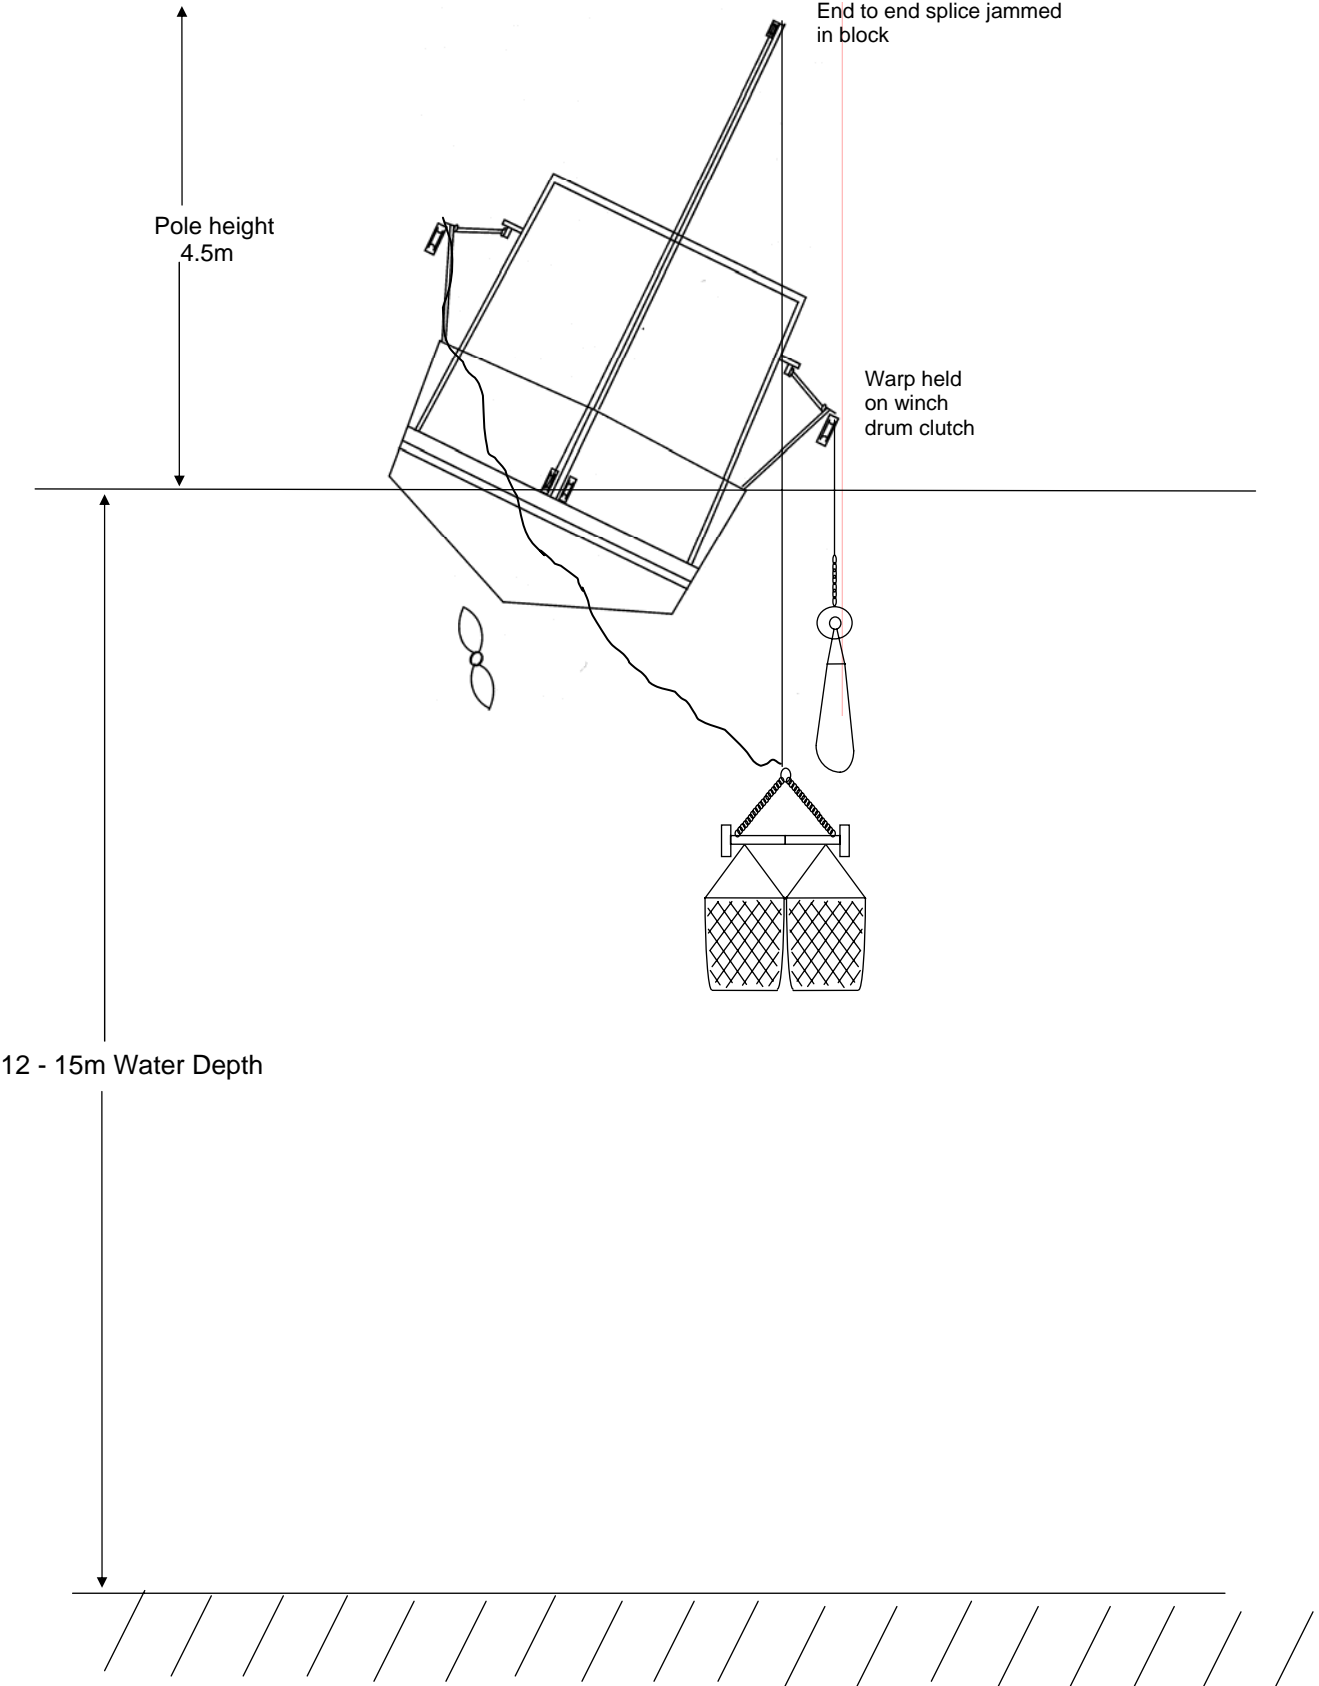
FIGURE 2

The practice of hauling scallop dredges over the stern with such a high lifting pole over the transom can lead to both dredges coming onto one side as the vessel rolls and naturally heels in that condition. With heavy weights in the dredge bags this could lead to a situation as depicted in Figure 2 (Page 20) with disastrous consequences.

POSSIBLE ARRANGEMENT AT THE TIME OF THE INCIDENT

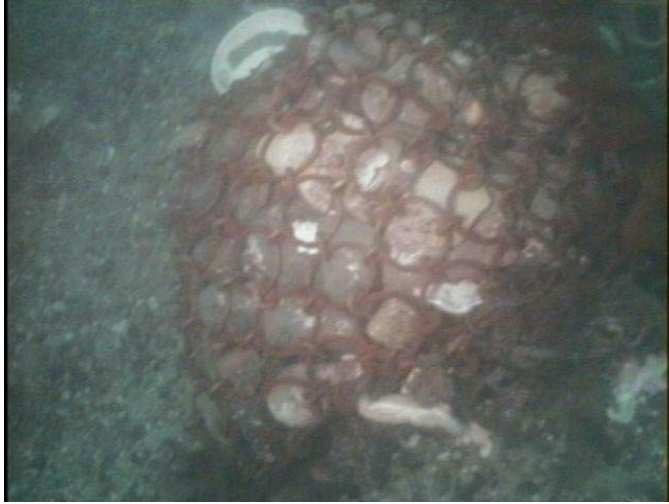
Photo 1
Starboard dredge

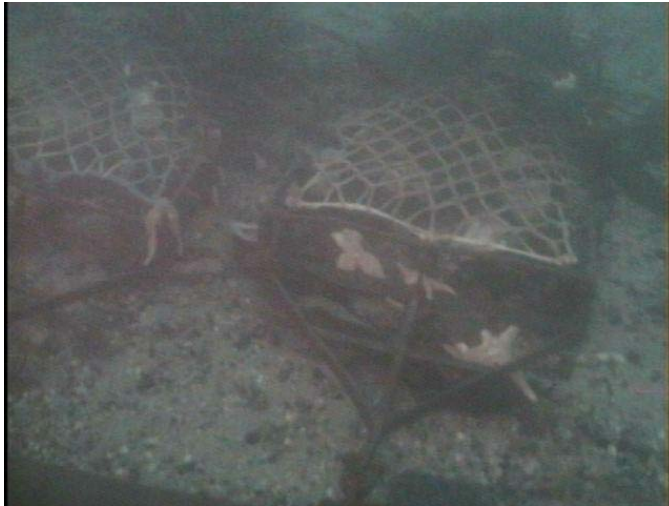
Photo 2
Port dredge

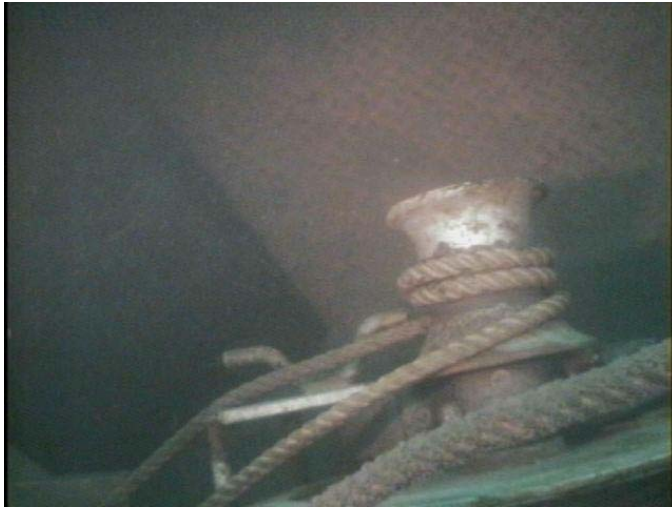
Photo 4
Port winch Capstan

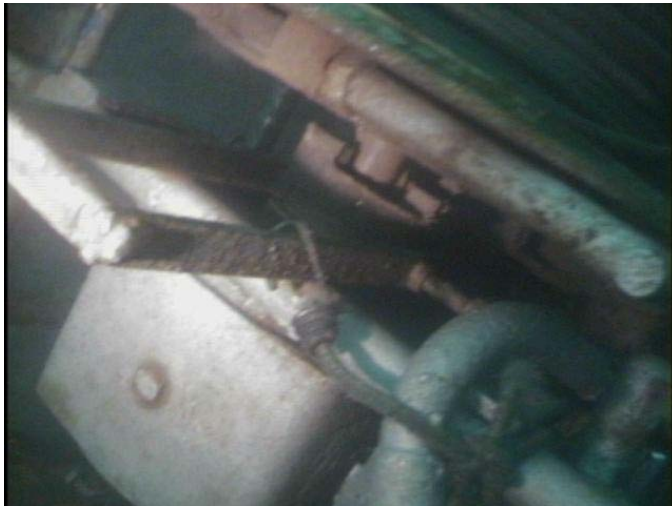
2.3.2.3 The portside dredge was brought up to the port spreader and secured in place by the brake on the winch with the clutch being disengaged on the portside.

Photo 5
Port winch clutch (out)

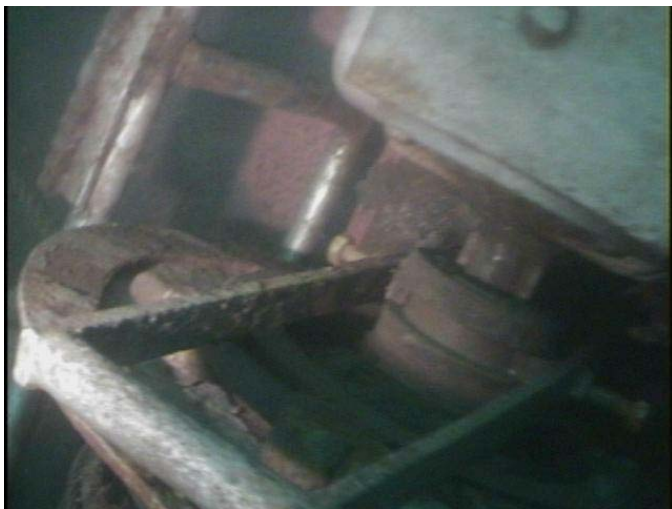
2.3.2.4 The starboard dredge was then hauled up to a position at the starboard spreader and the winch was stopped. The starboard brake band was not applied and the dredge was held in place with the winch clutch still in place.

Photo 6
Starboard winch
clutch (in)

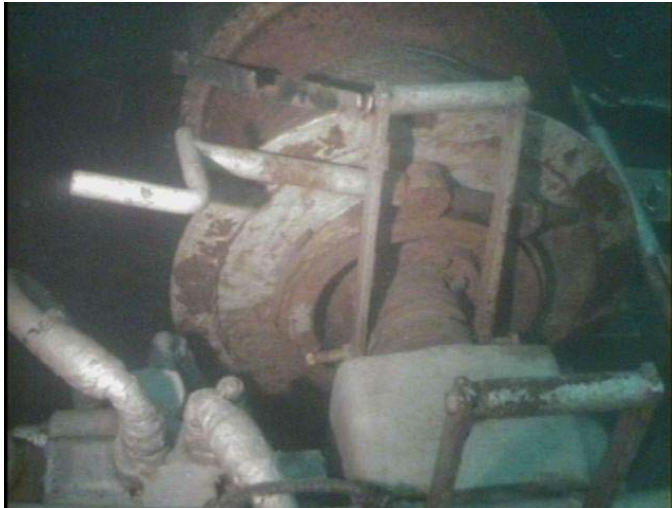
Photo 7
Starboard brake band (off)

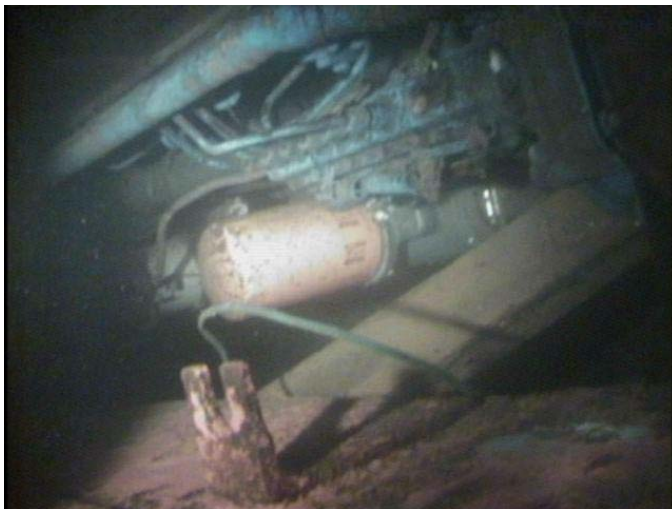
2.2.5 In order for the *Tetsuko* to recover (haul) and deploy (shoot) the trawls a lifting winch was fitted on board. The installation of the winch was placed directly over the access hatch from the main deck to the engine compartment. The access hatch coaming to the engine compartment was 120mm and was found during the dive investigation to be fitted with an unsecured wooden cover.

The result of the winch installation was such that it was not possible for a person of the stature of the skipper to gain any proper access down below the deck to allow him to turn off a sea cock, change a blocked filter or affect emergency repairs. The unsecured cover gave little protection against water on deck and possible prevention of flooding below deck. With the freeing ports welded closed, water on deck could not be discharged and hence would pour under deck into the one open space below.

Photo 8
Engine compartment

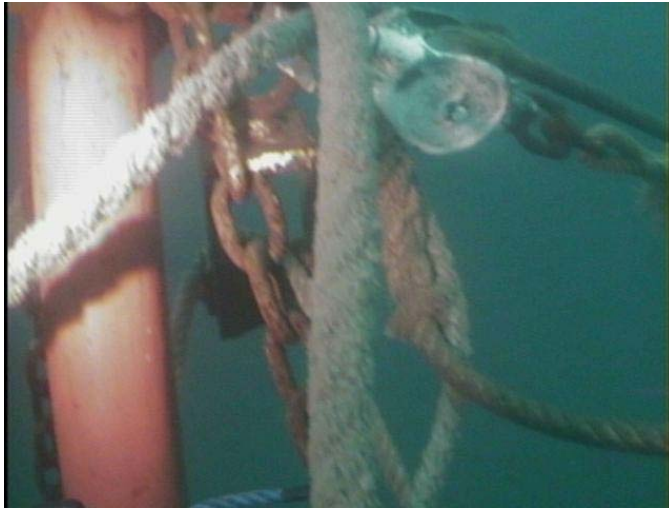
Photo 10
Lifting pole top
note splice in jilsen rope jammed
in block

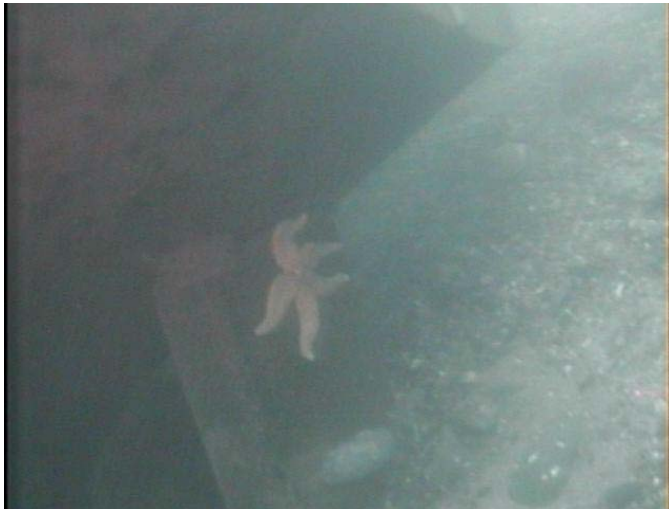
2.3.2.2 She was moving ahead through the water with the propeller engaged, rudder to starboard.

Photo 11
Rudder hard to starboard

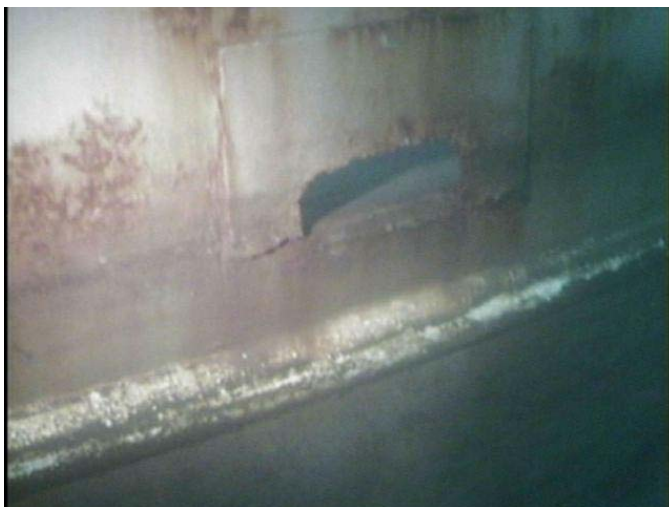
Photo 12
Scupper (partly plated over)

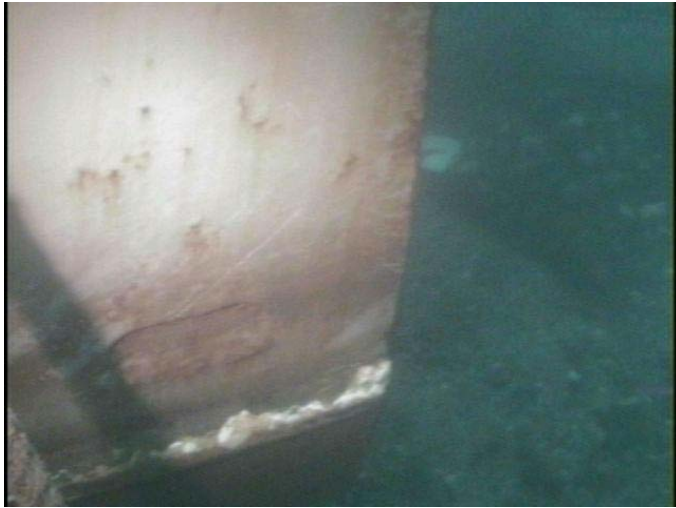
Photo 13
Scupper at aft end welded up

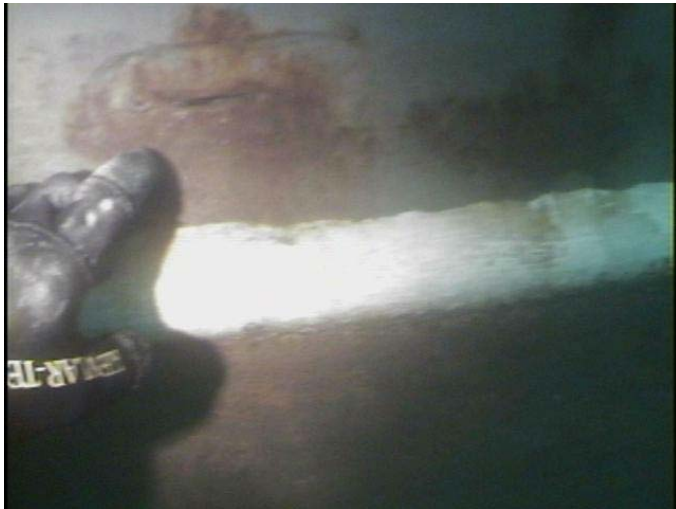
Photo 14
Scupper welded up but with
small slot cut

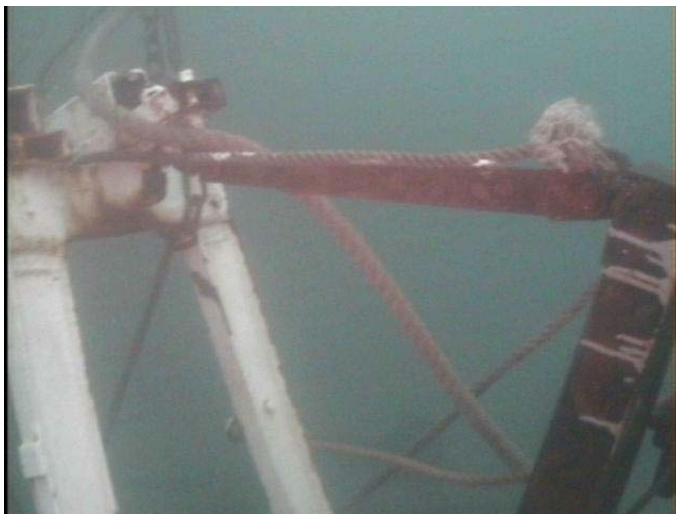
Photo 15
New spreader arms fitted to
gantry (P)

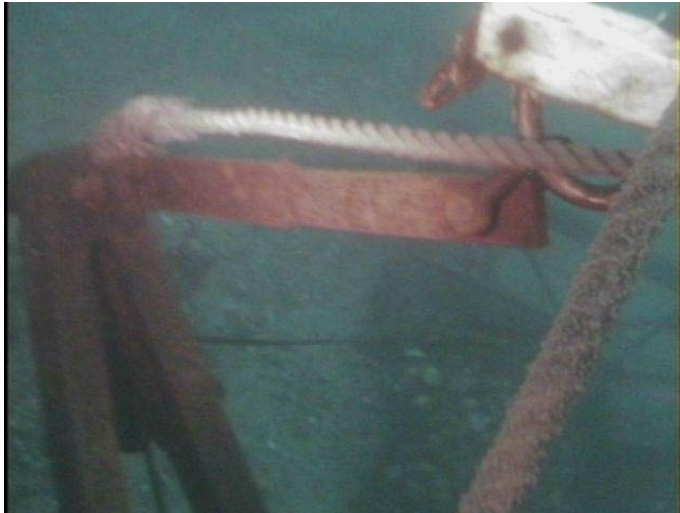
Photo 16
New spreader arms fitted
to gantry (S)

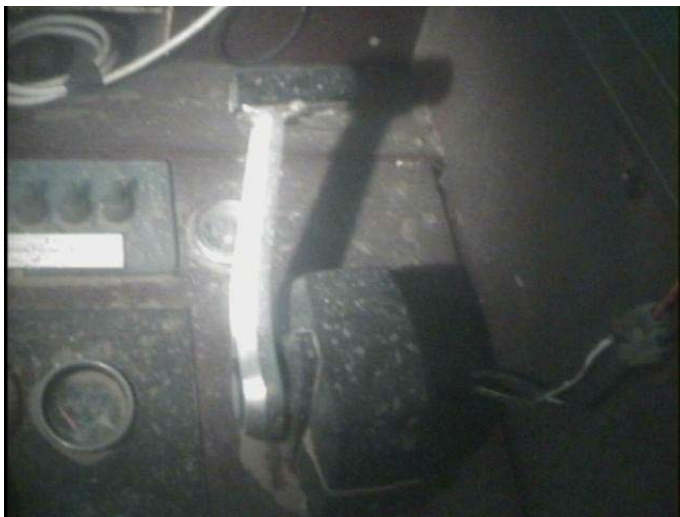
Photo 17
Throttle lever, in gear, half
to three-quarters ahead
