## **Casualty Investigation Report CA 76**

**Collision between Isle of Man registered vessel British Vigilance  
and Bermudan registered vessel Stena King  
on the 25<sup>th</sup> March 2002**

***Isle of Man Government Marine Administration***

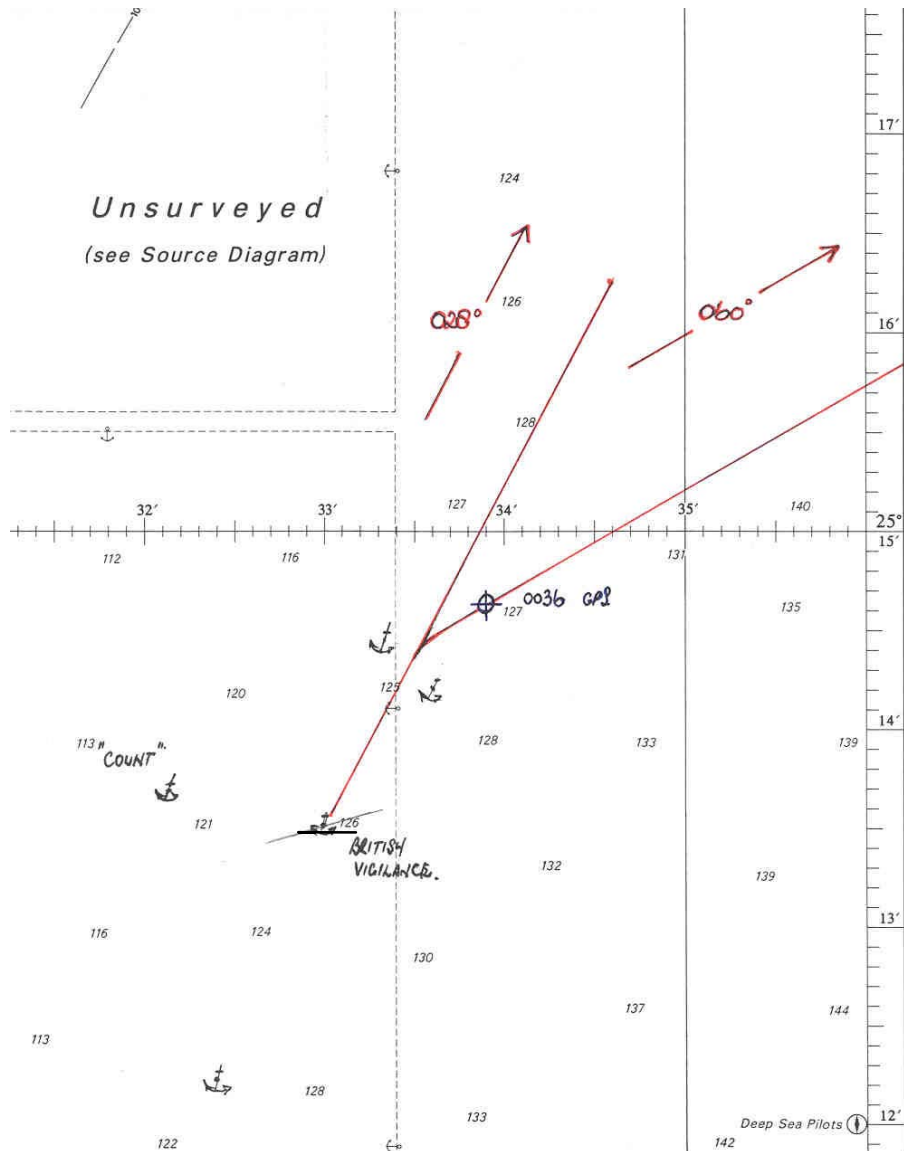
Section of Admiralty Chart No. 3526 Offshore Anchorages Port of Fujairah.

“British Vigilance’s” track from her anchorage position and other known ships anchored in the vicinity.

“British Vigilance” lay at anchor with the ship’s head 254 to 272 degrees between 2240 hours and 2336 hours.

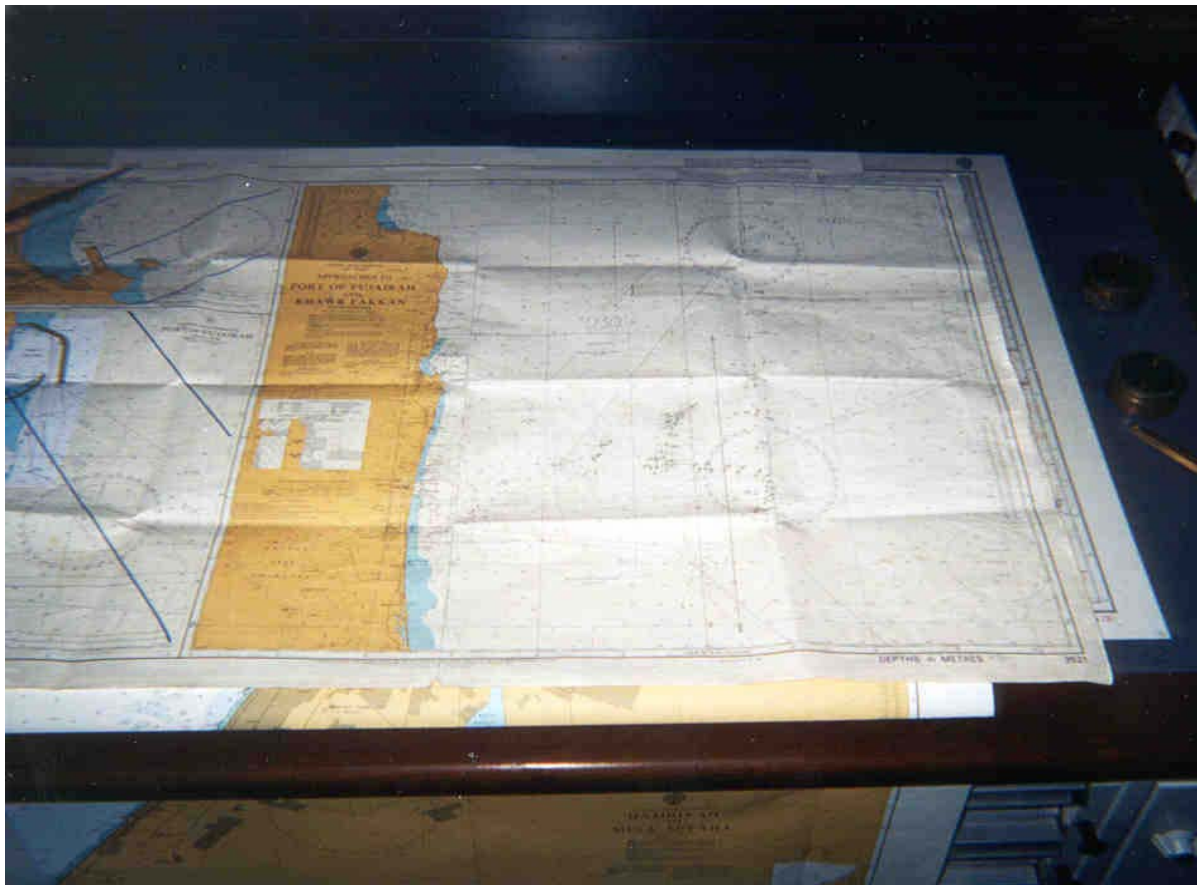
Picture No.1

Chart Table situated on Port Bridge Console with Chart No.3521  
Approaches to Port of Fujairah and Khawr Fakkan

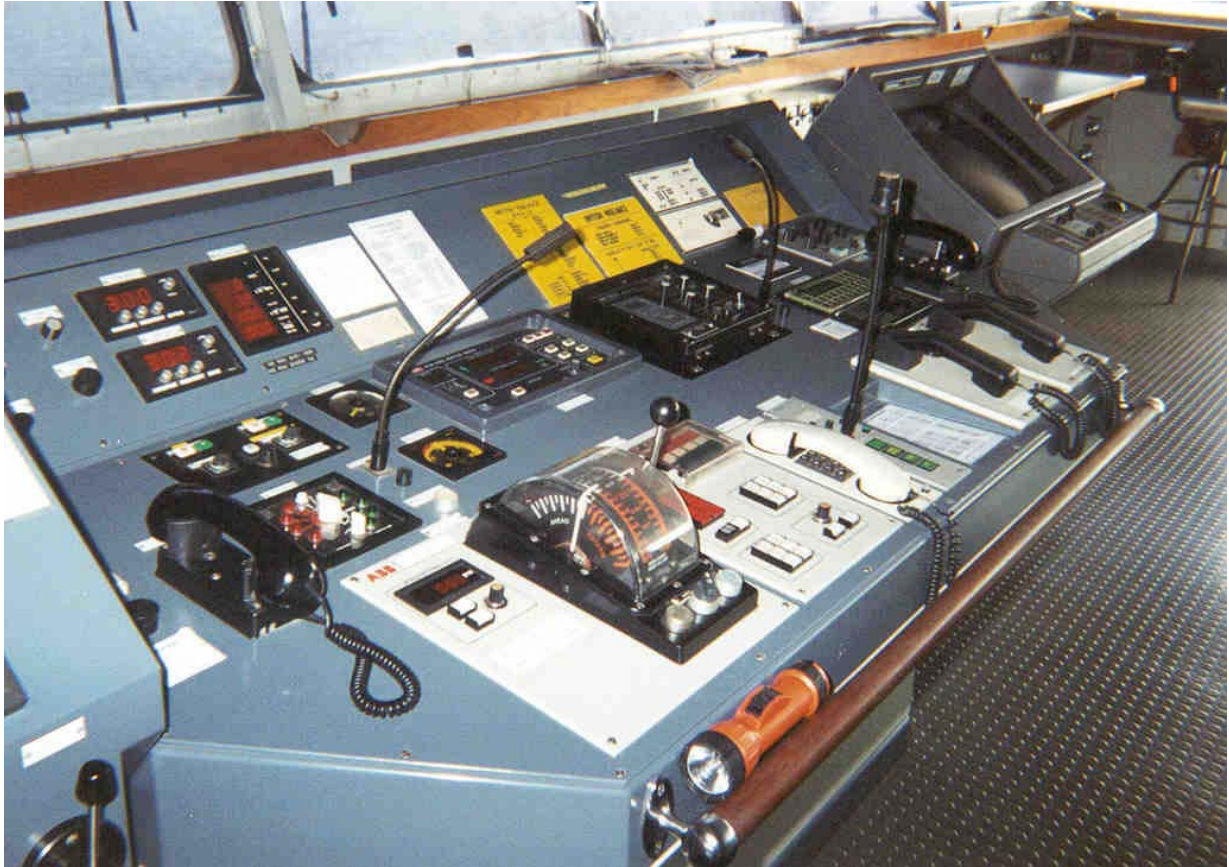
Picture No.2

Bridge Centre Console - Depicts position of bridge control telegraph, doppler speed log, echo sounder unit, starboard radar unit -10cm display

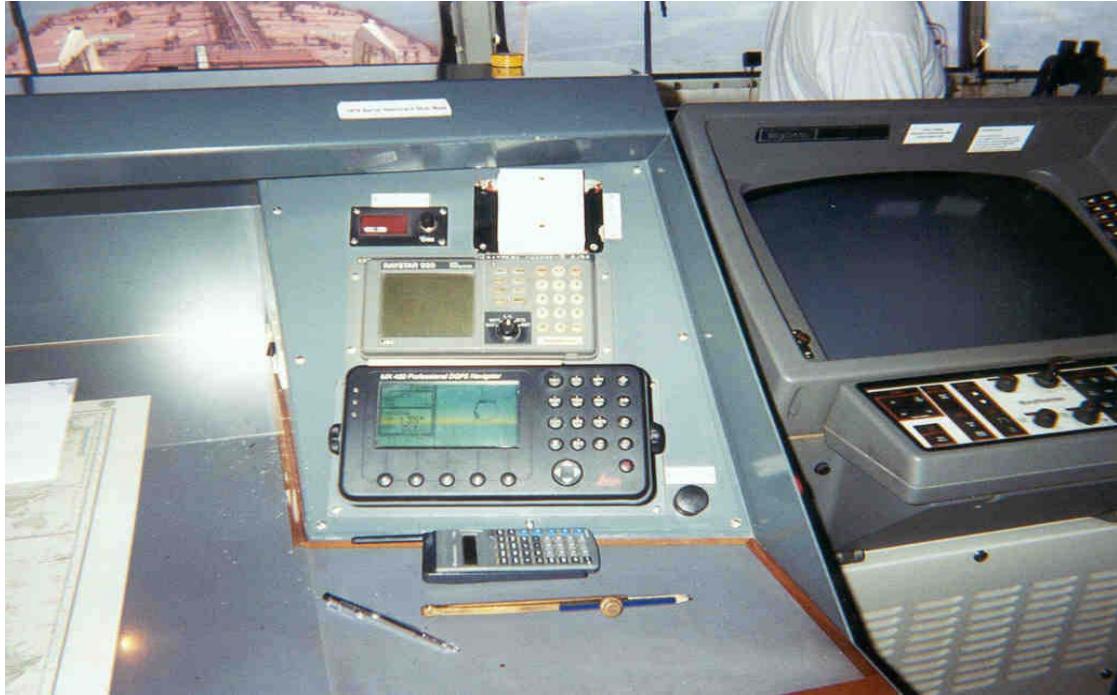
Picture No.3

Shows GPS unit on Bridge Port Console adjacent to port side ARPA radar unit.

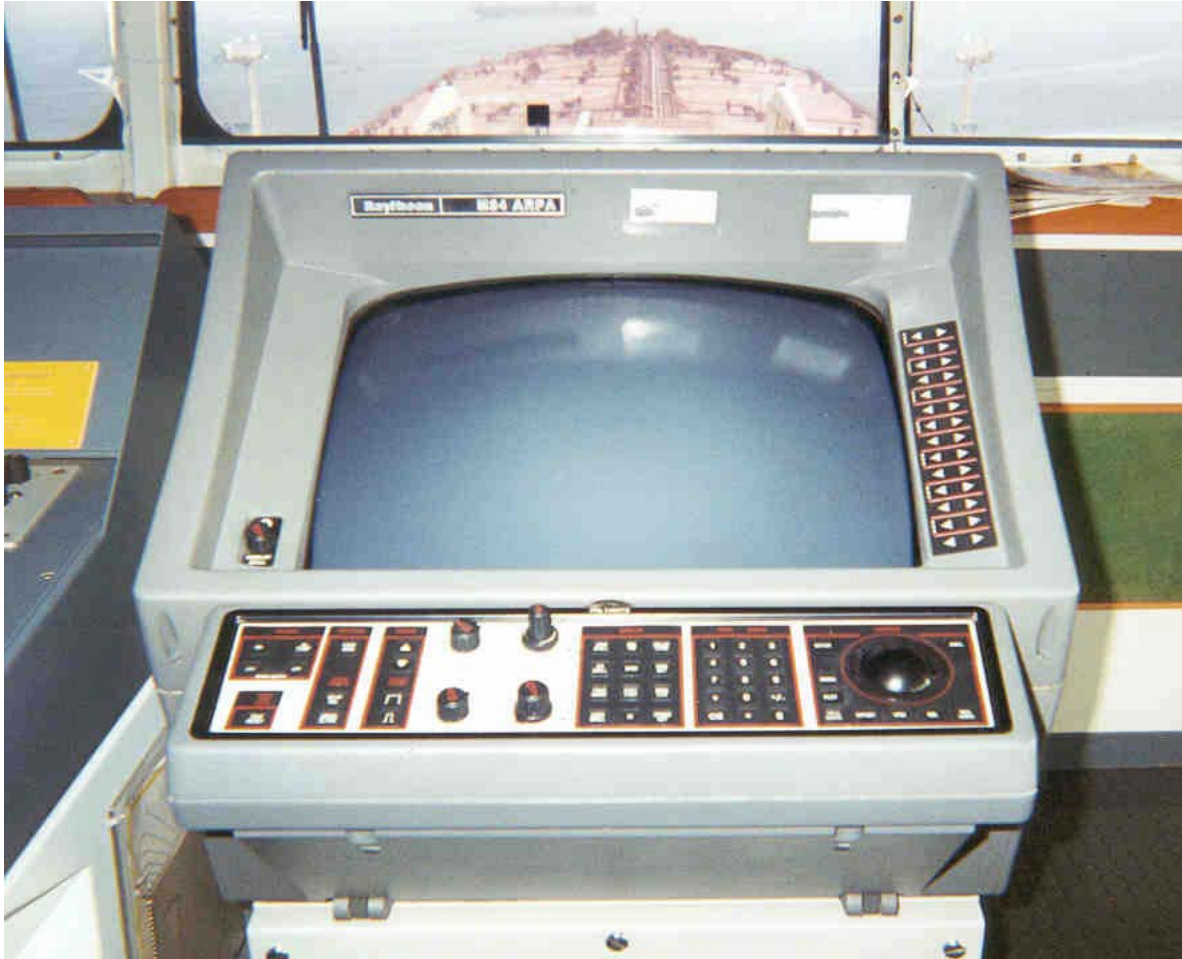
Picture No. 4

Bridge Port Console - Port side ARPA radar unit used on 3cm display

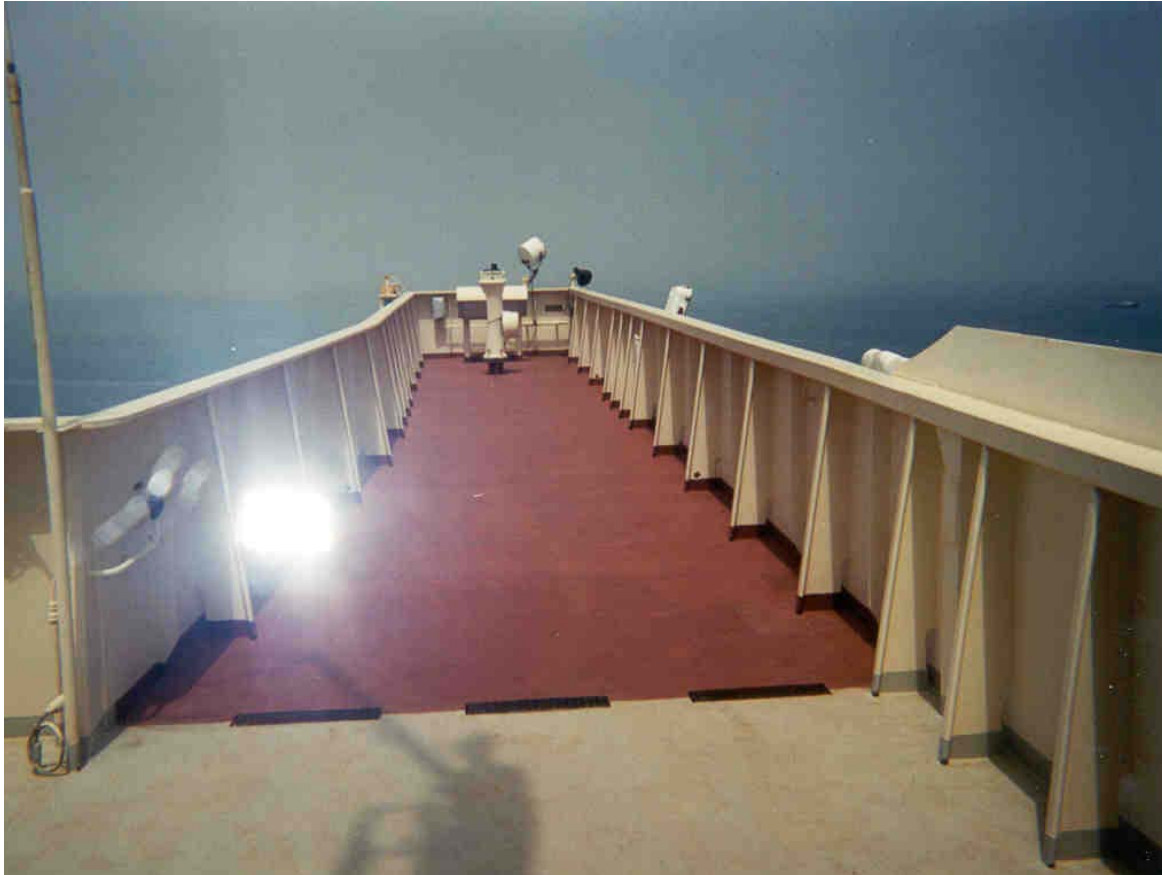
Picture No.5

View of Port Bridge Wing from Wheelhouse doorway

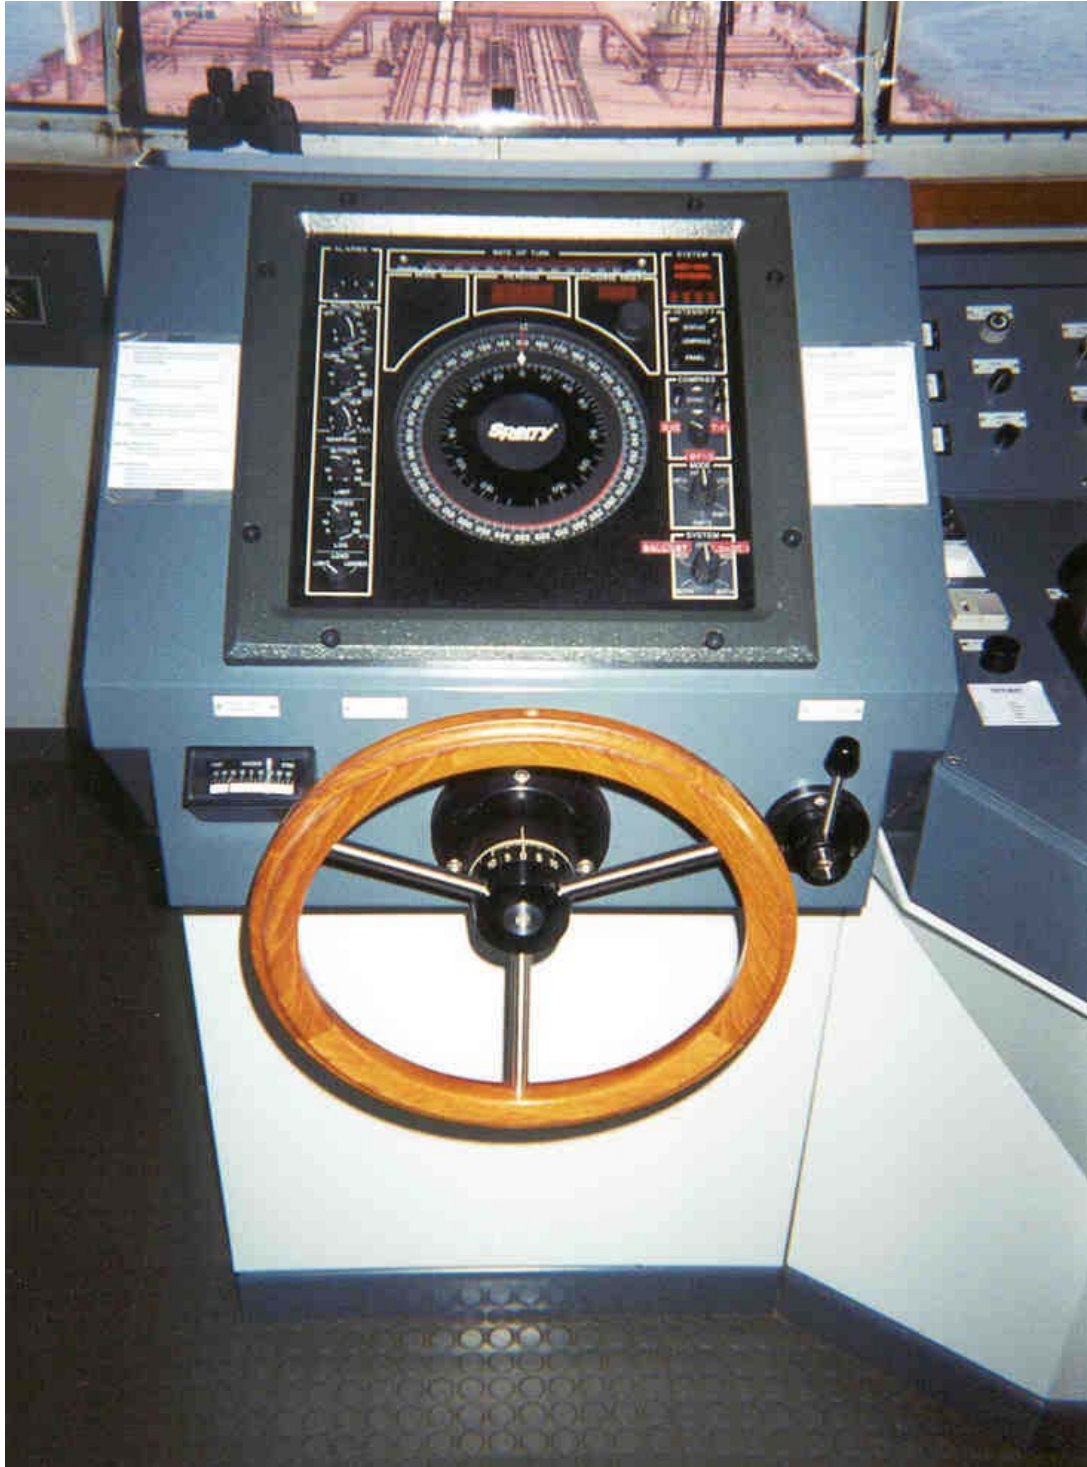
Picture No. 6

View of Steering Console

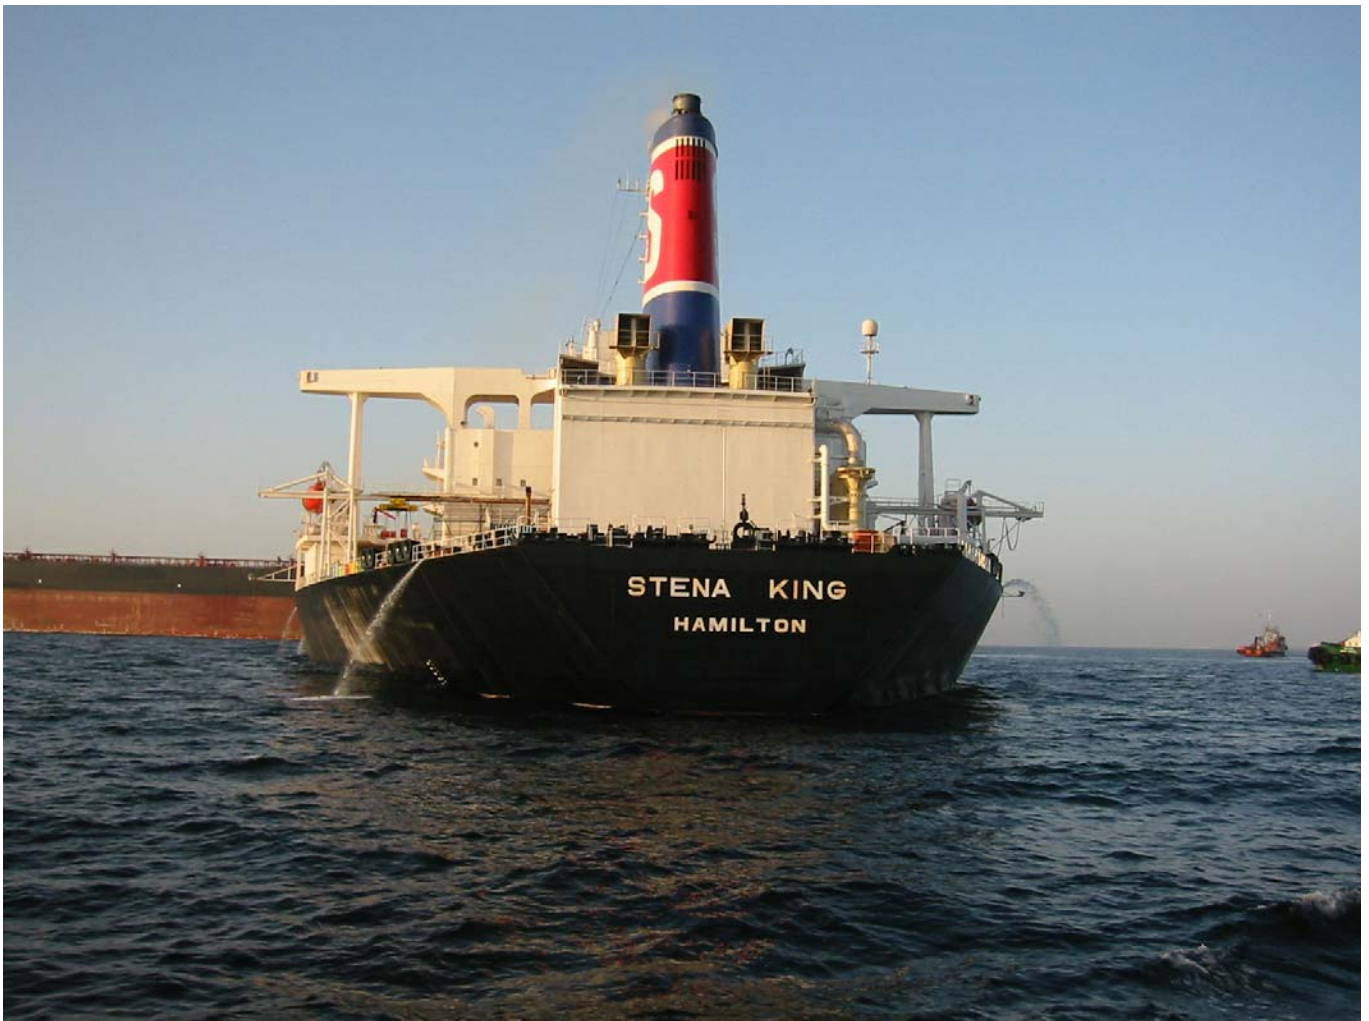
Picture No.1

Resting position of the “Stena King” embedded in port side of “British Vigilance”

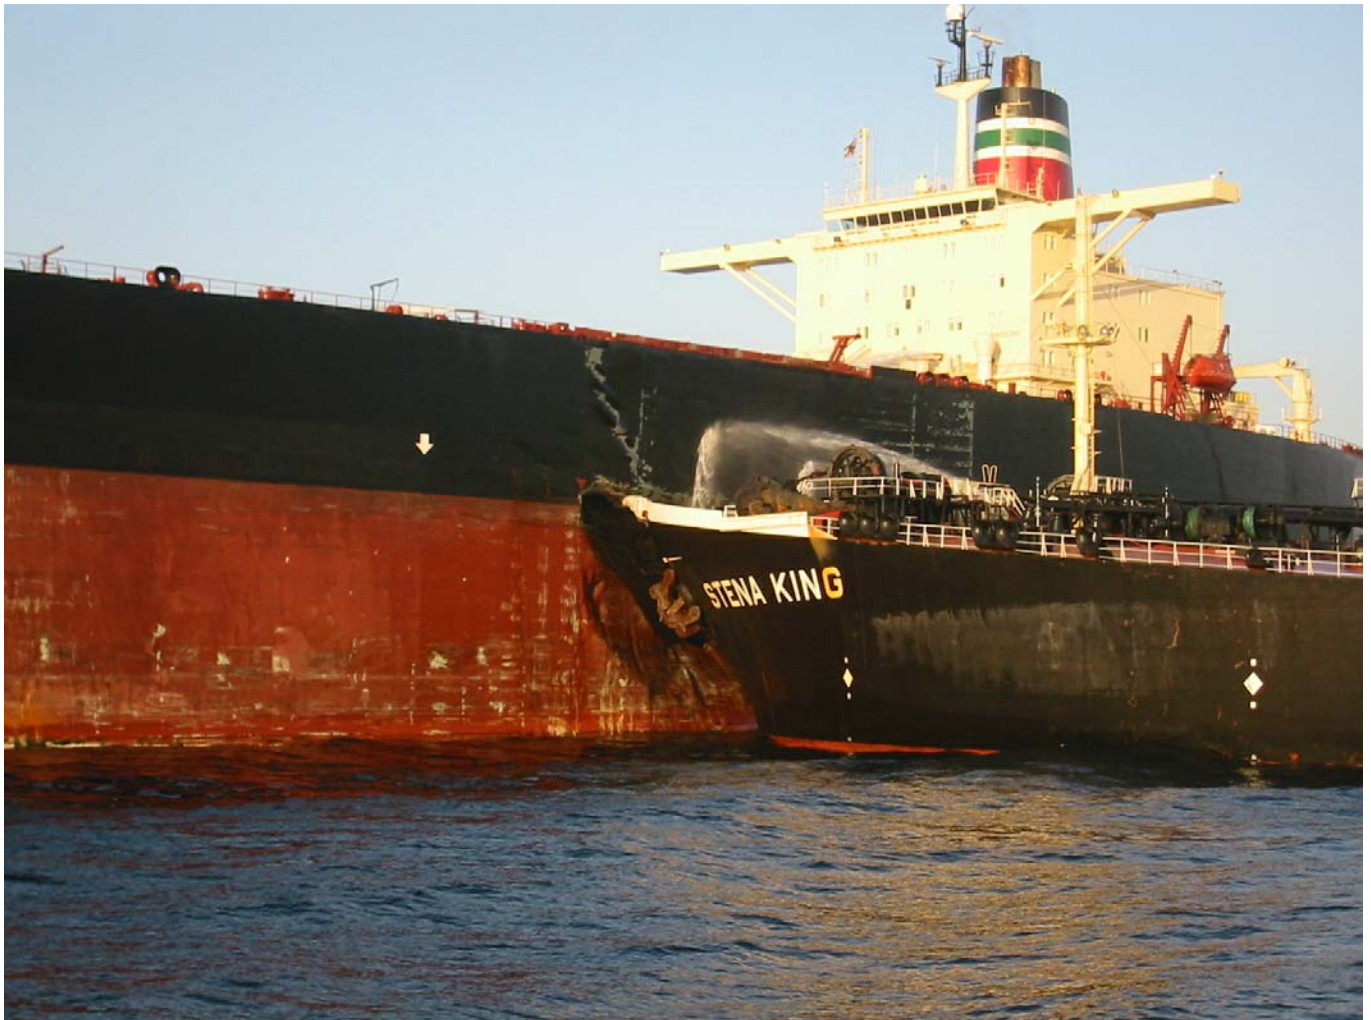
Picture No.2

- 1.4. The “British Vigilance” sustained damage to her port side in way of No. 5 “U” shaped segregated ballast tank, the penetration extending into No. 5 port cargo side tank and No.6 port cargo side tank forward bulkhead. The damage covered an area on the ship’s side from frame 150 to 160. The “Stena King” received damage to her hull in way of the fore part, the forecandle area in particular on the starboard side and the starboard windlass area.

Depicts bow of “Stena King” embedded in port side of “British Vigilance” in way of No.5 “U” Port Ballast Tank

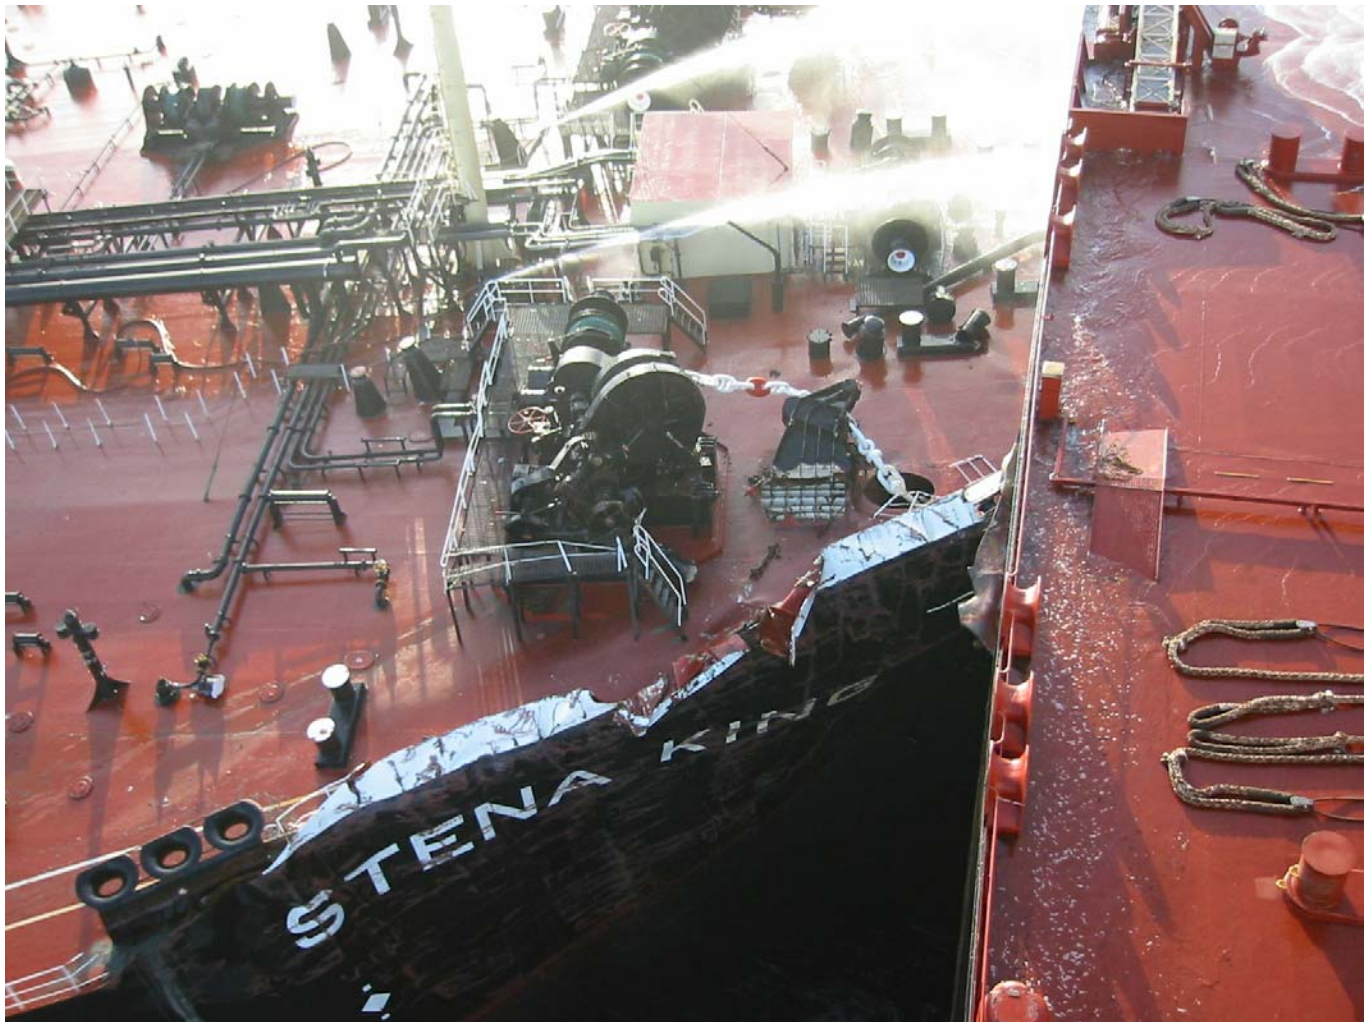
Picture No.3

Bow of "Stena King viewed from the port bridge wing of "British Vigilance"

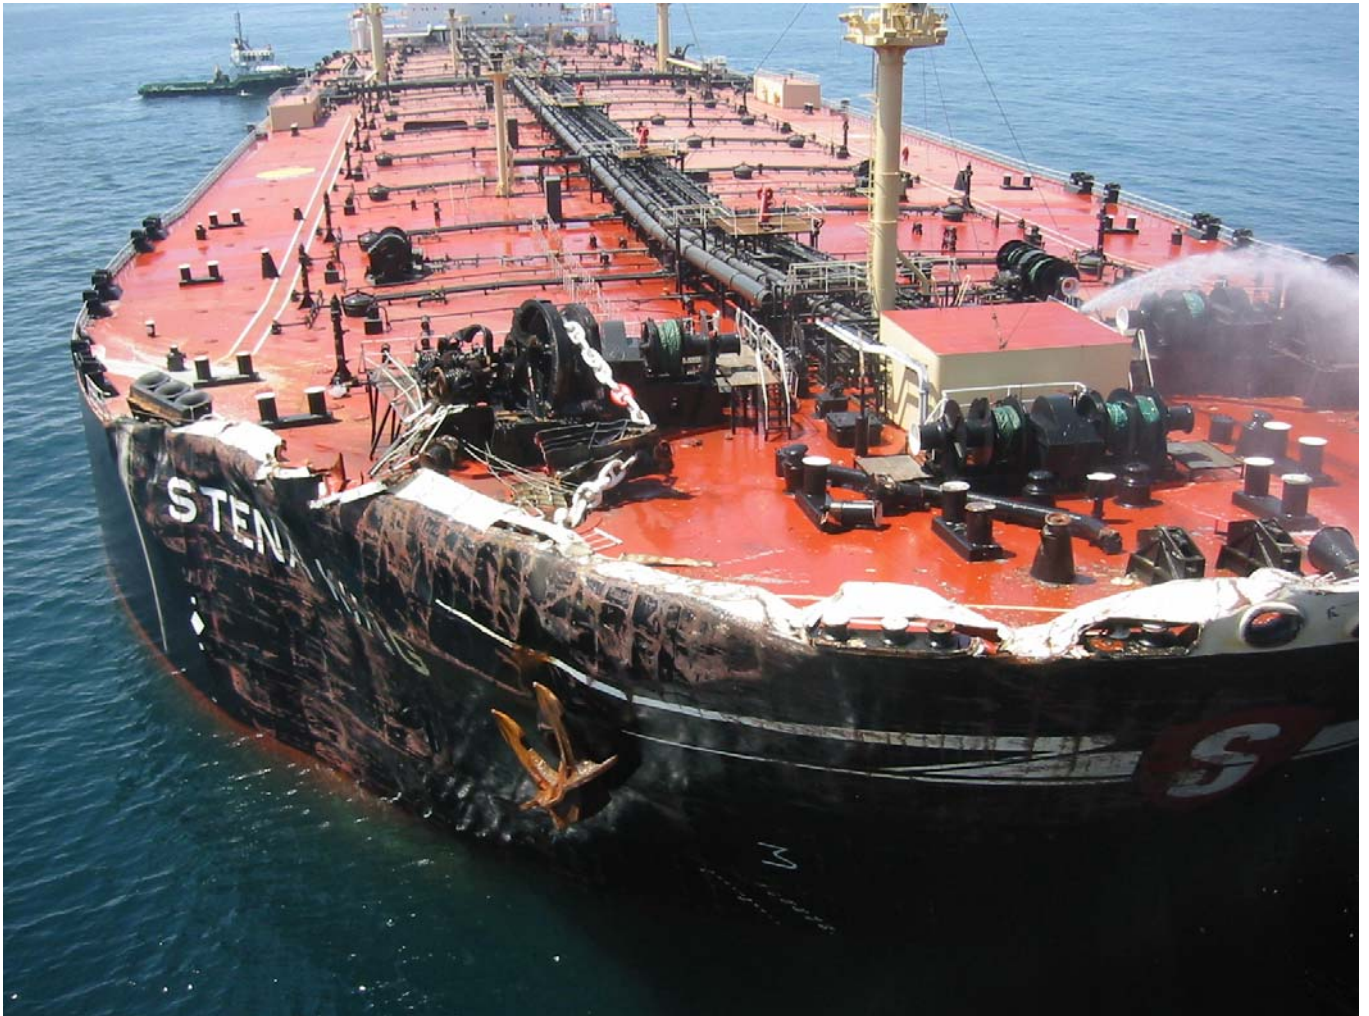
Picture No.4

Note the extent of the damage on the forecastle in particular the starboard bow section of the “Stena King” as she is brought clear of the “British Vigilance” giving clear evidence as to the angle of approach at impact.

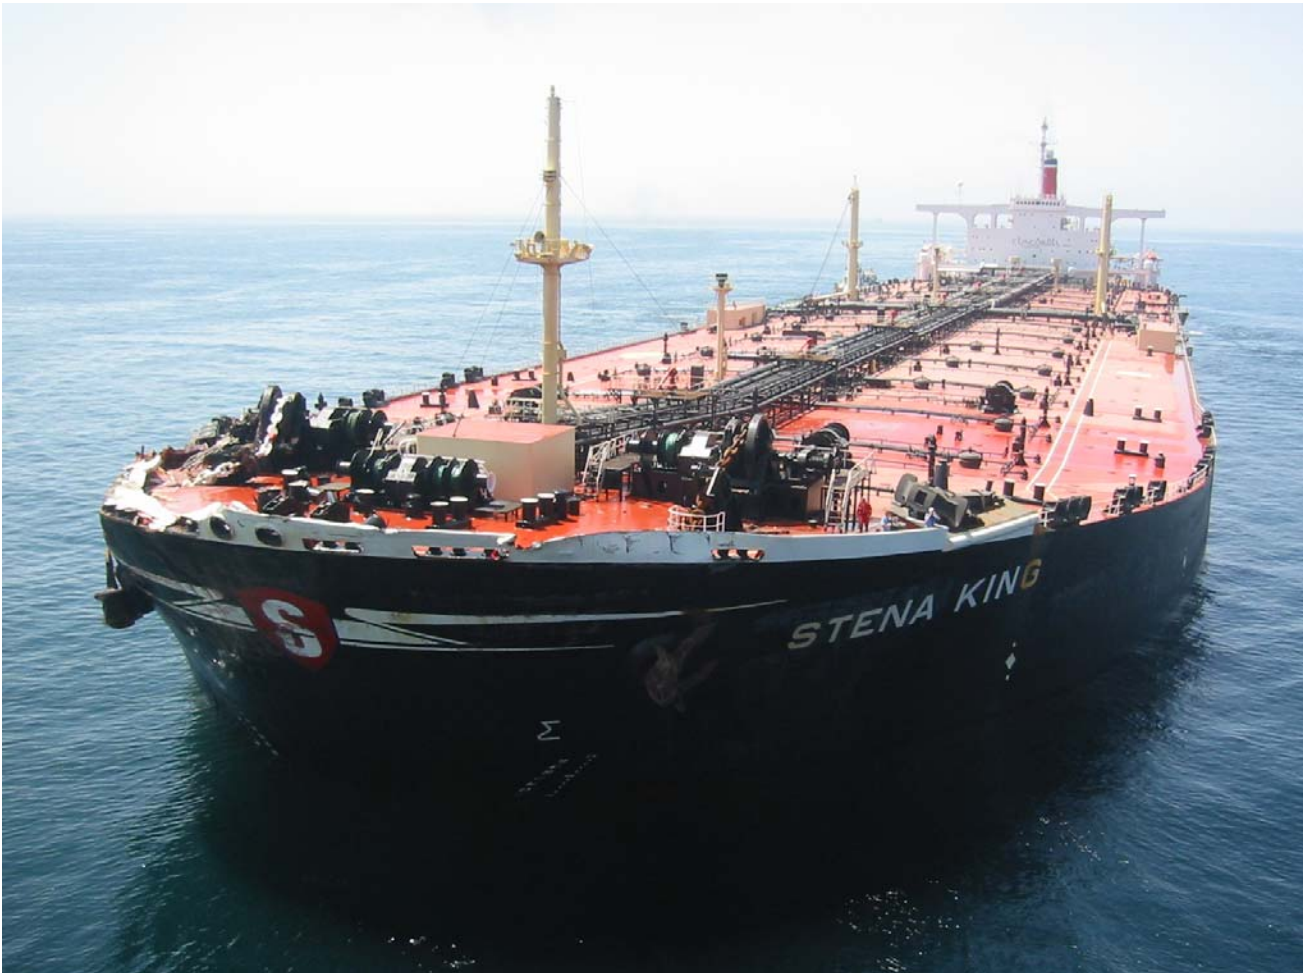
Picture No.5

Note the minimal damage to the port bow section of the “Stena King” compared to Picture No.4 which provides a clear indication as to the angle of impact

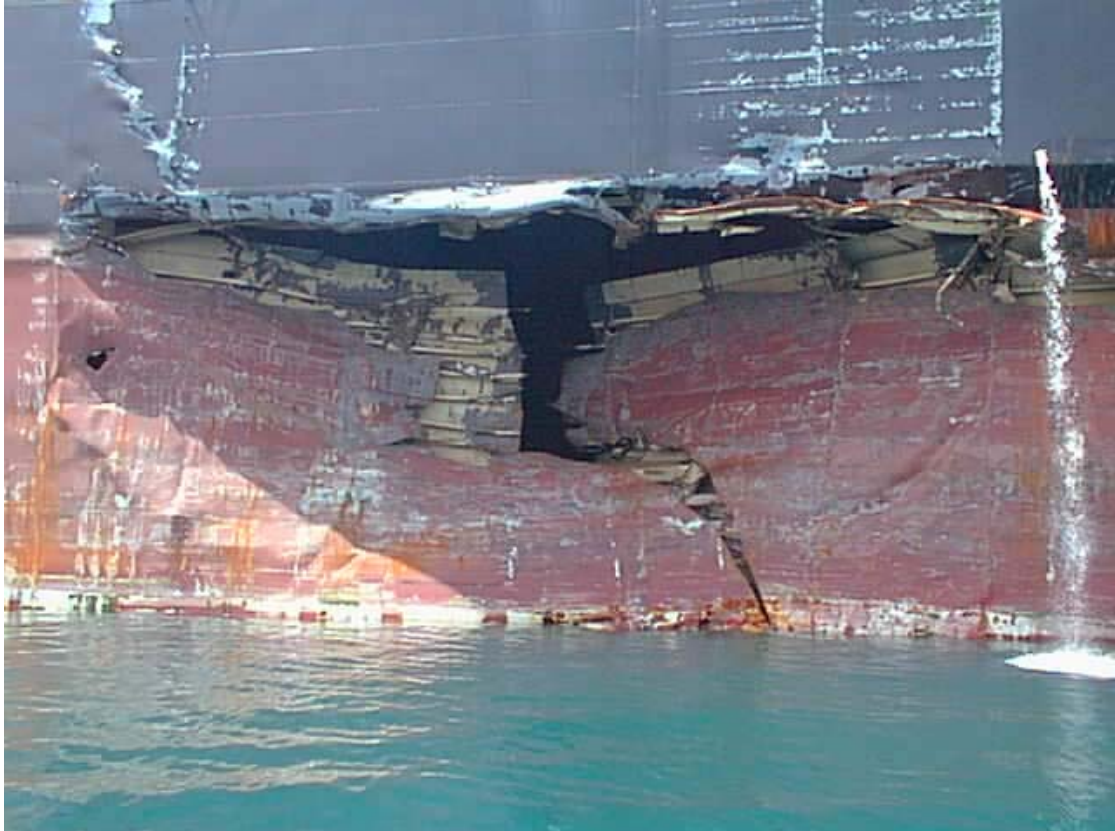
Picture No.6

Extent of damage sustained to "British Vigilance" in the area of No.5 "U" Port Ballast Tank, viewed from the probable angle of impact

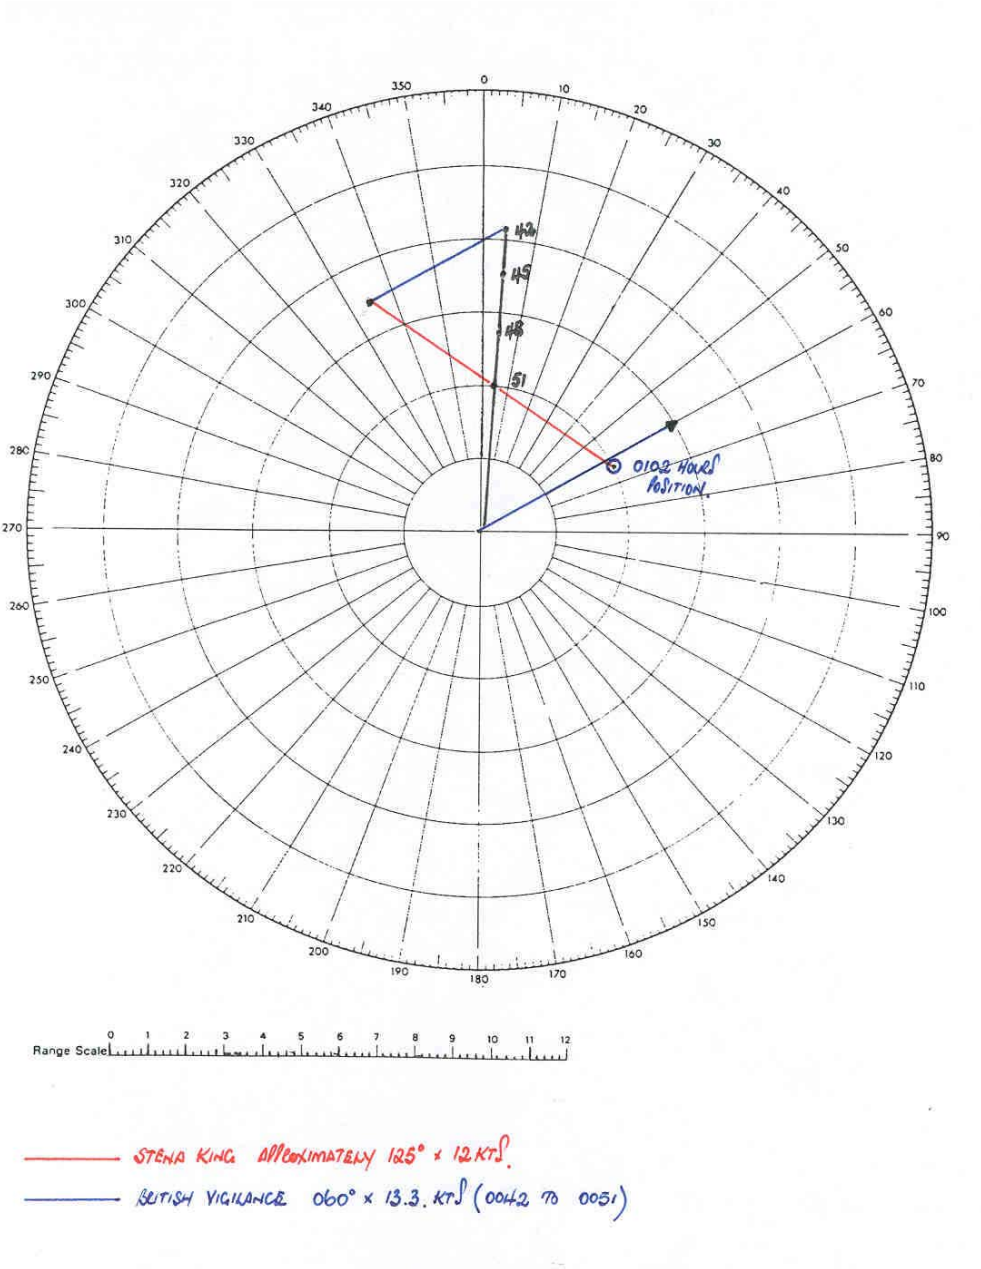
Plotting Chart

Reconstruction of the most probable plotted course and speed of “Stena King” with the nearest estimated times of a plot from “British Vigilance”
