## **Casualty Investigation Report CA 75**

**Grounding of Isle of Man registered vessel City of Sunderland  
at the Port of Hanko, Finland on the 1<sup>st</sup> January 2002**

***Isle of Man Government Marine Administration***

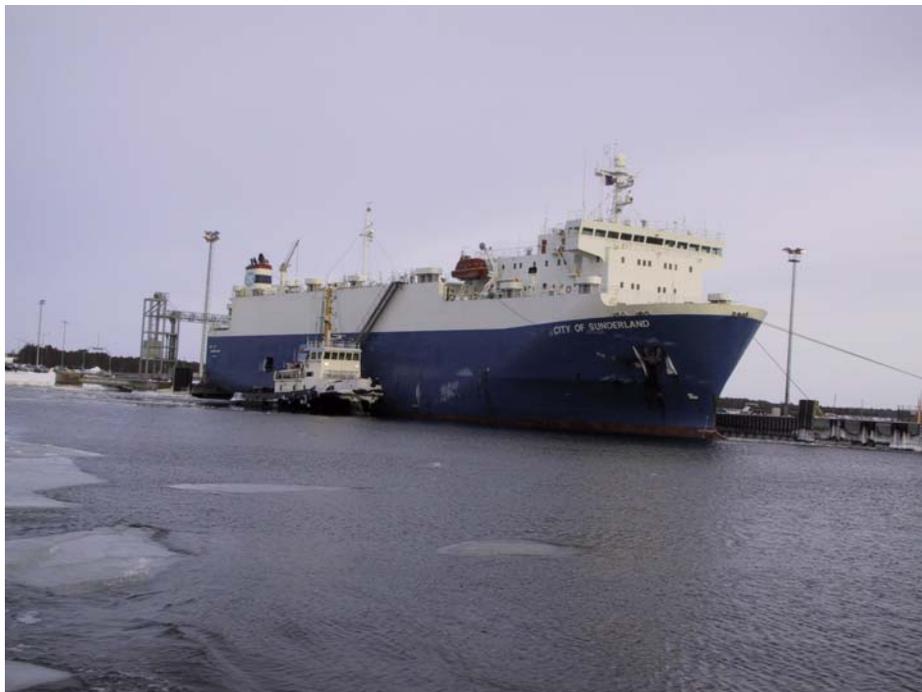
Picture No.1

“City of Sunderland” berthed at No. 2 Ro-Ro Berth Hanko after refloating

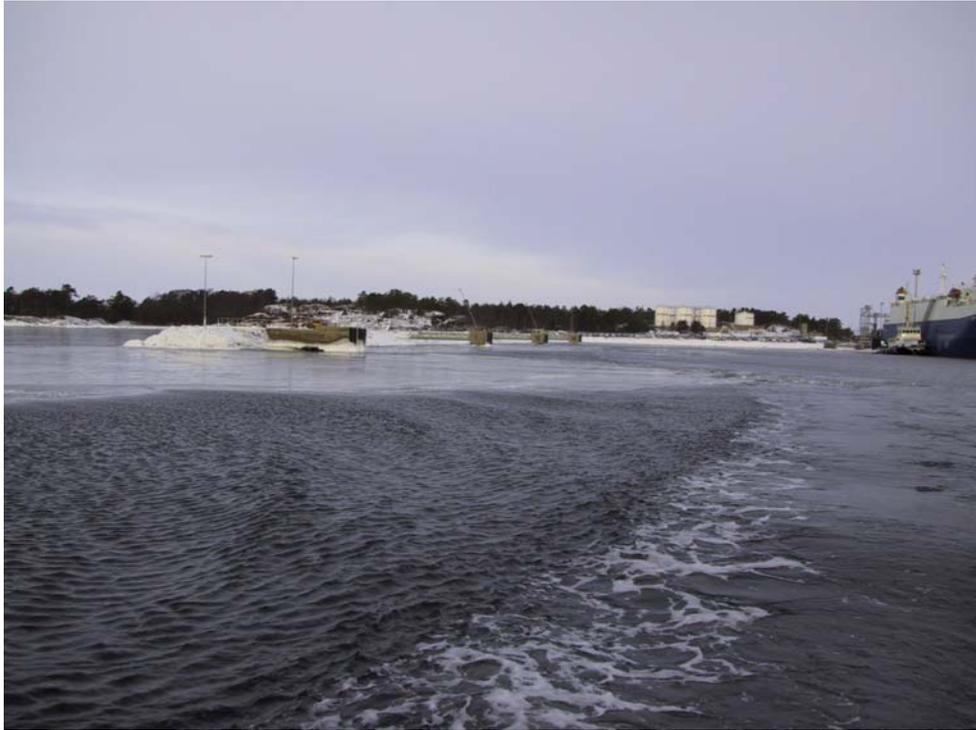
Picture No.2

Shows the Western Jetty where the “City of Sunderland” landed eventually across the Dock from the intended Ro-Ro Berth No.2

- 4.22. The ship was forced onto the Western Jetty and pinned there by the severe weather conditions. The starboard bow landed on the middle dolphin. There was 50 metres or more of the ship overlapping the inner dolphin and the ship was lying at angle to the jetty. The Master told the pilot he would require another tug before any further attempt was made to manoeuvre the ship onto the Ro-Ro berth. The Pilot advised the Master another tug could be ordered from Helsinki, but it would take up to 6 or 7 hours to arrive. Meanwhile the tug “Ajax” was being made fast forward, the Deck CPO confirmed this fact at 1842 hours. The Master was unhappy about the ship’s angled position as she lay on the jetty, this fact was confirmed by the Chief Officer from aft. He requested the Master to move the ship forward to avoid any further damage on the dolphin. As the Master attempted to manoeuvre the ship forwards on the main engine the Pilot had the tug “Ajax” pull the ship forward. However, the Pilot’s intention was to pull the ship off the berth, and take it out to the anchorage via the main channel. The Master’s actions were to manoeuvre his ship sufficiently forward with the sole intention of providing a safe place for the ship to lie and await the second tug. The Pilot was of the opinion that the ship would be damaged if it remained on the jetty. It appears the Pilot never discussed or told the Master his intention to return to the anchorage, or sought his agreement to leave the port. The “City of Sunderland” has apparently stayed on this jetty previously to wait for a tug. The Pilot ordered the Master to provide the engine movements as the tug “Ajax” attempted to pull the ship off the jetty and up into the wind. The strength of the wind again proved too much, the Pilot was forced into the decision to turn the ship to starboard and proceed down the secondary channel via Granskarharun and Albertsklackarna to the anchorage area.

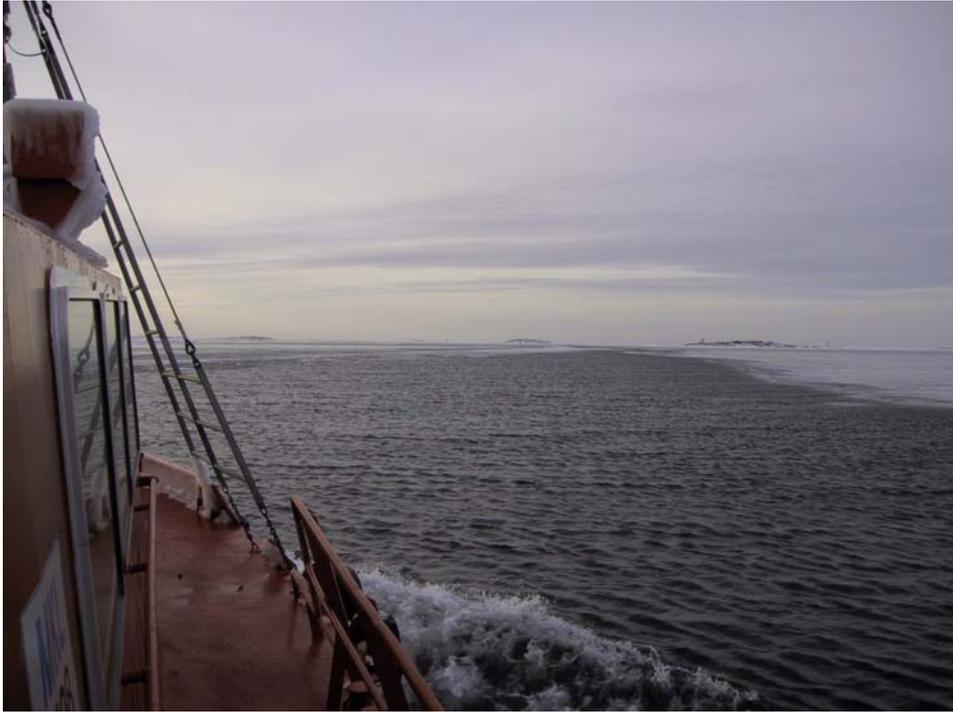
Picture No.3

Depicts the westerly course of the secondary channel from the Western Jetty to Granskarsharun in the distance

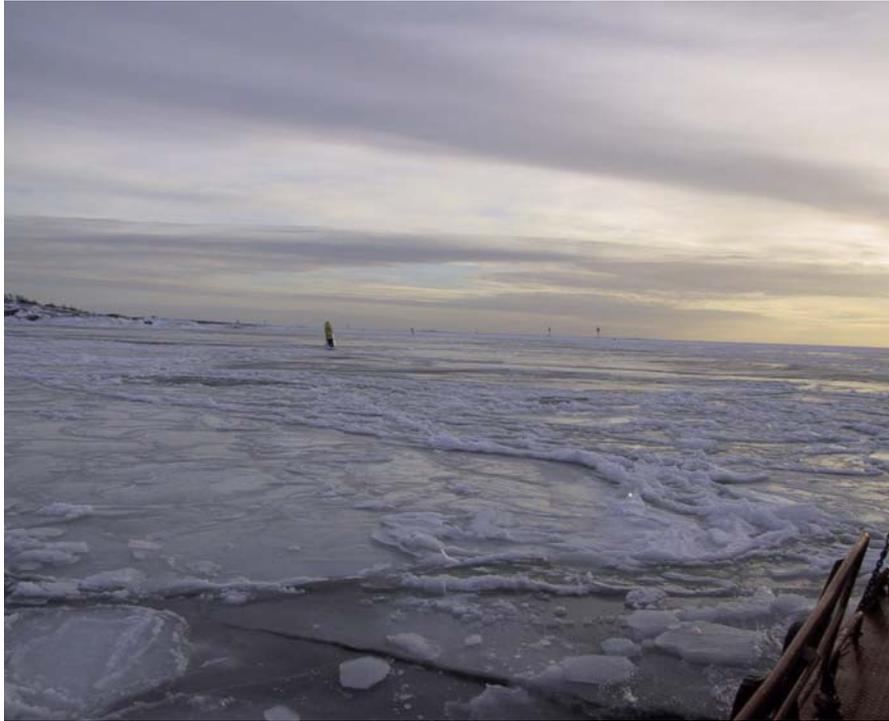
Picture No.4

Depicts the south easterly course from Granskarsharun to Albertsklackarna

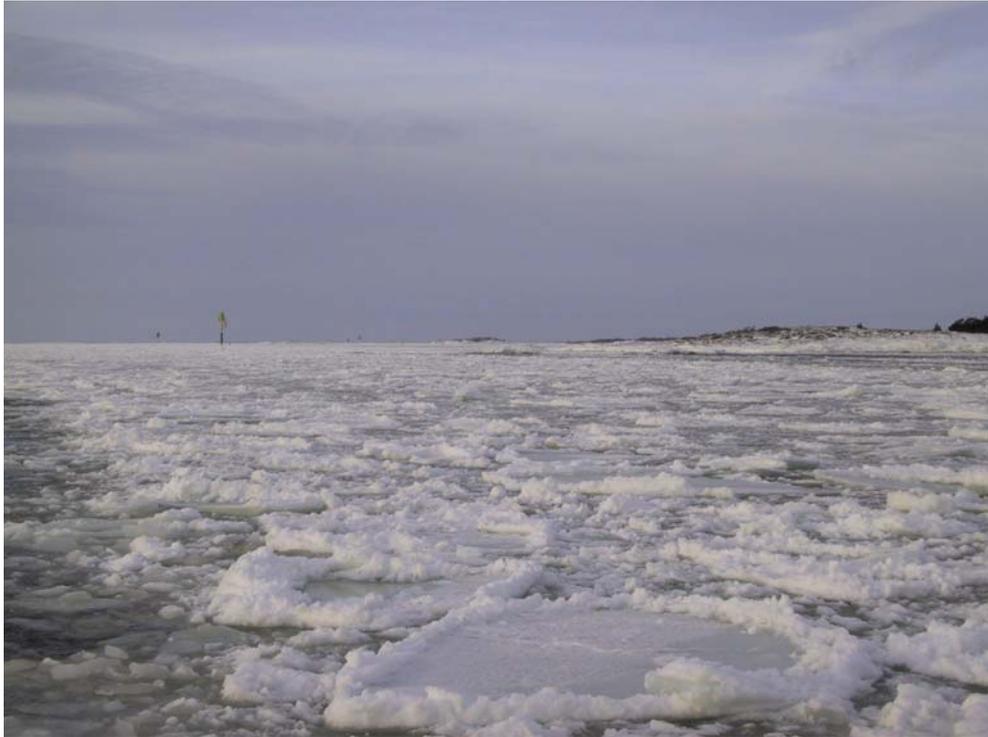
Picture No.5

Depicts the beacon lying close to the south west of Vastertistron Island and the area close to the south of the island where the City of Sunderland grounded

- 4.31. The lack of recorded ship's positions on the south easterly heading makes it difficult to identify the actual buoy which was picked out by the tug's searchlight. However, given the close proximity of the time of grounding to the time the tug was let go, the probable identity of this buoy is the north cardinal mark positioned on the north eastern edge of the Albertsklackarna group of islands. It has not been determined whether this beacon was ever correctly identified.

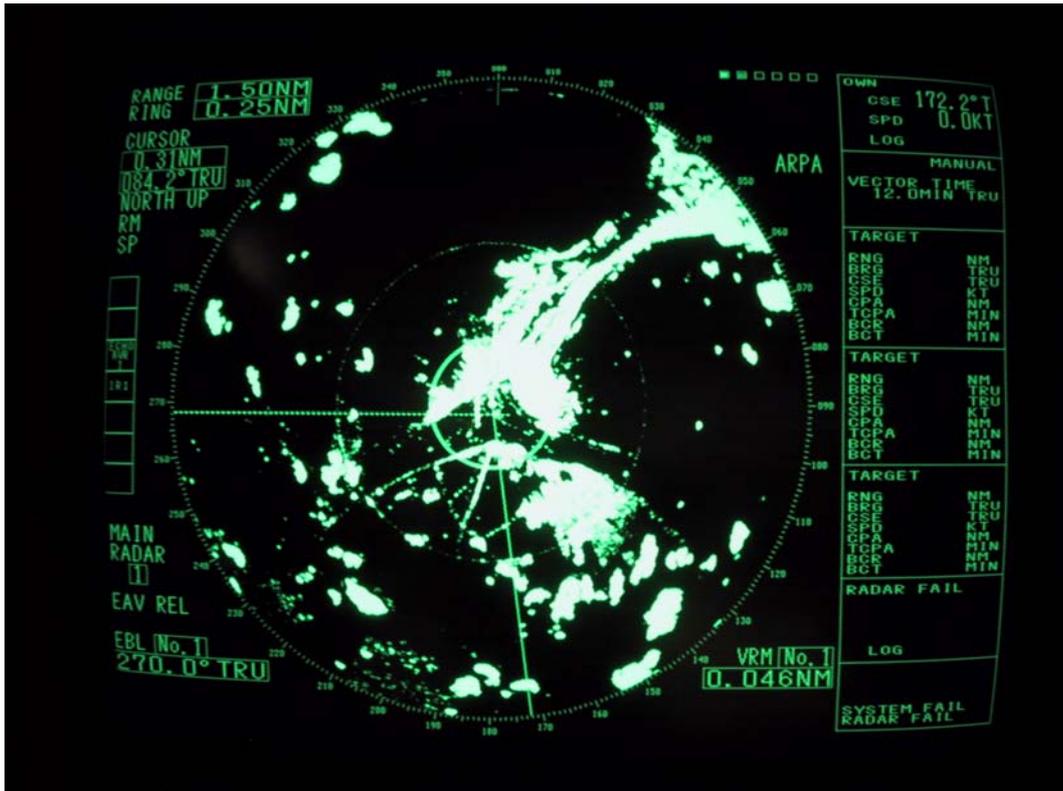
Picture No.6

View of radar picture covering the area from the berth at Hanko to Vastertristron

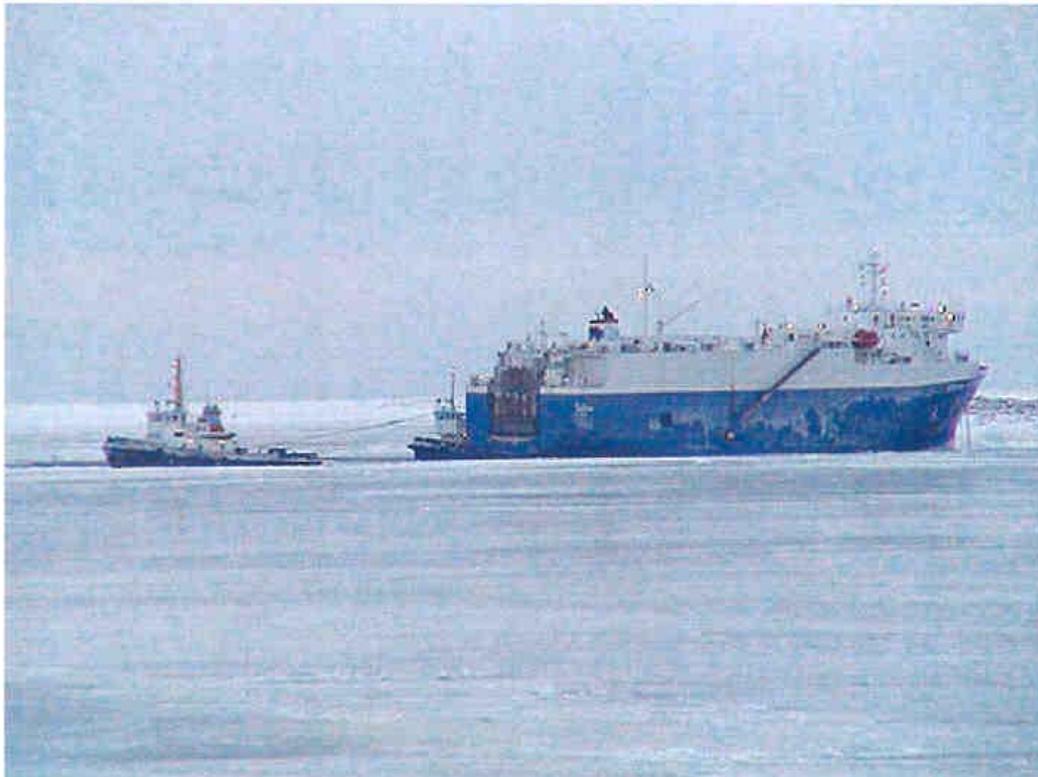
Picture No.7

- 4.34. Damage was sustained to the underside of No.1 Fuel Oil Tank ( P ) frames 105 to 109, No.1 Double Bottom Tank ( P ) & ( S ) frames 70 to 90, No.2 Double Bottom Tank ( P ), No.2 Fuel Oil Tank ( P ) frames 39 to 54, Engine Room Oil Tanks on the port side in way of frames 17 to 28. A number of cracks were found in the areas of hull indents mentioned above, cracks were also discovered on the propeller blades. The resulting grounding caused no apparent oil pollution or environmental damage to the area.

“City of Sunderland” preparing to be re-floated with the assistance of tugs at Vastertistron Island

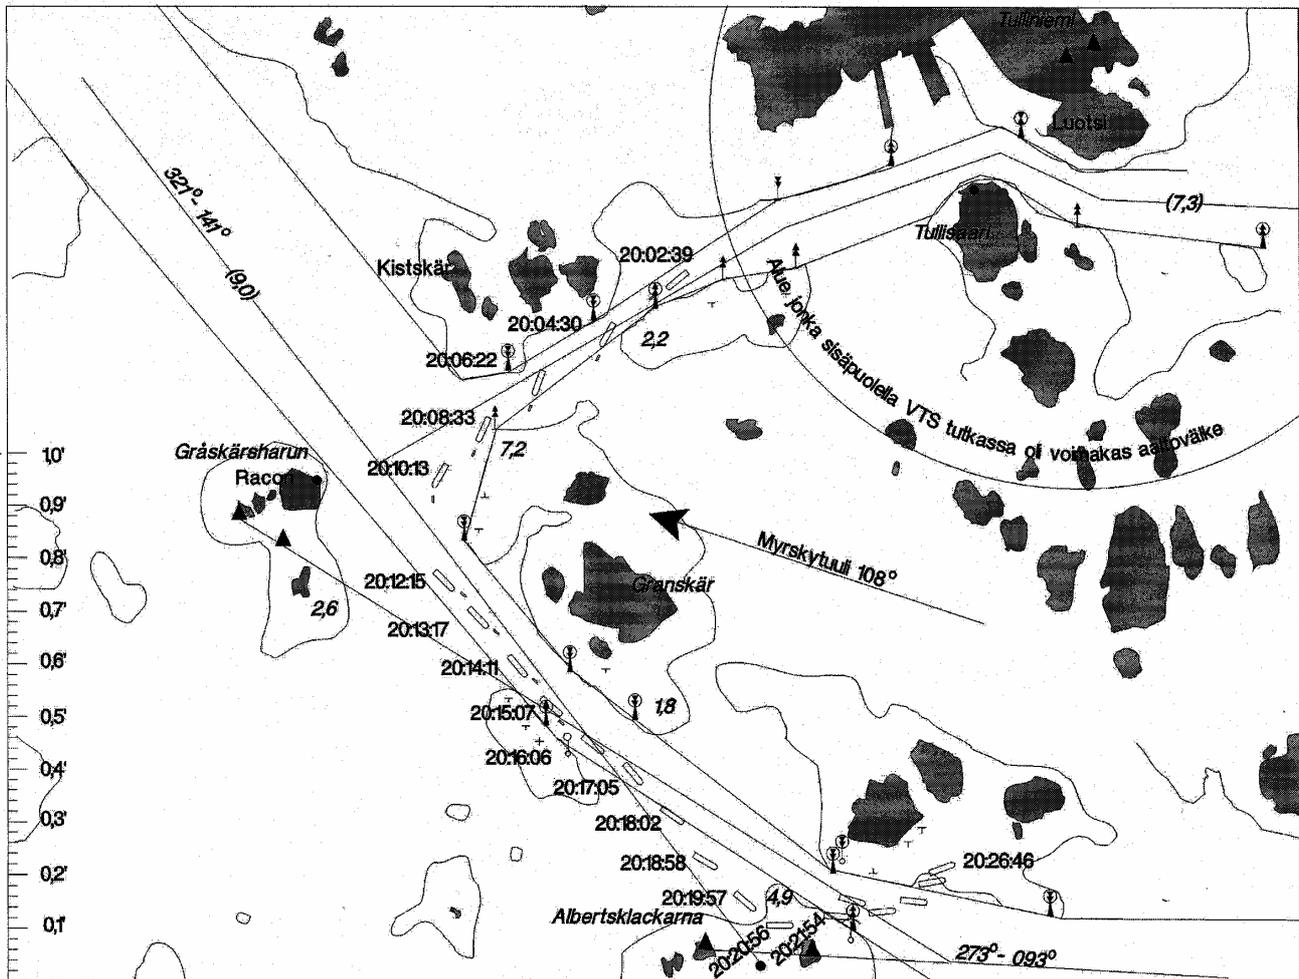
Appendix II

A section from a Finnish chart representing the Approaches to Hanko.  
The "City of Sunderland's" track has been recorded from an unknown source west of the Western Jetty to the position of grounding south-east of Vastertiströn Island
