Isle of Man Government

Casualty Investigation Report CA73

BEN VARREY - Fatal Accident

07/09/2001

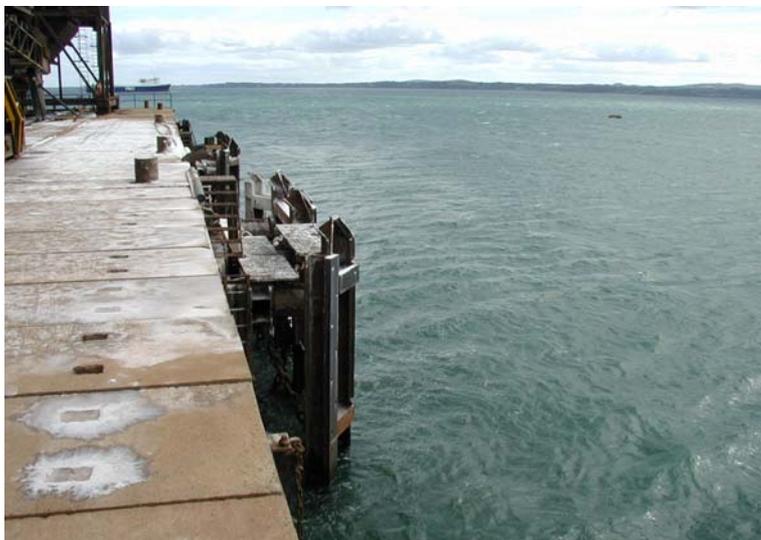
Basic Construction of the Kilroot Salt Jetty

- 5.3 At the time the jetty top was about 2 metres above the bulwark so that it is unlikely that he could have reached high enough from this position to receive the receipt book from a person ashore. The jetty representative first intended to exchange the book at the aft set of fenders but when the Chief Officer proceeded forwards, he climbed back up to the jetty top and also walked forward.

- 5.4 No-one saw the Chief Officer after this moment until the accident. Given the relative heights between the bulwark top and the jetty, the only way in which a person of normal stature could have effectively reached high enough to pass an object between the ship and a person on the jetty would have been to stand on the bulwark capping. The raised forecastle provided enough height to do it but the shape of the ship's bow and the positioning of the jetty fenders meant that the horizontal distance between a person on board on the forecastle and a person ashore was too far to reach. Similarly, aft, the fender positions, well proud of the jetty face, meant that the ship's bridge wing was also too far off horizontally to pass anything by hand.

5.7 A determination of how the Chief Officer came to be outboard is more difficult. However, it is clear that in view of the relative heights between ship and the small platform on top of the fender, the vertical distance would have been too far to safely pass the book over. Even standing on one of the sockets, as the Master saw him do, the additional height would have been insufficient.

That they examine the procedures for transfer of paperwork between the jetty and ships alongside, and develop and implement a means of transfer which can be used in any weather and sea conditions to swap paperwork between jetty and ship without the necessity for either jetty personnel to approach too closely to the edge or ship's personnel to leave a safe place on deck.

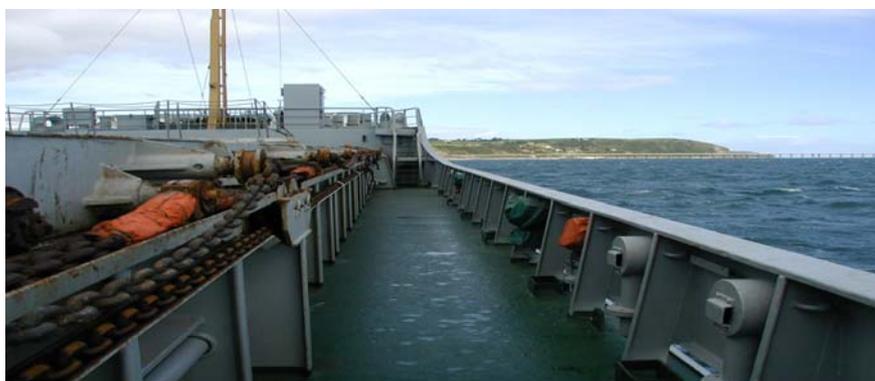
-
- 5.9 There were no items of portable equipment in the vicinity on which he could have stood to gain more height and it must be concluded that he stood on an item of ships structure.

- 5.10 It is also inconceivable that he could have fallen outboard in an upright position had he stood on the top of any of the air vent heads, (the cylindrical items visible just below bulwark height in the picture) or on any other piece of structure below bulwark height.

- 5.11 On the other hand, if he stood on the bulwark capping, leaning against the fender, which was flush with the ship's side, he would have had sufficient height to reach the fender top and a slip from this position could have resulted in him falling vertically downwards when the ship moved away from the fender. It is established that the ship was moving vigorously on and off the fenders with a bodily sideways motion. It is therefore concluded that the Chief Officer, having failed to reach high enough from the deck fittings, climbed on to the bulwark top, supporting himself on the fender to reach the jetty representative and collect the receipt book. From this position he slipped and dropped vertically between the ship and the fender as the ship moved off the fender becoming trapped and crushed when the ship moved back in again.

That, unless a safe means of access to ships at this jetty can be rigged, they make no further crew changes at this berth.

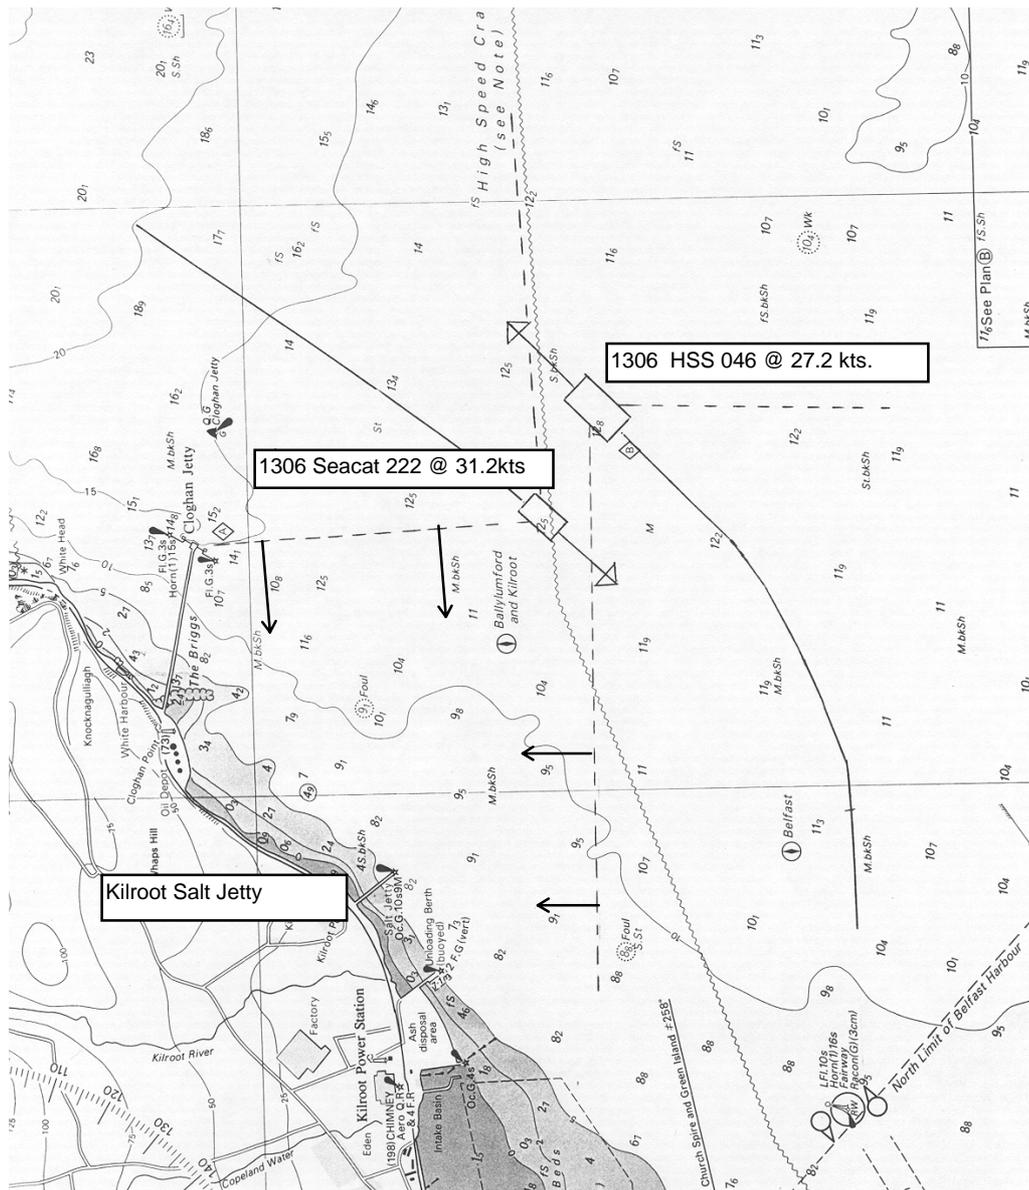
- 5.21 Plotting the relative positions of the two fast craft at 1306 and assuming the wave angles of 45 degrees for HSS and 35 degrees for Seacat, the wave from Seacat has approximately 2500 metres to travel to the jetty in a mean water depth of 10 metres. Similarly, at 1306 the wave from the HSS craft had 1500 metres to travel in a mean depth of 8 metres. The respective maximum wave propagation velocities are:

From which it may be expected that the wave effect from the Seacat Class vessel will arrive at the jetty at 13:10:00 (nearest ½ minute.) while that from the HSS Class vessel will arrive at 13:09:00 (nearest ½ minute). The wash effect from the Seacat Class vessel, although a supercritical wash has a low amplitude while that from the HSS class vessel is a subcritical wash effect and subject to sea state attenuation.

- 5.23 However, the magnitude of the errors is acceptable in relation to the time approximation in determining the time of the accident. The calculation indicates that wave effects from either of the two craft, or from both of them combined would most likely have arrived at the jetty between 1310 and 1315 at the latest.

- 5.24 The best estimate for the time of the accident is 1325 (± 5 minutes). The tide was nearly full which has the effect of increasing water depth over the figures used, which in turn reduces the propagation time of the wave and leads to an earlier wave arrival time.
- 5.25 It seems reasonable, therefore, to conclude that any unexpected ship motions associated with the passage of the two fast craft had already occurred when the accident happened and, had such motions been noticeable in the prevailing conditions, the Chief Officer would already have noticed them.
- 5.26 It is therefore concluded that the wave effects from the two fast craft played no significant part in this accident.
