**CRANKCASE EXPLOSION  
CASUALTY INVESTIGATION**

**BRITISH VALOUR - OFFSHORE BERMUDA**

**23.03hrs (GMT) 18 MARCH 2001**

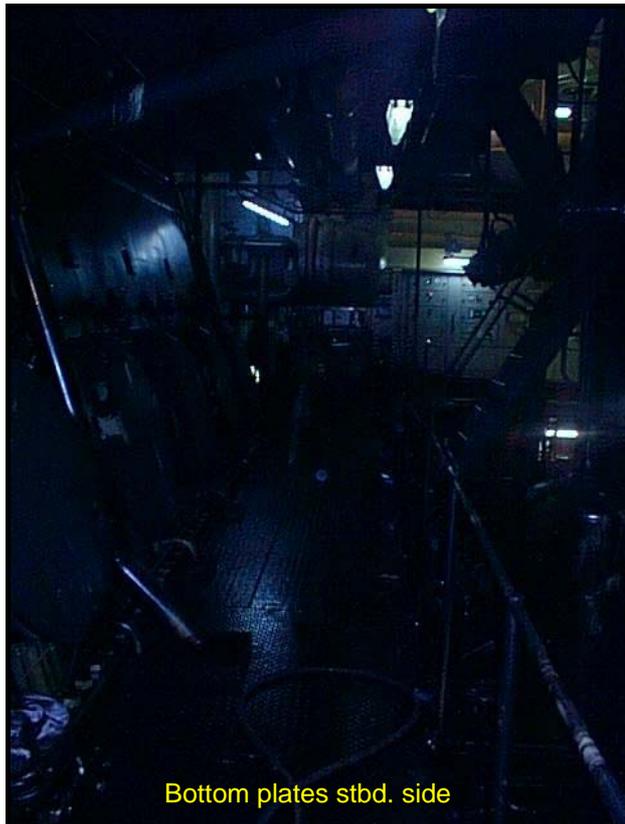
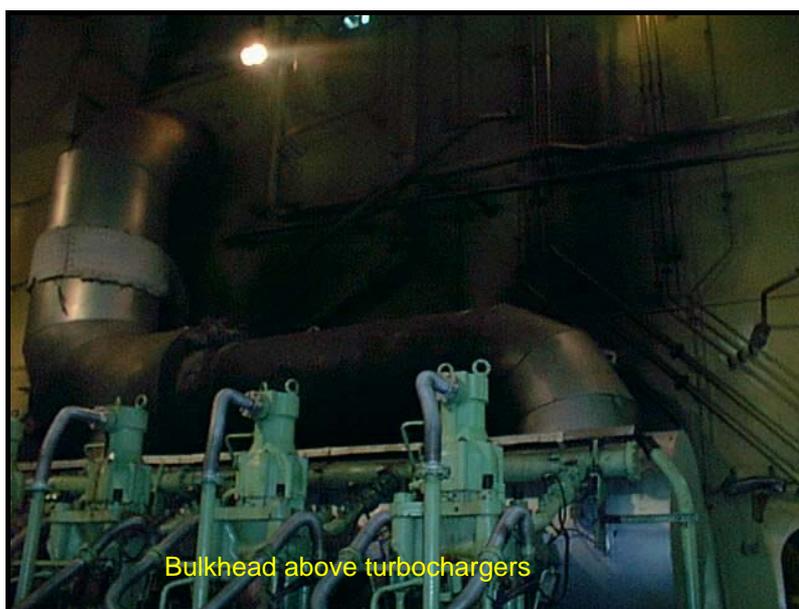
- 2.1 The engineroom was smoke/soot blackened on the starboard side, deck plates around the cylinder head area were distorted and dislodged from their original location, thermoplastic diffusers on fluorescent light fittings had melted sufficiently to flow easily under gravity and their own weight, physical contact damage was apparent in a number of locations.

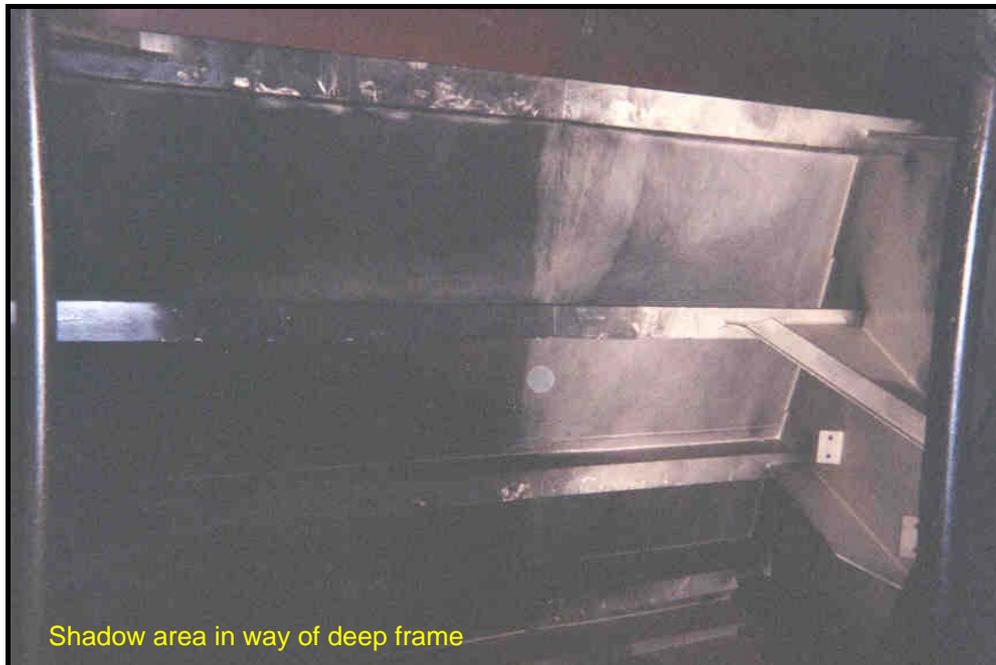
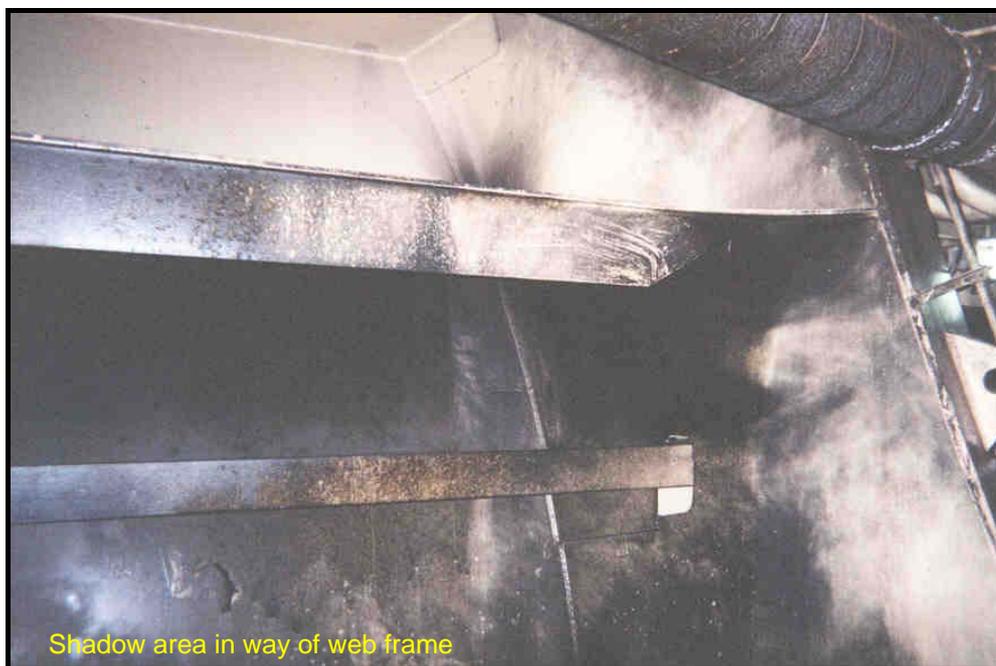
- 2.2 Soot was deposited over the entire side of the engine, on walkways, pipework, lagging and fittings facing the crankcase relief valves. Shadow areas (where soot was lightly deposited) existed on the ships side in way of deep frames and web frames in line of sight from the relief valves and where pipes intervened or the walkways turned back on themselves

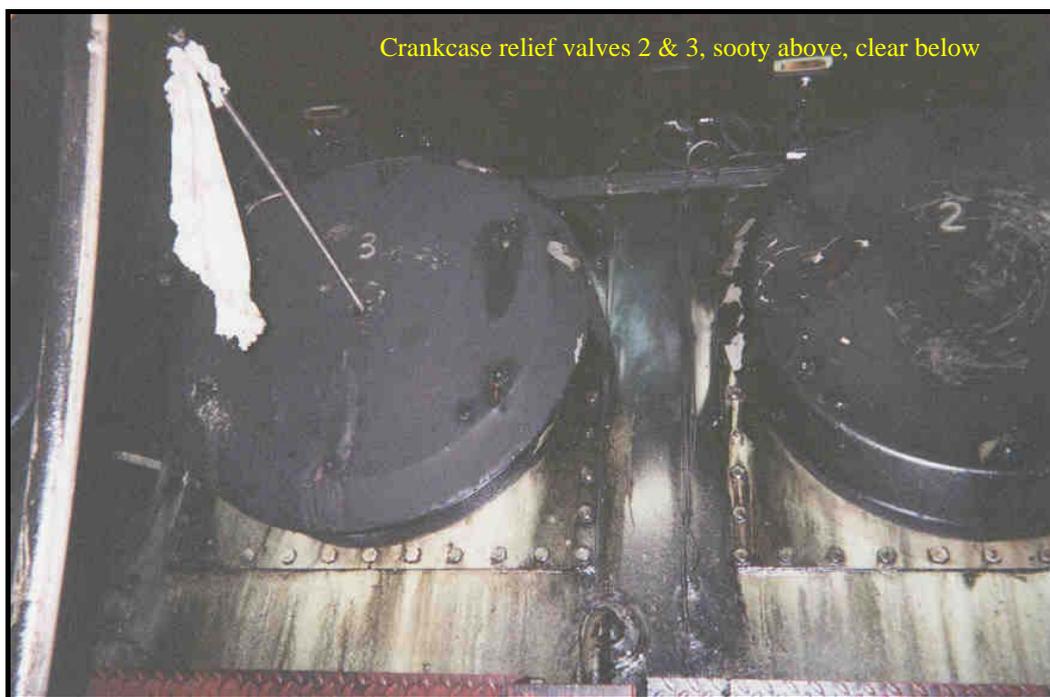
- 2.4 Ships staff performed a crankcase inspection, bearings and running surfaces were checked but nothing immediately obvious was discovered, a very small amount of 'squeezed' bearing white metal was found on top of the oil sump near no.8 main bearing, but not enough to raise suspicion of a hot spot. Engine monitoring systems indicated no bearing high temperature alarms initiated before or after the event and discoloration on internal surfaces was negligible to none existent.
- 2.5 External signs were that all eight crankcase explosion relief valves (located on the starboard side of the engine) had lifted, nos. 2, 5 and 6 were found to have incorrectly seated after closing under pressure from their return springs. Additionally two of the sealing rubber 'o' rings had become dislodged from their seats.

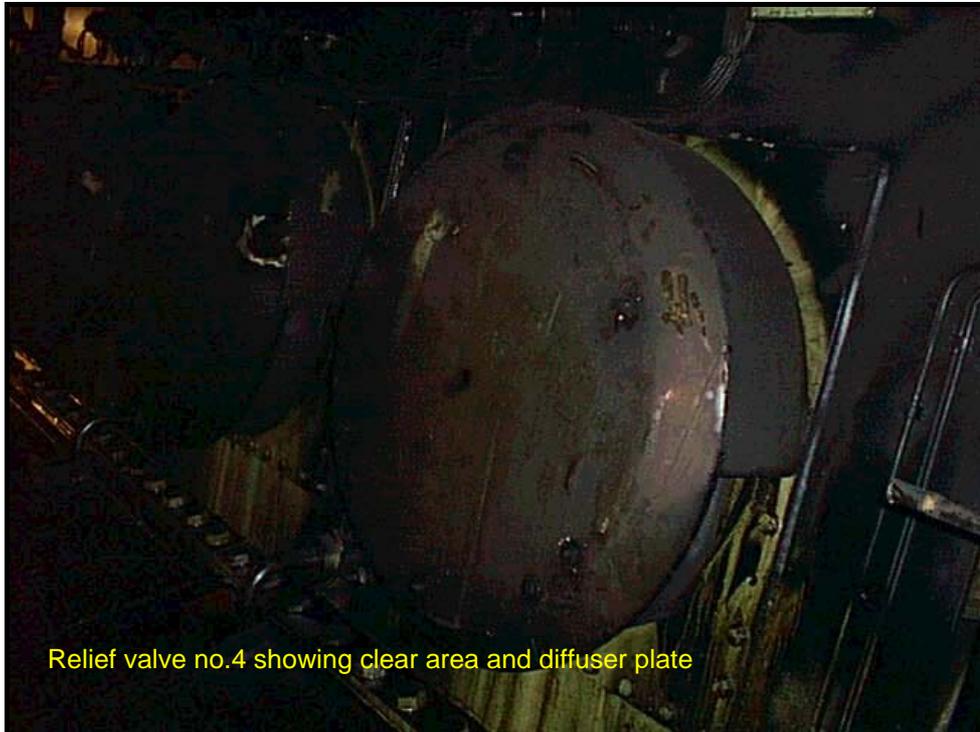
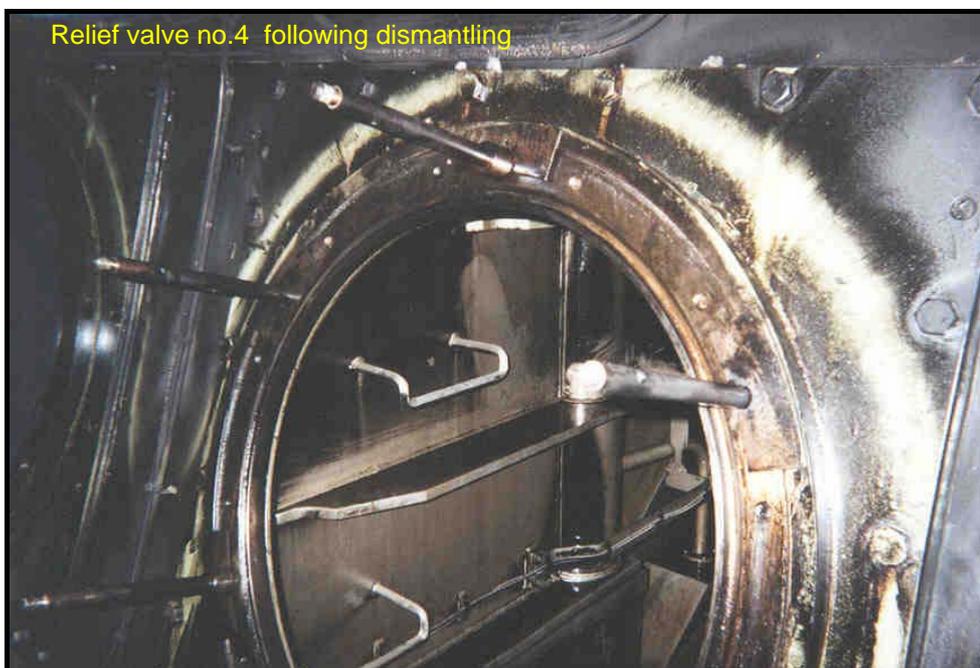
- 2.6 Paintwork immediately adjacent to the relief door periphery was relatively clean but approx. 40mm away it was covered in oily soot and approx. 100mm away, it was covered in dry soot. This soot was noted to be in the region “protected by the diffuser shield” (above the doors) whilst in the area below the diffuser shield (where gases are directed) the paintwork was observed to be less affected.

- 3.1 The findings are consistent with primary and secondary crankcase explosions which resulted in a flash fire external to the engine. The path of this was outwards and upwards from the crankcase overpressure relief valves which is in direct contradiction to normal design parameters (and indeed the installation on board the engine) which is supposed to deflect down and away from the engine.

- 5.1 As a result of the evidence discovered during the investigation, we would propose in the interests of safety to recommend that crankcase relief valve diffusion plates be removed due to the reduction in effectiveness of flame arresting systems caused by the concentration of expelled gases. It is proposed that this would be achieved by making a submission to IMO for consideration and discussion at DE 46 (2003 ).

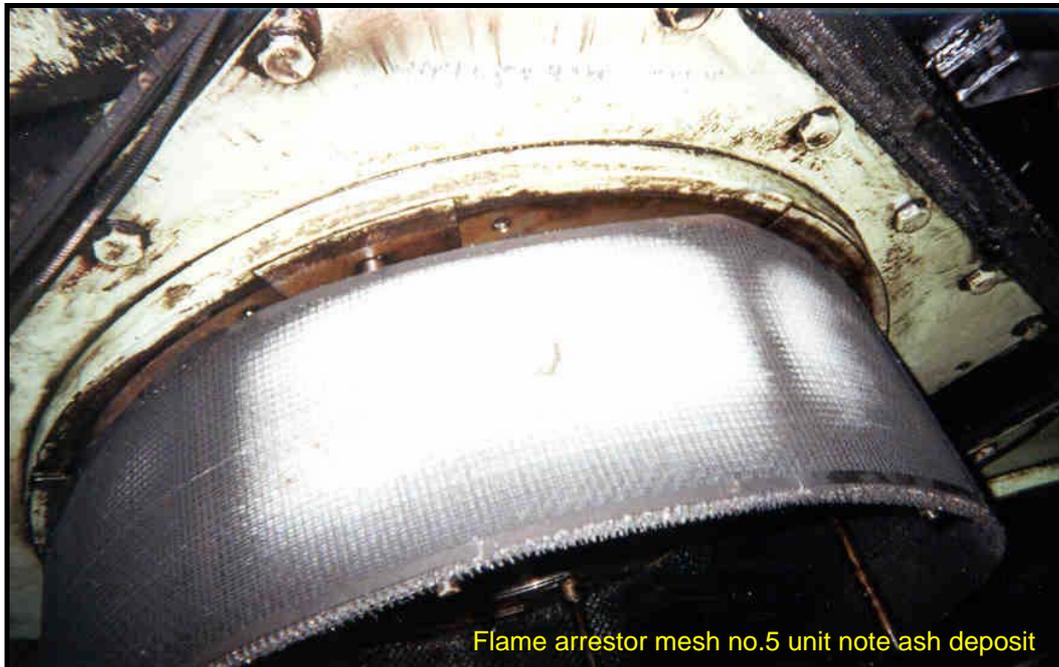
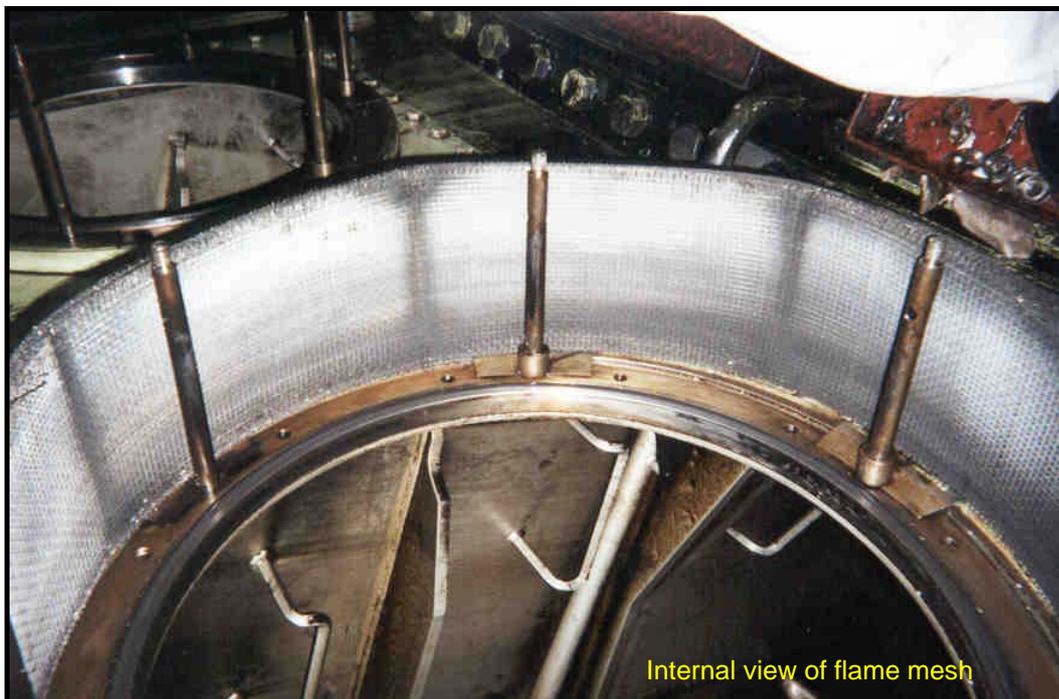
- 2.7 Flame arrestor mesh fitted to the relief valves Nos. 2,4,5,6 was seen to be very dry and had a whitish ash on the side exposed to the crankcase during lifting/operation, of these, no.5 exhibited the most obvious signs of high temperature

- 3.4 The flame arrestors failed to prevent expelled oily mist ignition and therefore did not perform as designed.
- 3.5 The crankcase oil mist monitor was found inoperable, the attending service engineer advised this to be a result of overpressure caused by the explosion(s), a crankcase high mist alarm occurred in the five second period between the first abnormality indication - ME governor minor fault and the ME cyl no.1 outlet high temp and would tend to support the theory that the damage occurred as a result of the explosion. Due to the short time-span between first indication and explosion, it would be doubtful if the monitor could have slowed the engine quickly enough to prevent an explosion.

Service note MSI-0156E (dated 11 April 2001) recommends the removal of the diffusing cover and service note MSI-0165E (dated 15 Aug 2001) recommends the flame arrestors be changed to a redesigned type with greater strength and efficiency, these service notes have been circulated recommending a change of fittings to the modified designs.

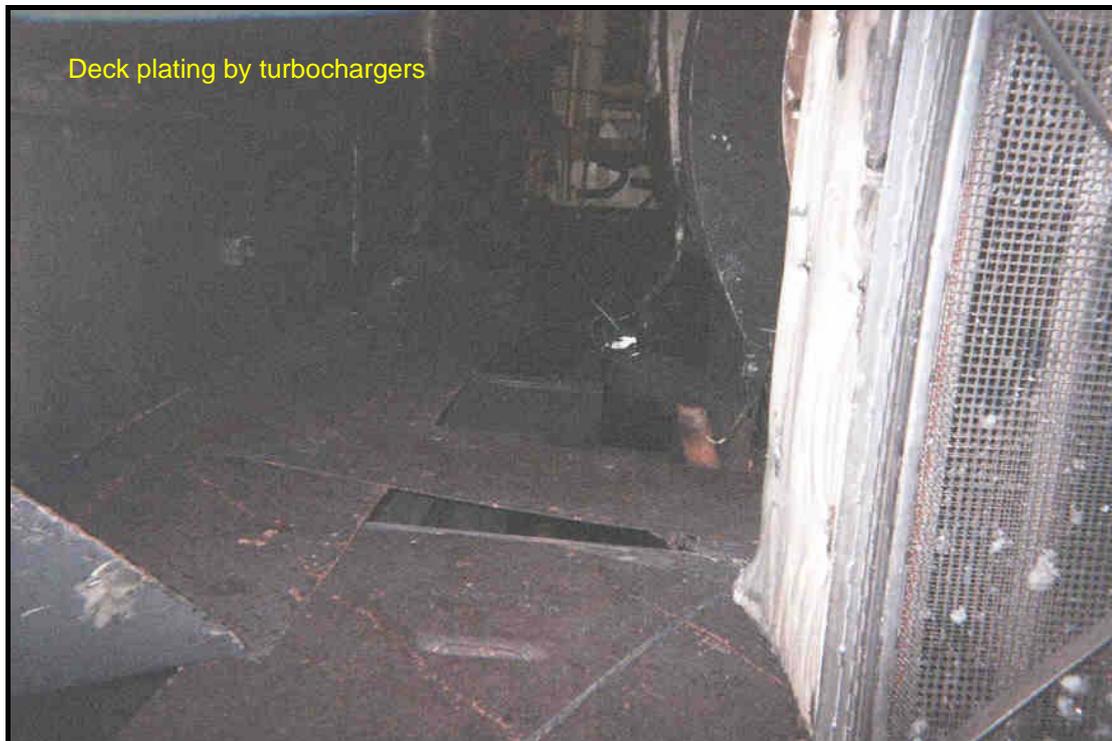
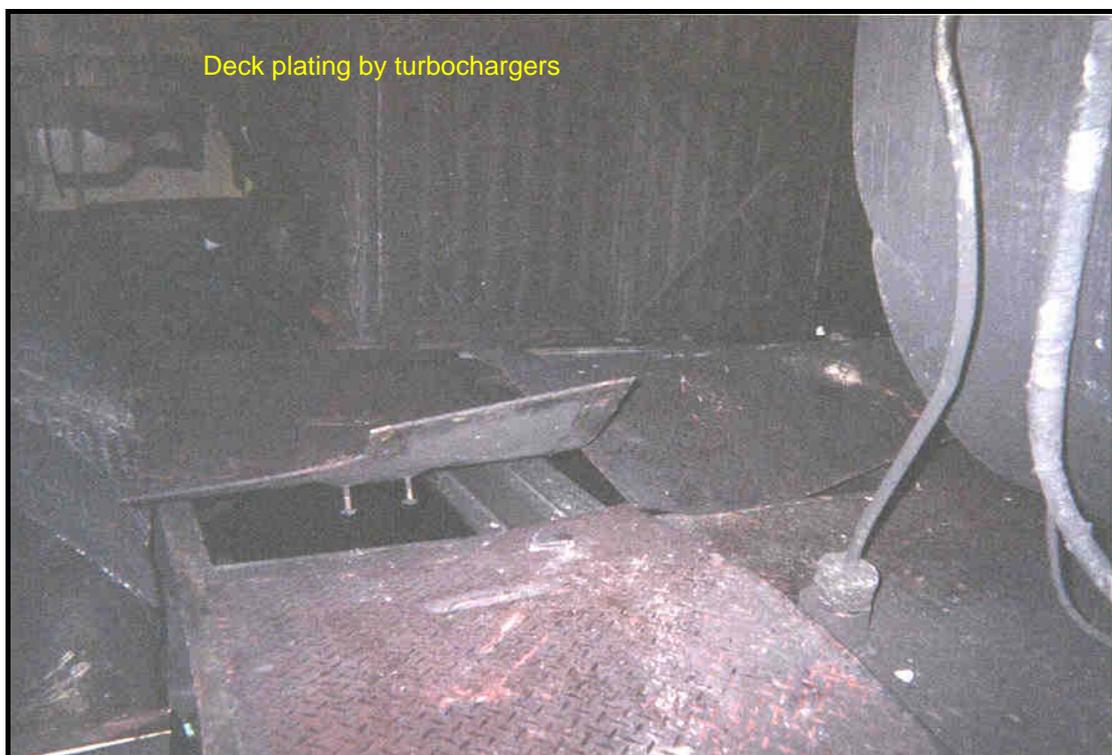
- 2.8 Fixed steel deck plating at cylinder head level was dislodged, distorted or lifted, particularly in way of the turbochargers and air coolers where the clear space around the engine is restricted, many securing screws had been sheared or stripped of their threads.

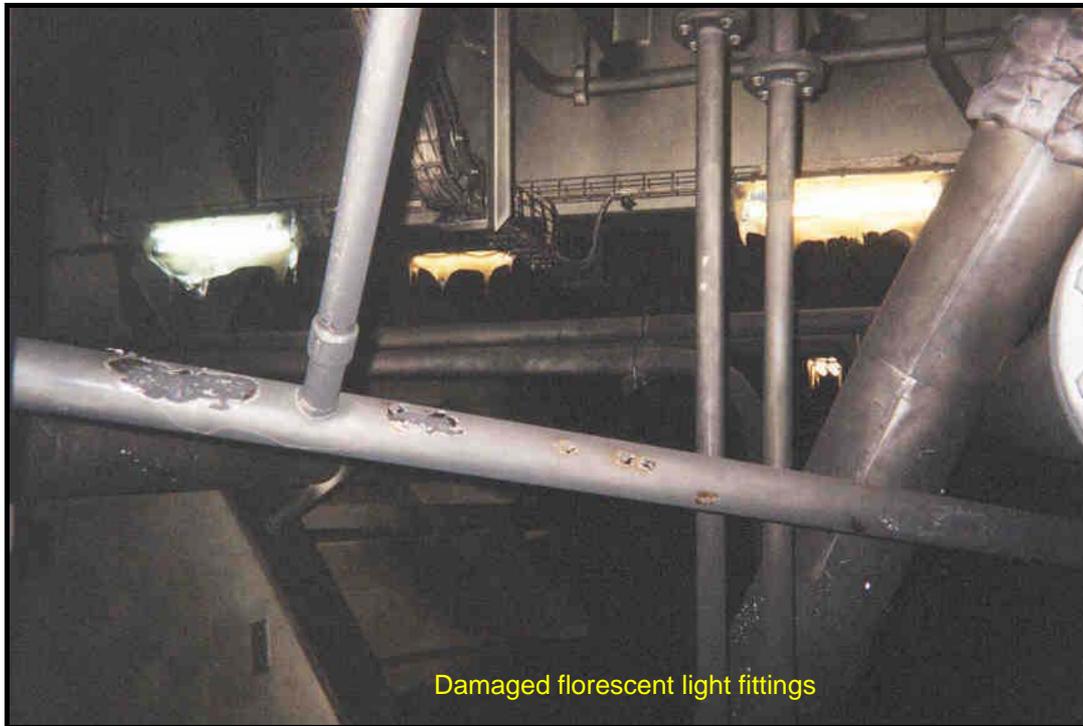
- 2.9 Significant soot and smoke damage on the starboard ships side, plates, walkways, pipes and ducts was apparent.
- 2.10 A number of fluorescent light diffusers had largely melted away, the area from the bottom plates level right up to cylinder head level on the starboard side of the engine room was affected

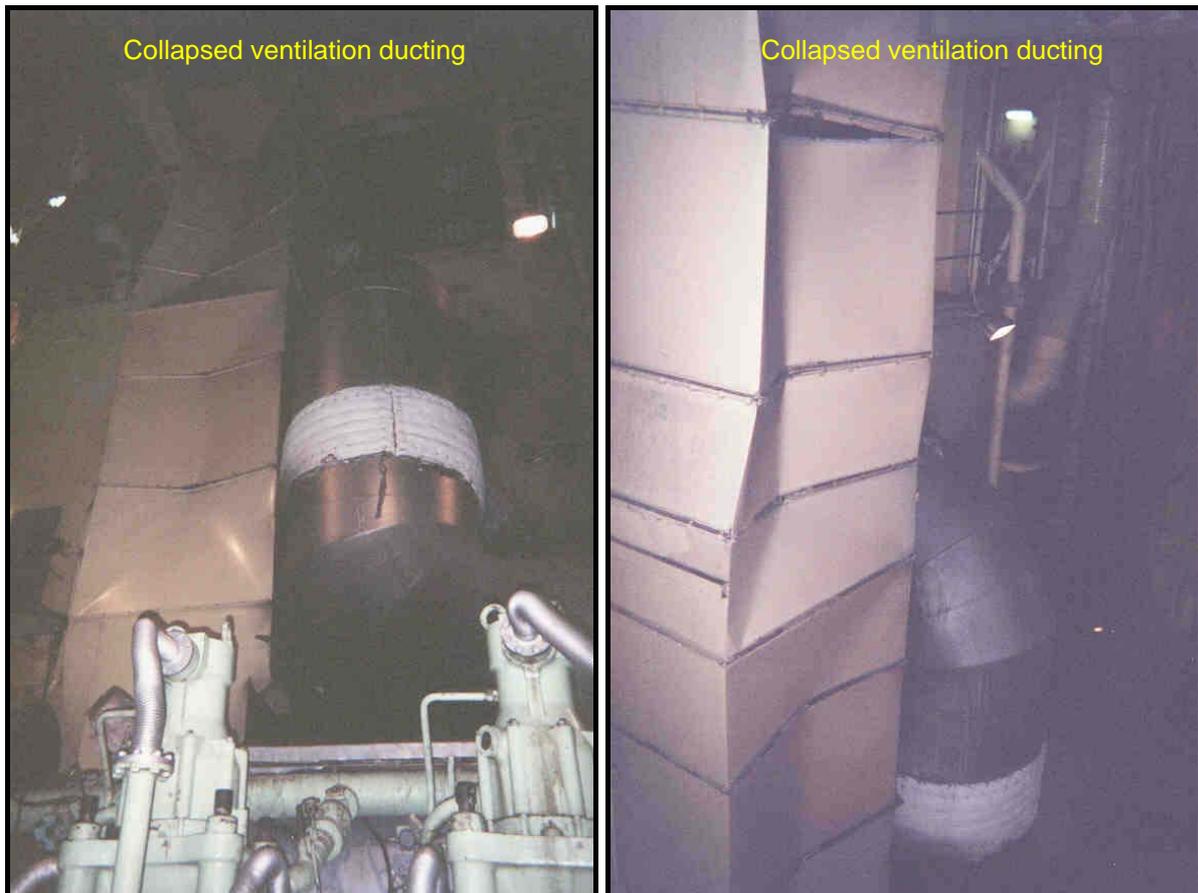
2.13 Engineroom ventilation ducting was significantly deformed, dislodged or collapsed and acoustic insulation was found littered over the after deck .

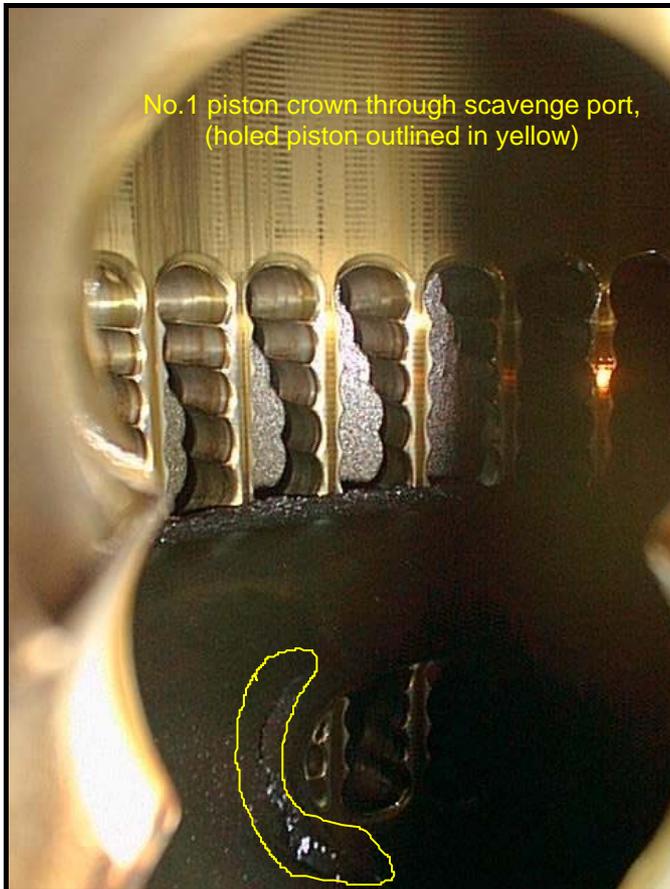
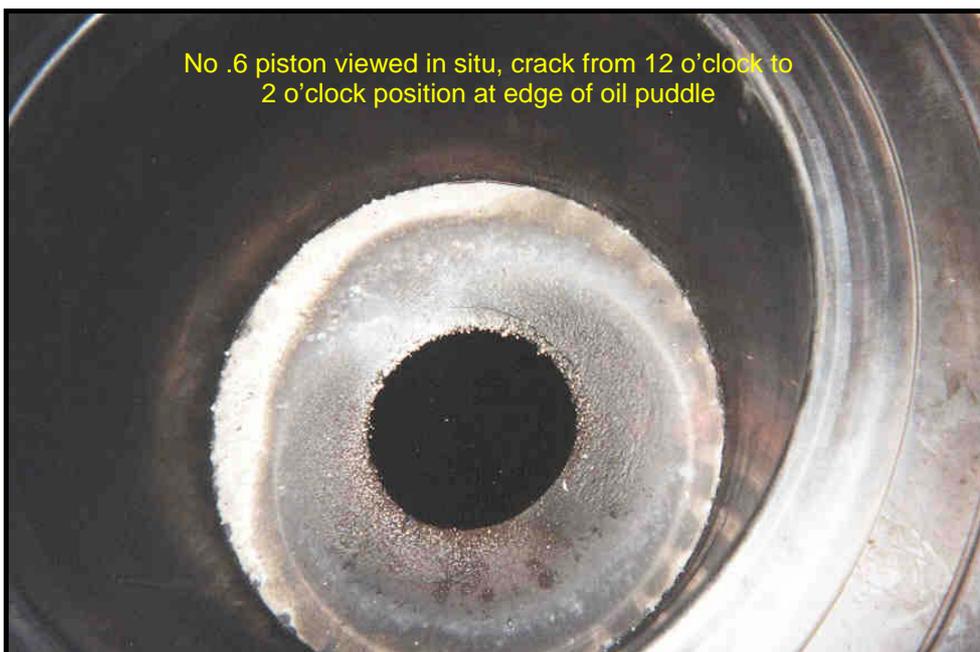
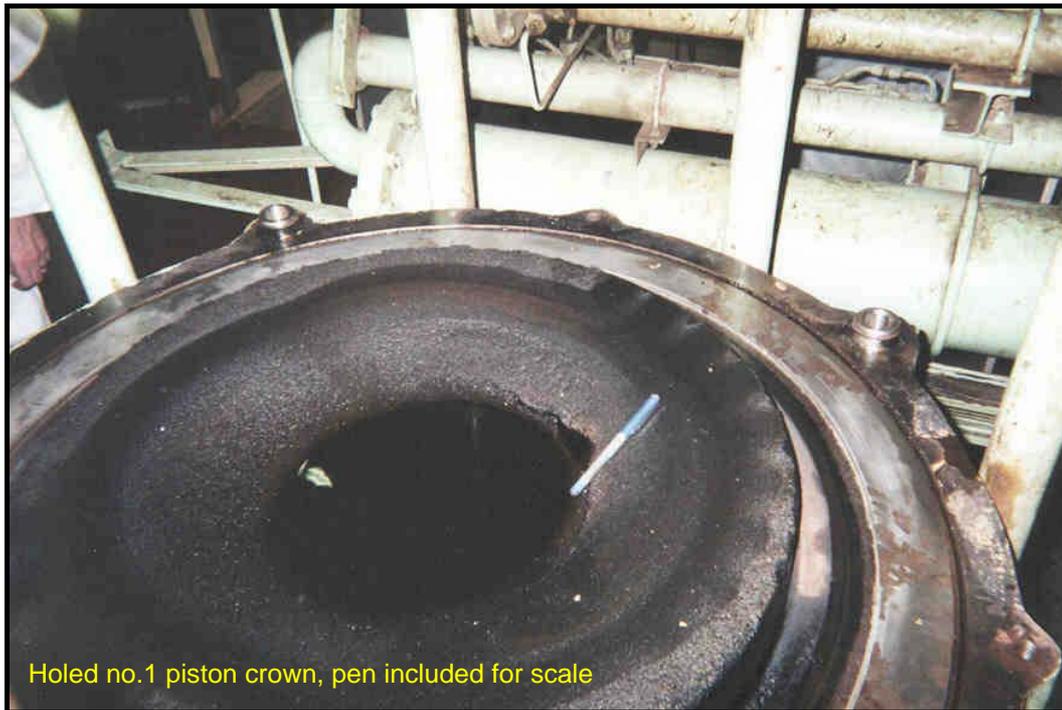
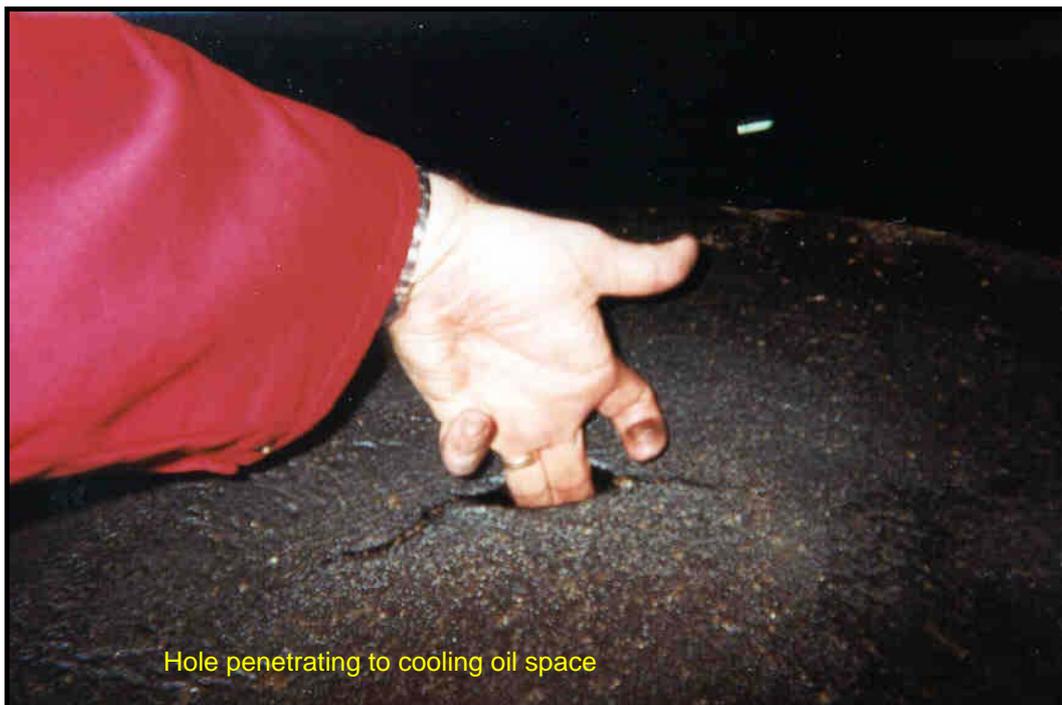
- 2.16 No.1 Piston crown was found to be cracked and holed which penetrated to the oil cooling space thereby allowing direct communication of the combustion space with the crankcase via the cooling oil passages and would indicate a probable initiation site.

- 4.1 The failure of no.1 unit, piston crown, allowed direct communication of the combustion chamber with the crankcase via the piston cooling oil passages. This allowed hot combustion gases to create and ignite a flammable oily mist mixture from the oil droplets normally present in the crankcase, causing a primary crankcase explosion.

- 4.3 Unusually large piston crown wear had occurred since overhaul in dry-dock in October 2000, the evidence gained indicates fuel impingement from poor atomisation which caused localised overheating and cooling oil breakdown on the internal surfaces of the crown and in turn increased the high temperature erosion in the areas of failure, ultimately leading to the mechanical failure of no.1 and no.6 piston crowns.

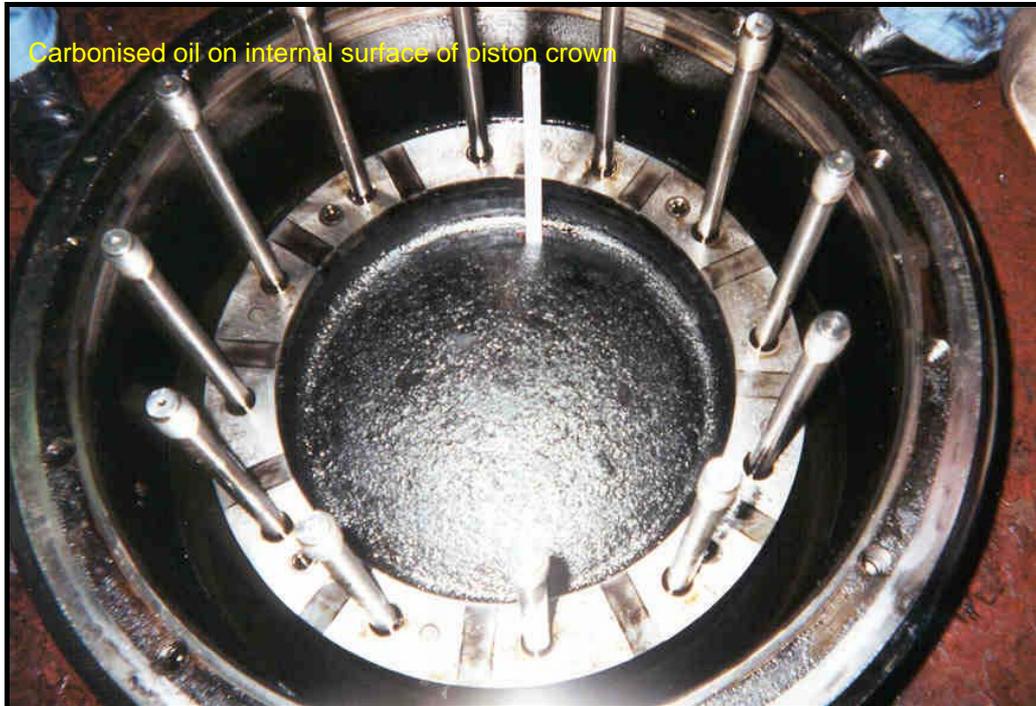
- 2.18 The scavenge space was found to be in a normal operating condition and showed no signs of internal fires.
- 2.19 Following dismantling, carbonised oil sludge was found to be coating the interior of the piston crowns.

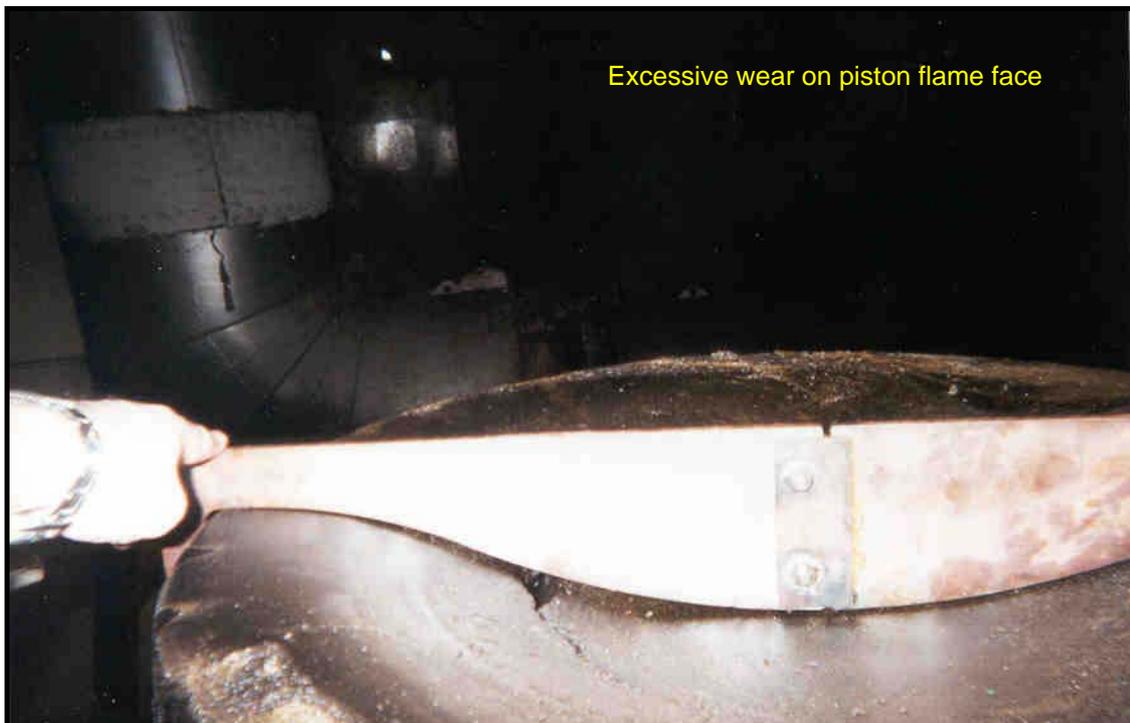
- 2.23 From historical records, it was determined that the engine performance monitoring system was not fully functional prior to the incident, this may have provided useful diagnostic information to developing problems with the combustion process.
- 2.24 During the investigation, calibrations showed No.1 and No.6 piston crowns to be out of tolerance for further use, whereas in dry dock less than eight months previously, calibrations had shown they were within wear tolerance for a further service period of 8,000 -10,000 running hours (approximately 11 - 14 months continuous service).

No.1 exhaust valve was also measured with the maximum allowed wear (12mm) and was recommended for exchange and reconditioning.
