Casualty Investigation Report CA - 63

Fatal Accident in Heavy Weather, 2nd March 2000

Johann Schulte

***Isle of Man Government
Marine Administration***

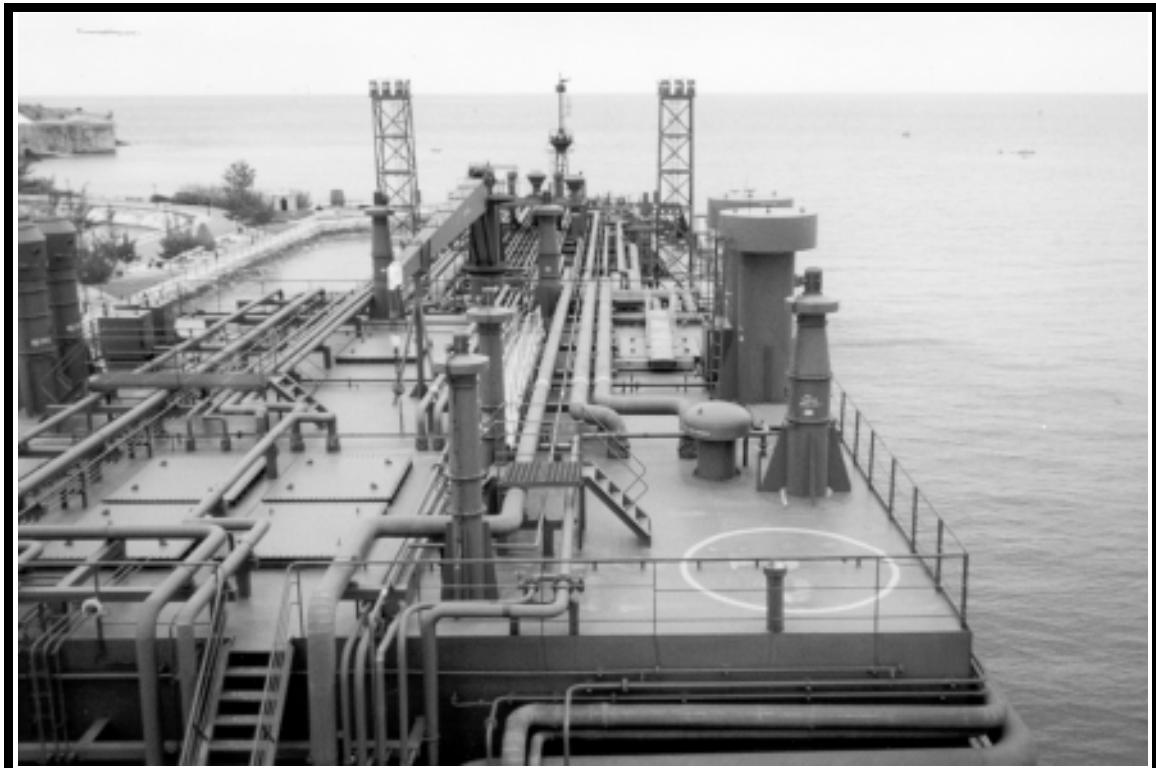
Diagram 1

The above picture depicts the view from a wheelhouse front window, starboard side of centre line, and shows the fore deck arrangement of the “Johann Schulte”. It confirms the impracticality of being able to visually see anyone or any group of people working forward, especially anyone on the forecastle. The forecastle deck area is completely hidden by the ship’s structures and the weather breakwater.

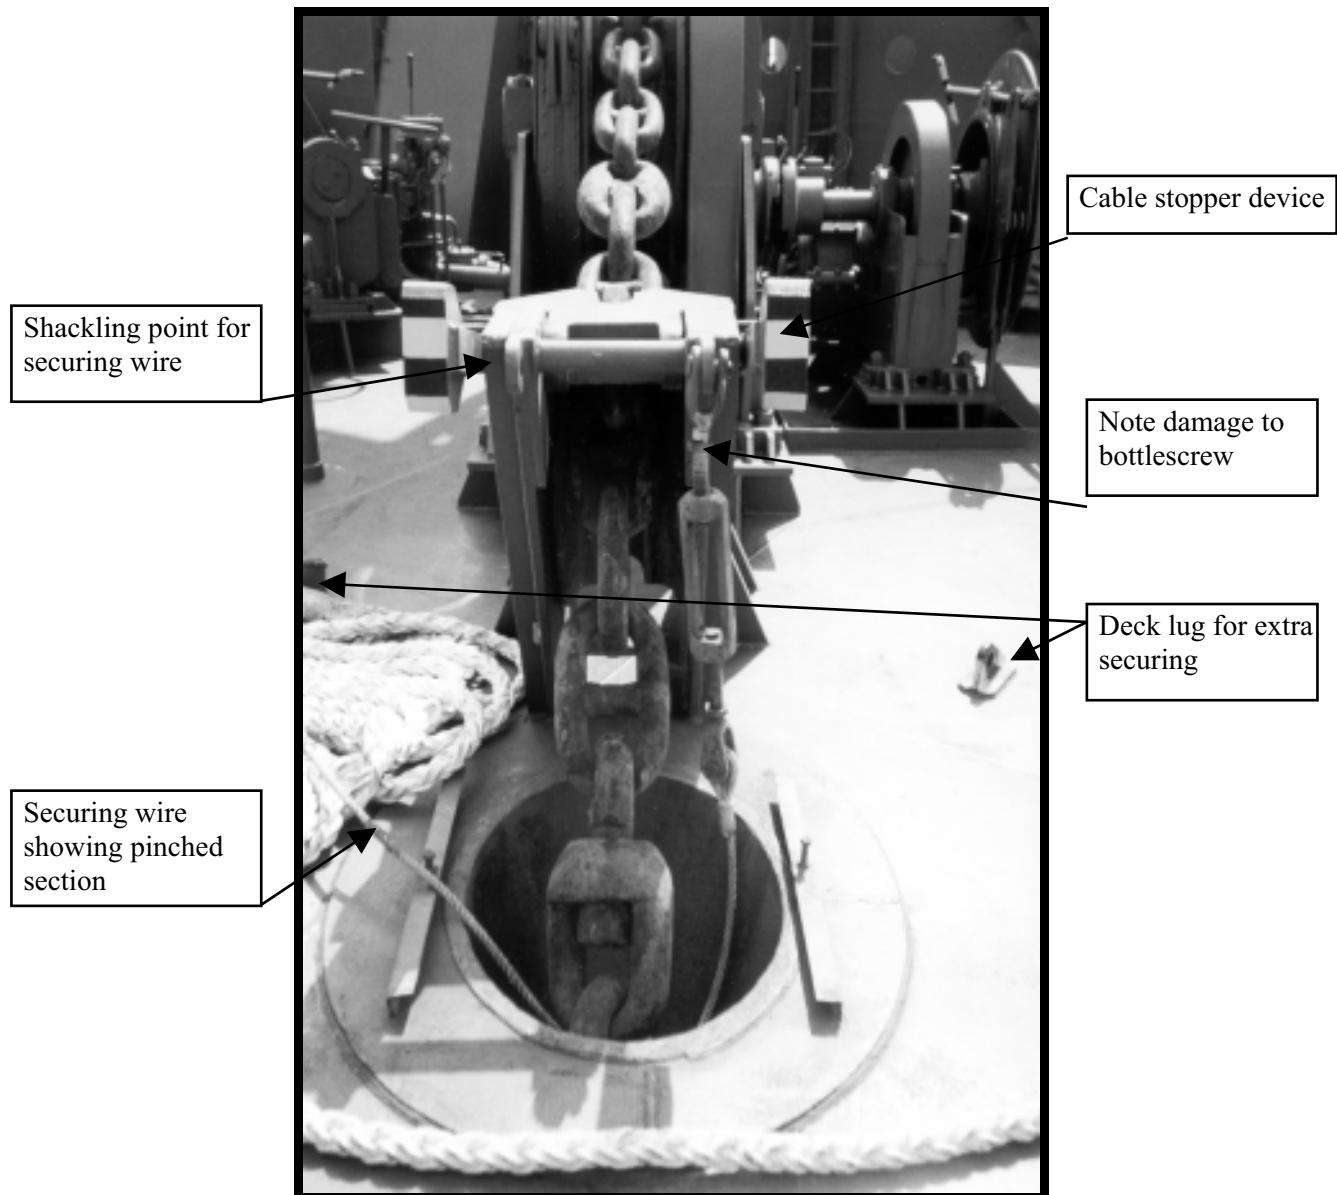
Diagram 2

The above picture shows the port side anchor securing arrangement on the “Johann Schulte”.

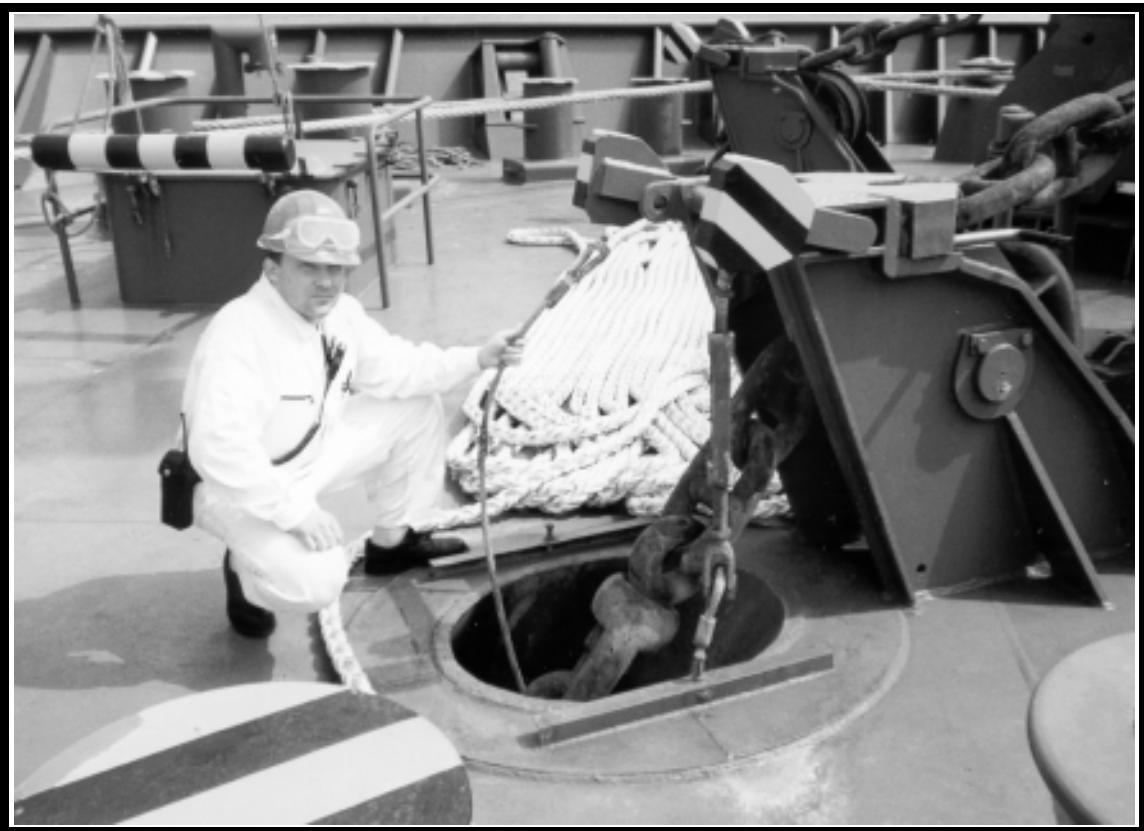
Diagram 3

The port side anchor cable securing arrangement with an officer depicting how the securing wire is passed through the anchor cable and secured by shackle to the eye bolt on the inside of the counter weights of the cable stopper.

- (viii) It is recommended that the anchor cable securing arrangement be assessed and;
 - (a) a stronger securing wire be used or,
 - (b) an alternative securing arrangement be introduced.
- (ix) Failure to follow a written procedure which is safety related should be made a

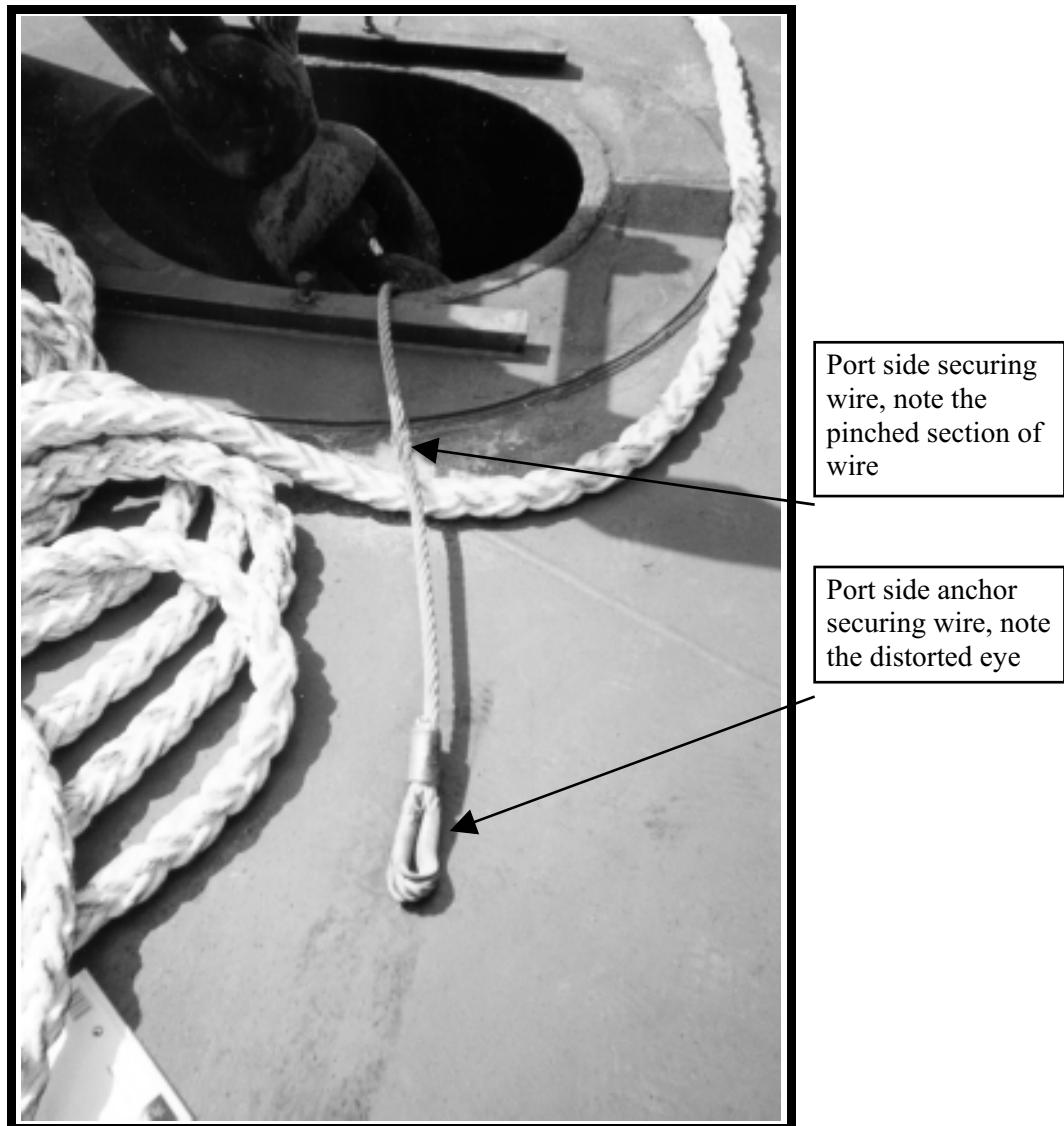
Diagram 4

or fittings. The crew is estimated to have moved onto the forecastle at about 0825 hours. About ten minutes later they were joined on the forecastle by two other seamen. The port anchor was described as being “ a bit loose ” so it was hove tight, this in turn slackened the securing wire around the cable. It was necessary to adjust the securing wire to hold the anchor cable properly. Photographs taken at the port of refuge (See Appendix I, Diagram No.2 & 3) show the type of cable securing arrangement, the wire, bottle screw attachment and shackle securing. Examination of the wire on the port cable securing arrangement showed that part of the wire had been “ pinched ” close to one end and the eye had somehow become distorted. It proved impossible under a test to pass a shackle through this eye, which leaves three possibilities;

- ♦ If the damage had been recent a shackle could not have been removed from the eye therefore it can be reasoned that without the presence of the shackle the damage could have been older and that might possibly suggest the anchor cable was not properly secured on departure from Sines.
- ♦ The “pinched” section of wire suffered damage when it was passed through another link in the cable while the crew were attempting to re-secure the cable.
- ♦ The distortion of the eye was caused during the re-securing of the anchor cable after the shackle had been removed from the securing wire eye to facilitate the ease of passing the wire between the anchor cable links or it was damaged by the force of water breaking onto the forecastle during the attempt to re-secure the anchor cable.

When the preliminary investigation officers examined the scene on the forecastle deck it was discovered that the securing wire eye had been distorted. The probable causes as to how this distortion happened have been examined in the analysis described in Part 4, paragraph 4.21

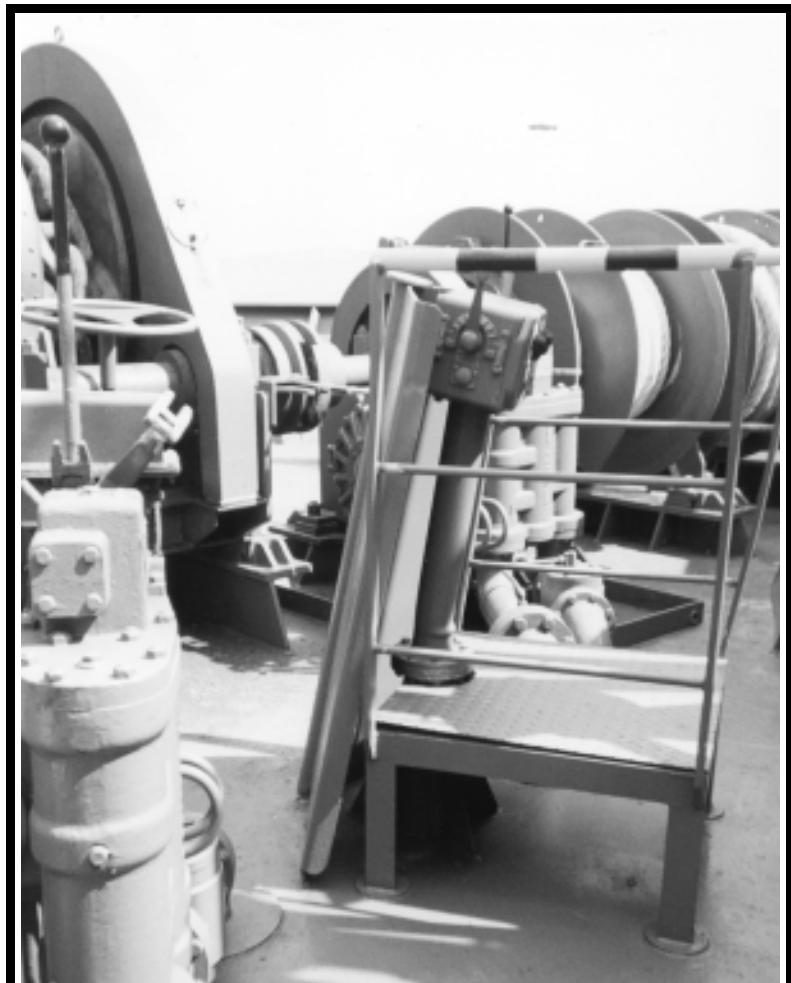
Diagram 5

The above picture above depicts the damage sustained to the windlass control stand which is just forward of the position where the Bosun was found by the 3rd Officer and Chief Engineer.

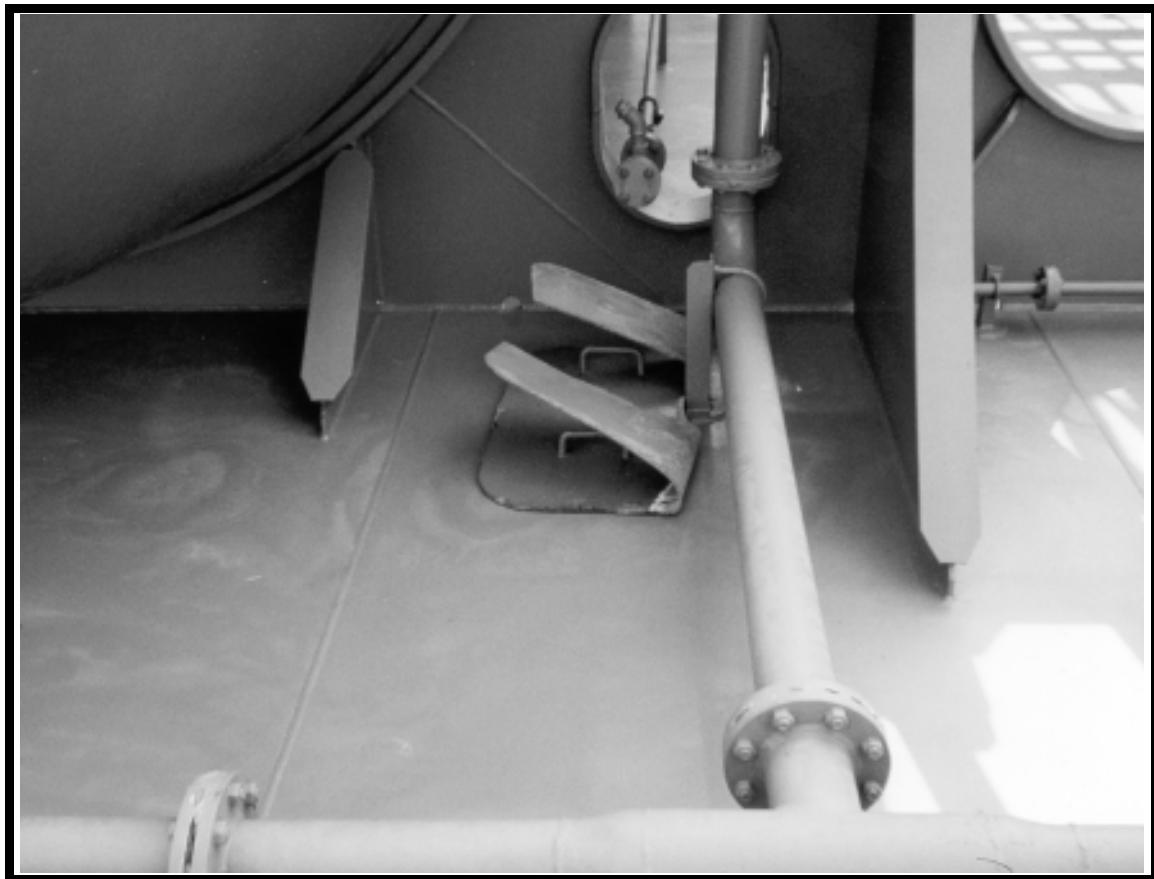
Diagram 6

The picture shows the forward underside area of No.1 (S) Deck Tank and depicts the position where the starboard hawse pipe cover was found.

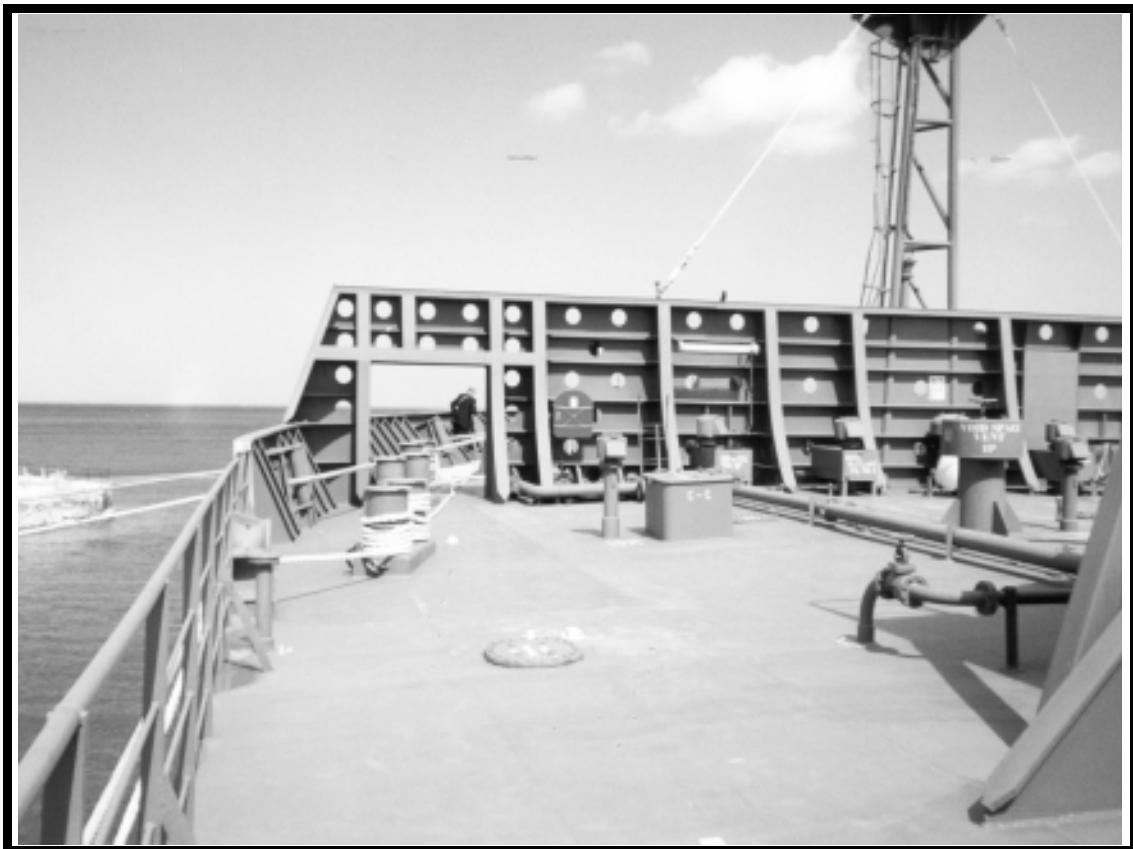
Diagram 7

The picture shows the position where the body of the Chief Officer was found in relation to the forecastle. The view looking forward shows the height of the weather breakwater and the port side access through which the 3rd Officer and Chief Engineer effected the rescue of the Bosun. Note the damage sustained to the safety ring on the foremast.

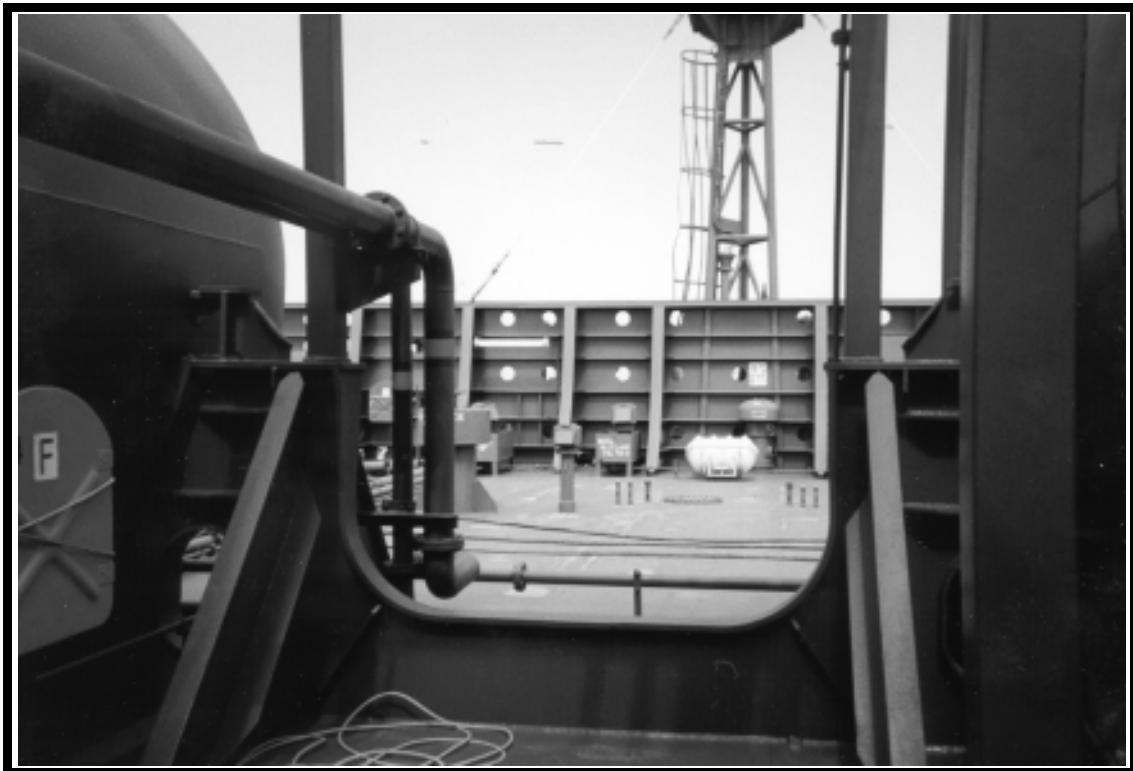
Diagram 8

The well area between the No.1 Deck Tanks close to where two of the seamen were found after the waves struck the ship.

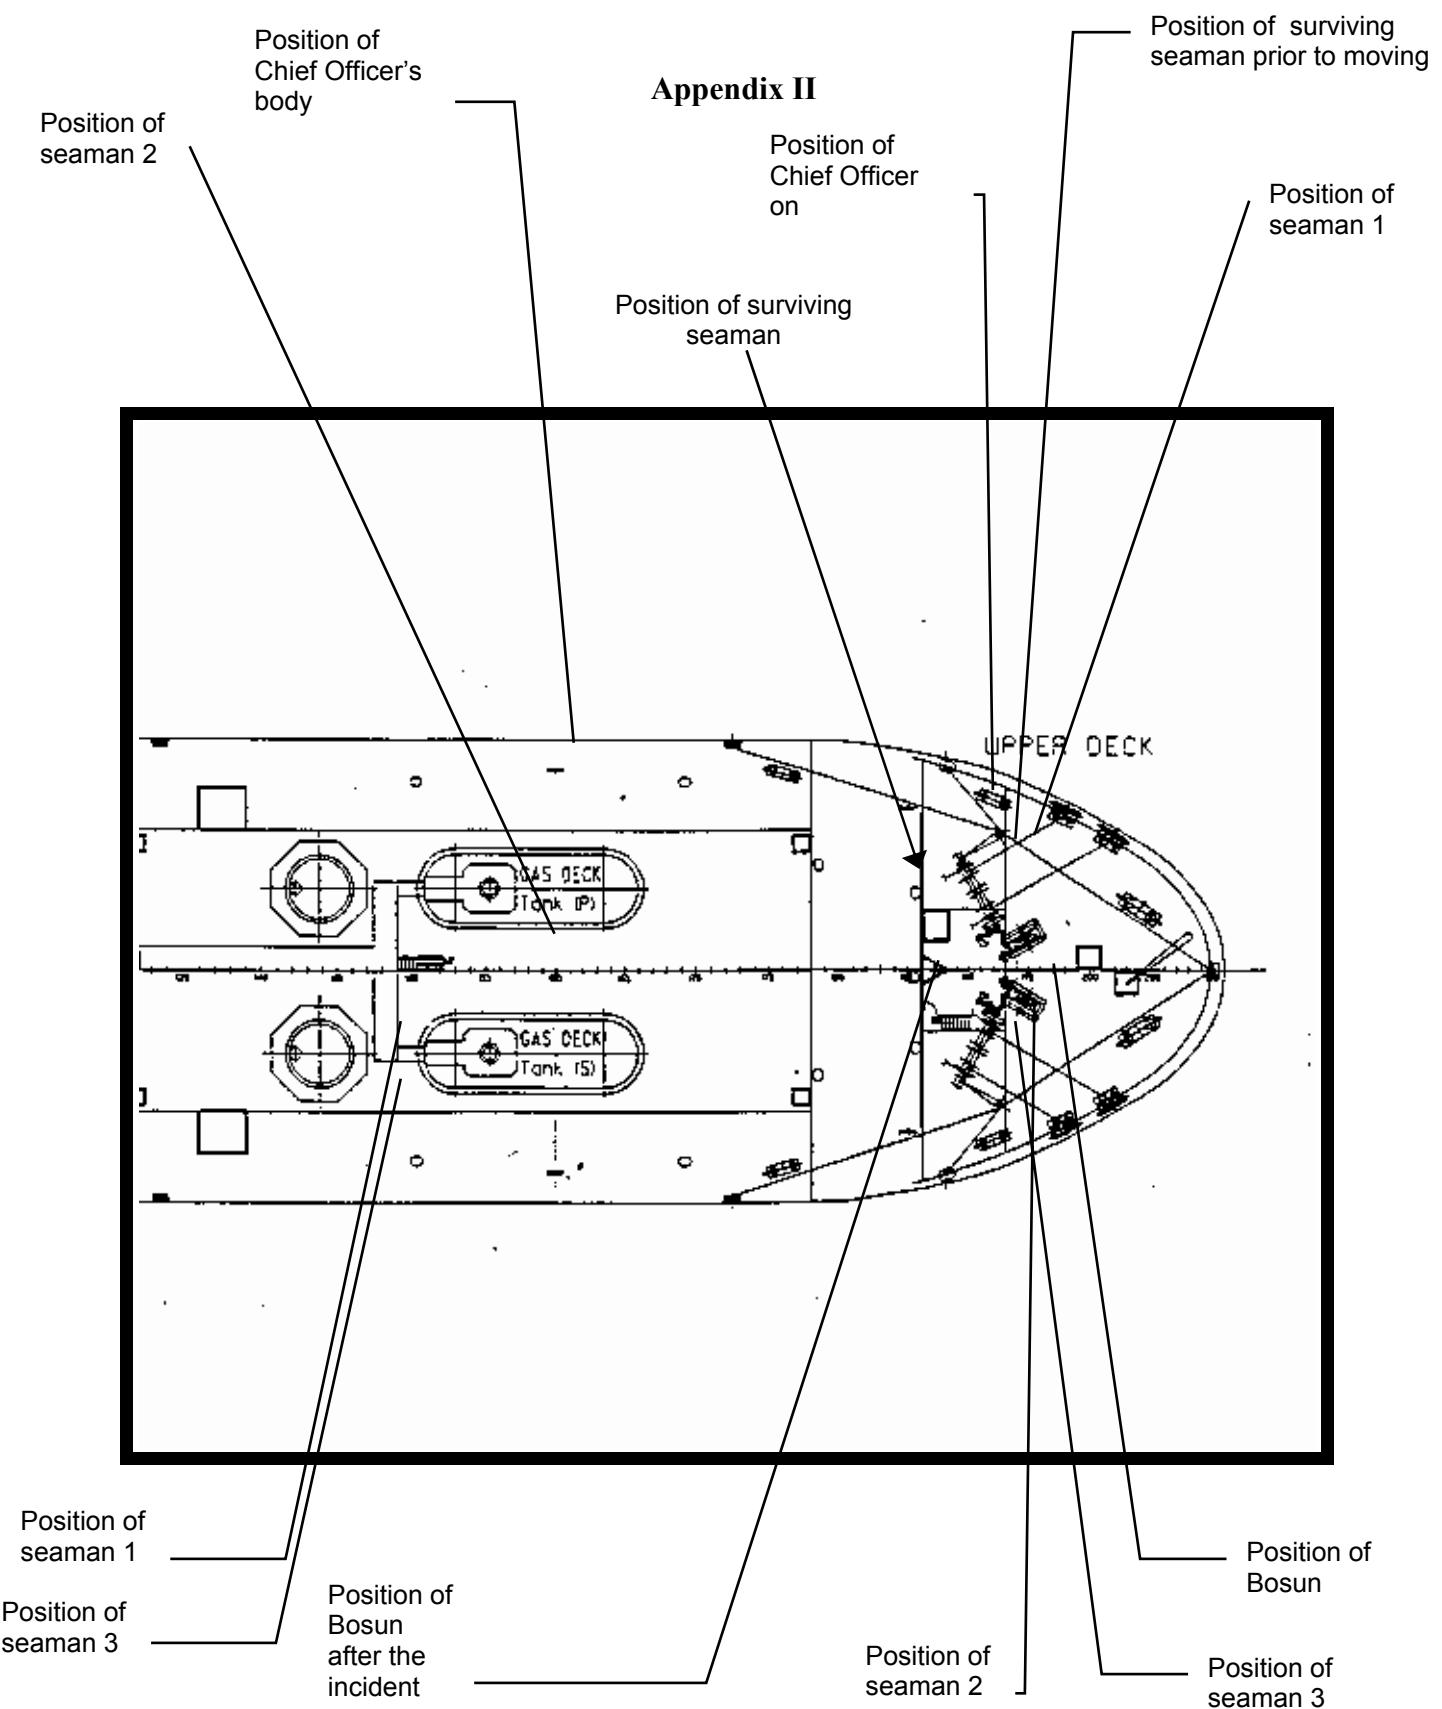
Appendix II

4.24 The impact of the waves threw the Chief Officer and four of the crew to the positions as indicated (See Appendix II, Diagram 1). The 0800 / 1220 seaman who survived the impact uninjured was unable to inform the Officer of the Watch on the bridge of the incident using his walkie-talkie radio because he had put the radio down in safe place to avoid damage by the wet spray coming over the bow.

The diagram above depicts the positions of the crew in their working positions on the forecastle head prior to the incident. Then the positions in which each of the crew were found after the waves struck.
