THE SHIP

The Sapphire is a single screw oil and chemical tanker (type 2) of 9914 grt and 14002 dwt. Built at Cant. Nav. Mario Morini S.p.A. in Ancona Italy and delivered in February 1997. Length overall is 143 metres, breadth of 22.0 meters and a loaded draft of 8.4 metres.

SUMMARY

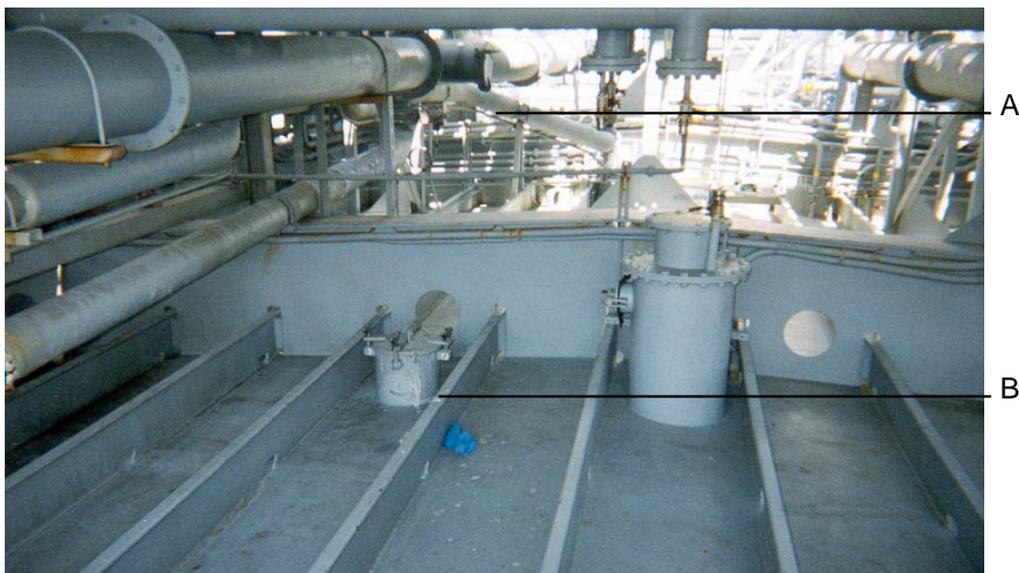
Photograph: looking aft from 6C tank lid. The tank ventilation line, supplied from a fan in the Forecastle, can be seen in the top left. Flexible trunking connected from opening (A) to the opening in the tanktop (B).

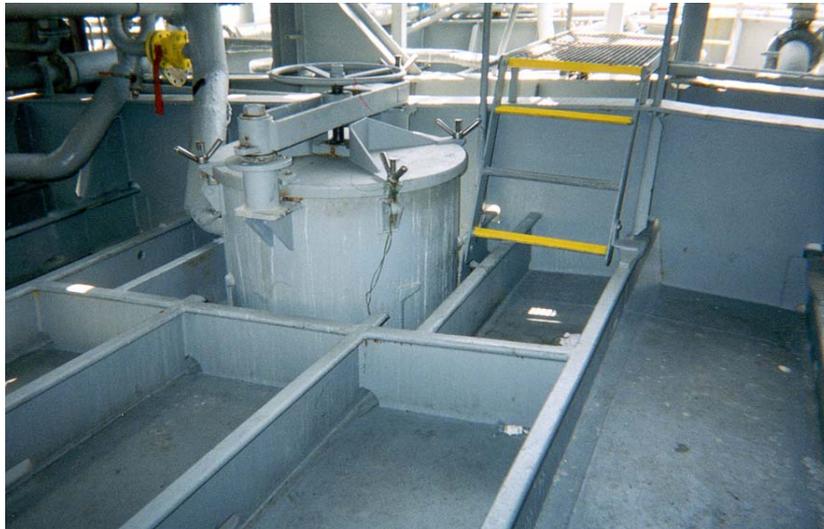
Photograph: Looking forward towards 6c tank lid. The warning notice of a Nitrogen atmosphere is attached to plastic wire on nearest tank hatch dog.

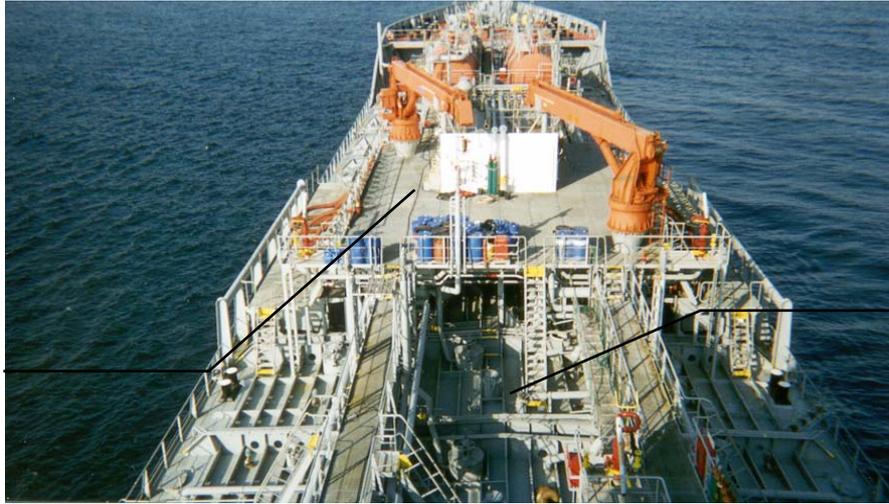
6C tanklid
is at fore
end and
below
manifold
platform,
not visible
from
wheelhouse

Pumpman and
Deckboy last
seen from the
wheelhouse in
this area at
approx. 1900.

Photograph: View from wheelhouse

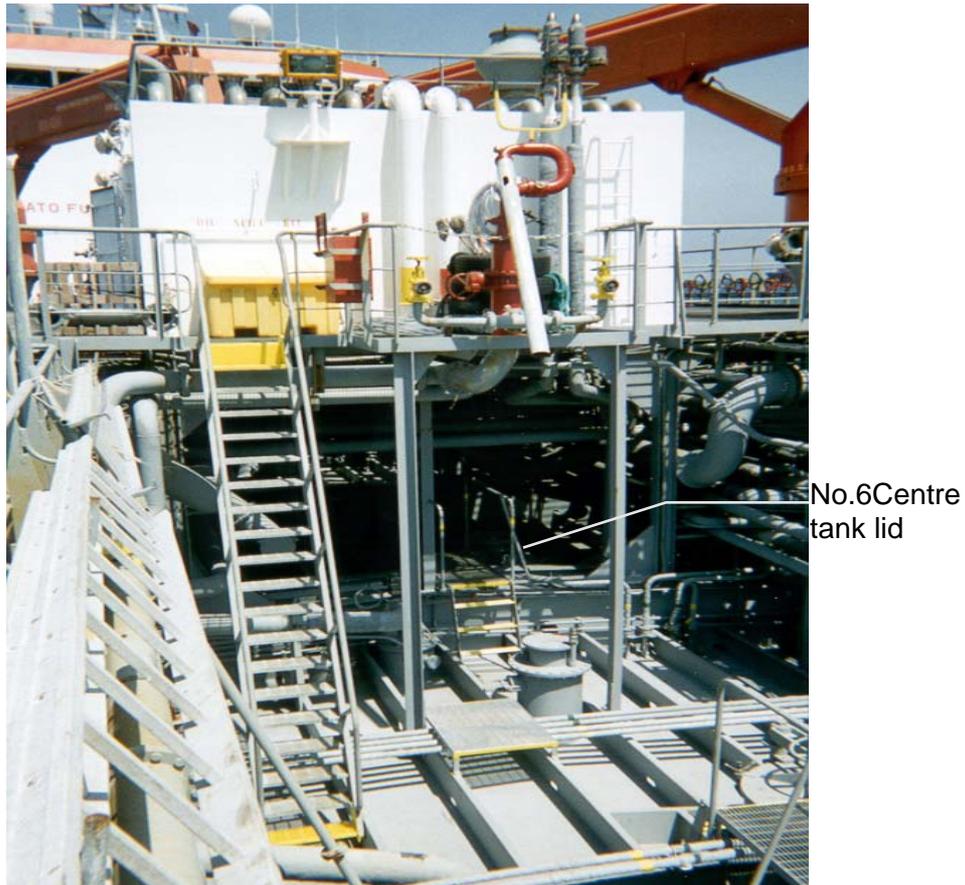
Photograph: The view the Chief Officer would have had at the time he noticed 6C tank lid open. 6C tank lid is in the shade, underneath the manifold platform.

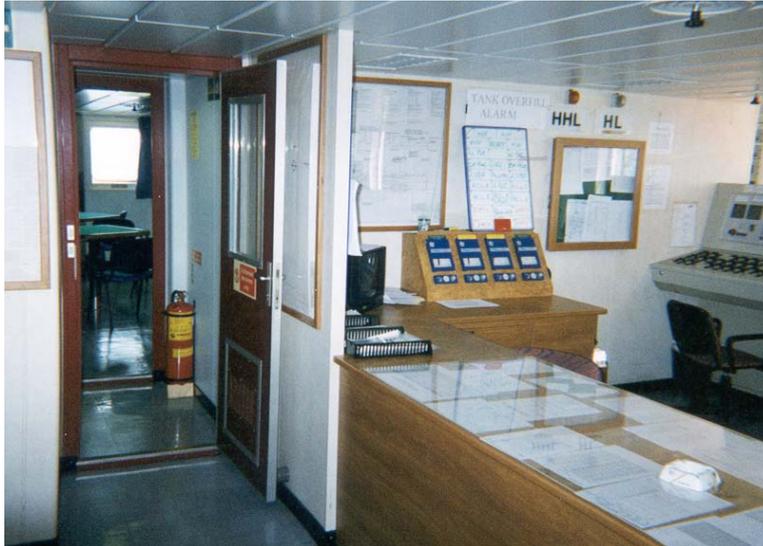
Photograph: View form the Cargo Control Room through to the Officer's TV room, the Crew TV room is to the left of picture. When the Chief Officer entered to raise the alarm nearly all the ships complement were in this area.

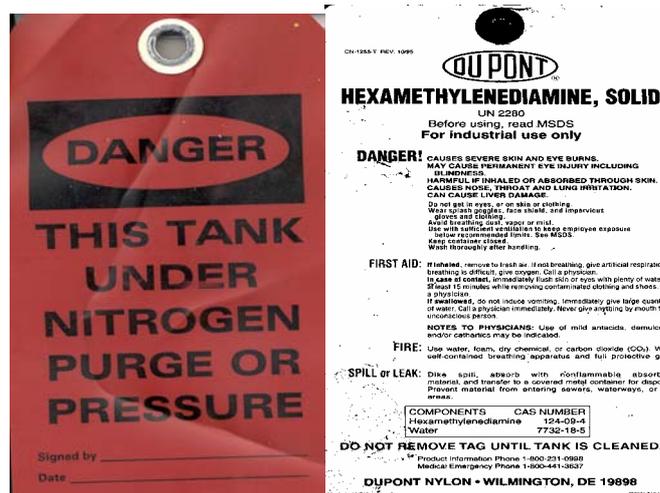
Photograph: The two tags that were fitted onto 6C tanklid on completion of loading, and were still in place after the incident.

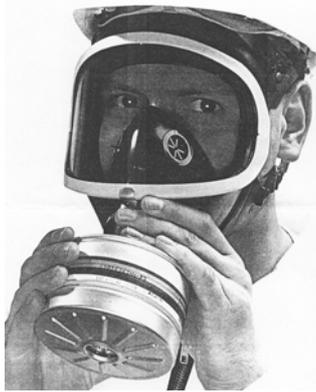
It is concluded that the ready availability of filter masks could lead crew members into a false sense of security unless their limitations are constantly stressed. There was no evidence of this during the time onboard.

Reproduction of the type of filter mask used onboard.

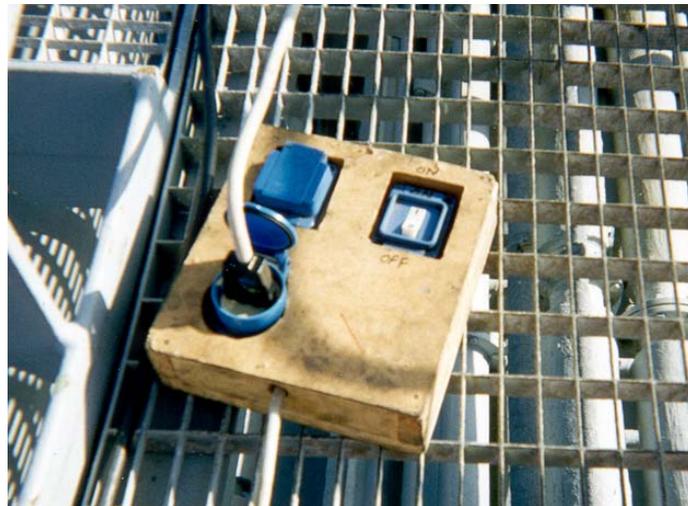
The electric cable for the grinder was standard 220v domestic cable used in any wandering/extension lead. None of the connections were either gas tight or water proof and were standard domestic connections with a total of three connections along the length of the walkway from the tank entrance to the port side of the accommodation. The cable then lead down to through an open porthole in an empty changing room on main deck level and was intended to be plugged into a normal two pin socket in the alleyway.

Photograph: One of the connections on the walkway above tank 7C

The use of domestic cabling and connections within the hazardous area is unacceptable and an extremely dangerous practice that must be stopped.

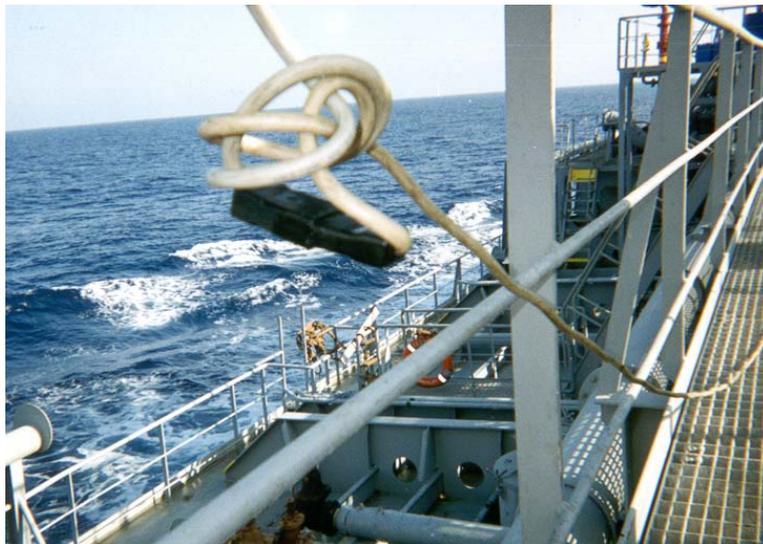
When challenged on using domestic electrical leads over such a large distance and with only "domestic" connections within the hazardous area the Chief Officer advised that there were no flammable vapours on board. When asked if this had been checked he said "it had not been but their experience told them that none of the present cargo was flammable." Even when challenged on the contents of the slop tanks, where one of the tied together connections was situated above, they were confident that in their experience it did not require checking.

Photograph: The standard of electrical connection above tanks 9c and slop tanks.

The Master and Chief Officer were advised that while they have the experience in the chemical trade, to make that decision on the use of this cabling and connections within the hazardous area once again gives the wrong signals to the crew onboard. Assumptions may be made that if domestic electrical wiring and connections are used on deck at this time then it will be safe in future, with possible disastrous consequences.

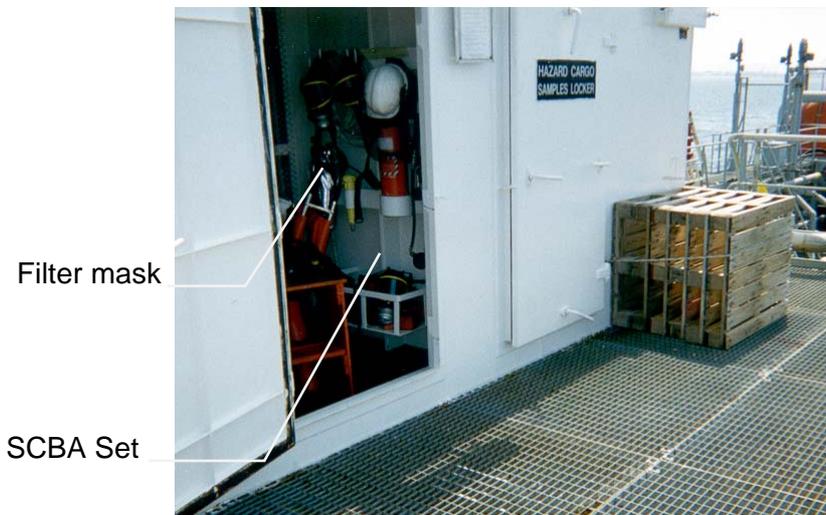
The ready availability of filter masks and the common practice of using filter masks without firm guidance and training in their limitations led crew members into a false sense of security and contributes to this accident.

Photograph: Manifold platform store room. Note SCBA and filter masks stowed in close proximity
