Ice Angel – Grounding in Polar Waters

Casualty Investigation
Report No. CA132

"Ice Angel"

Grounding in Polar Waters

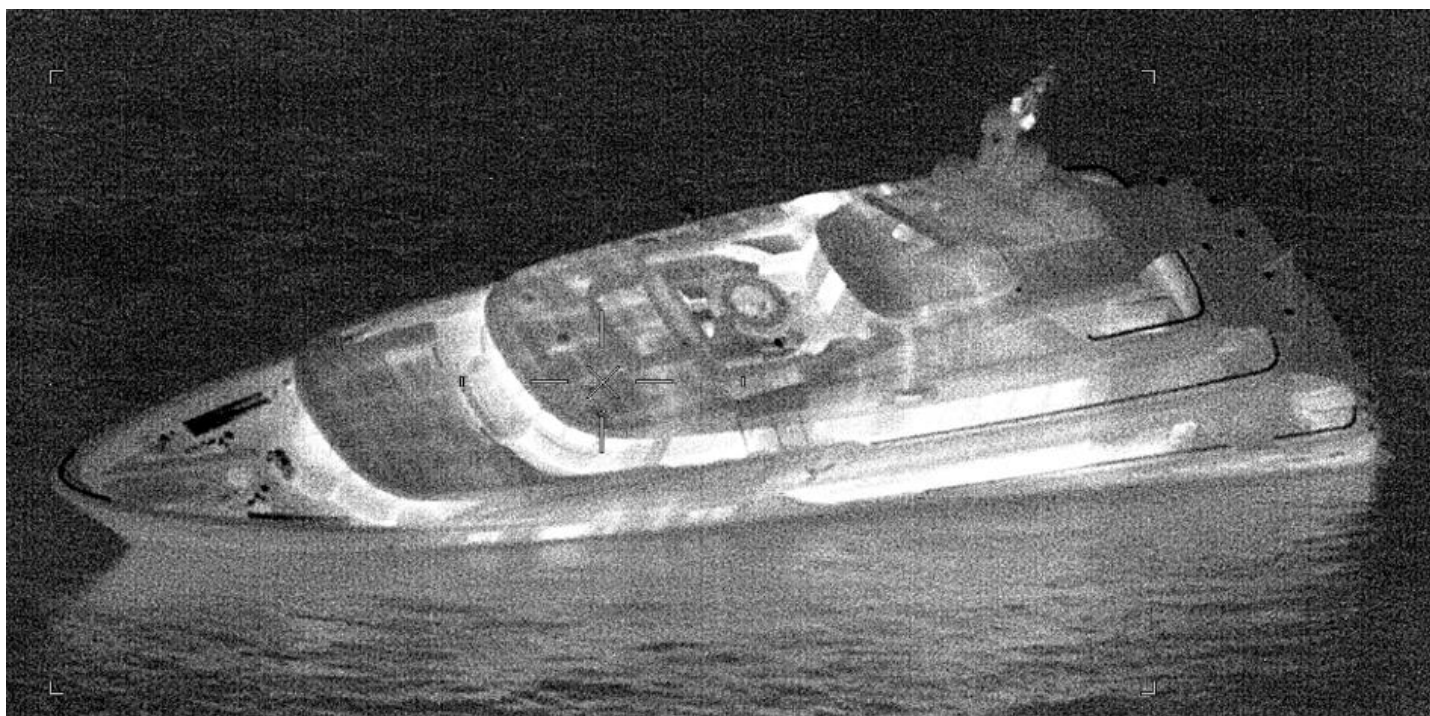
Ice Angel – aground on the uncharted rock pinnacle

As a result of the grounding, significant structural damage was caused rendering the yacht unseaworthy. Minor pollution to the marine environment was caused by ruptured fuel oil tanks leaking to sea. No injuries were sustained to any crew or guests on-board.

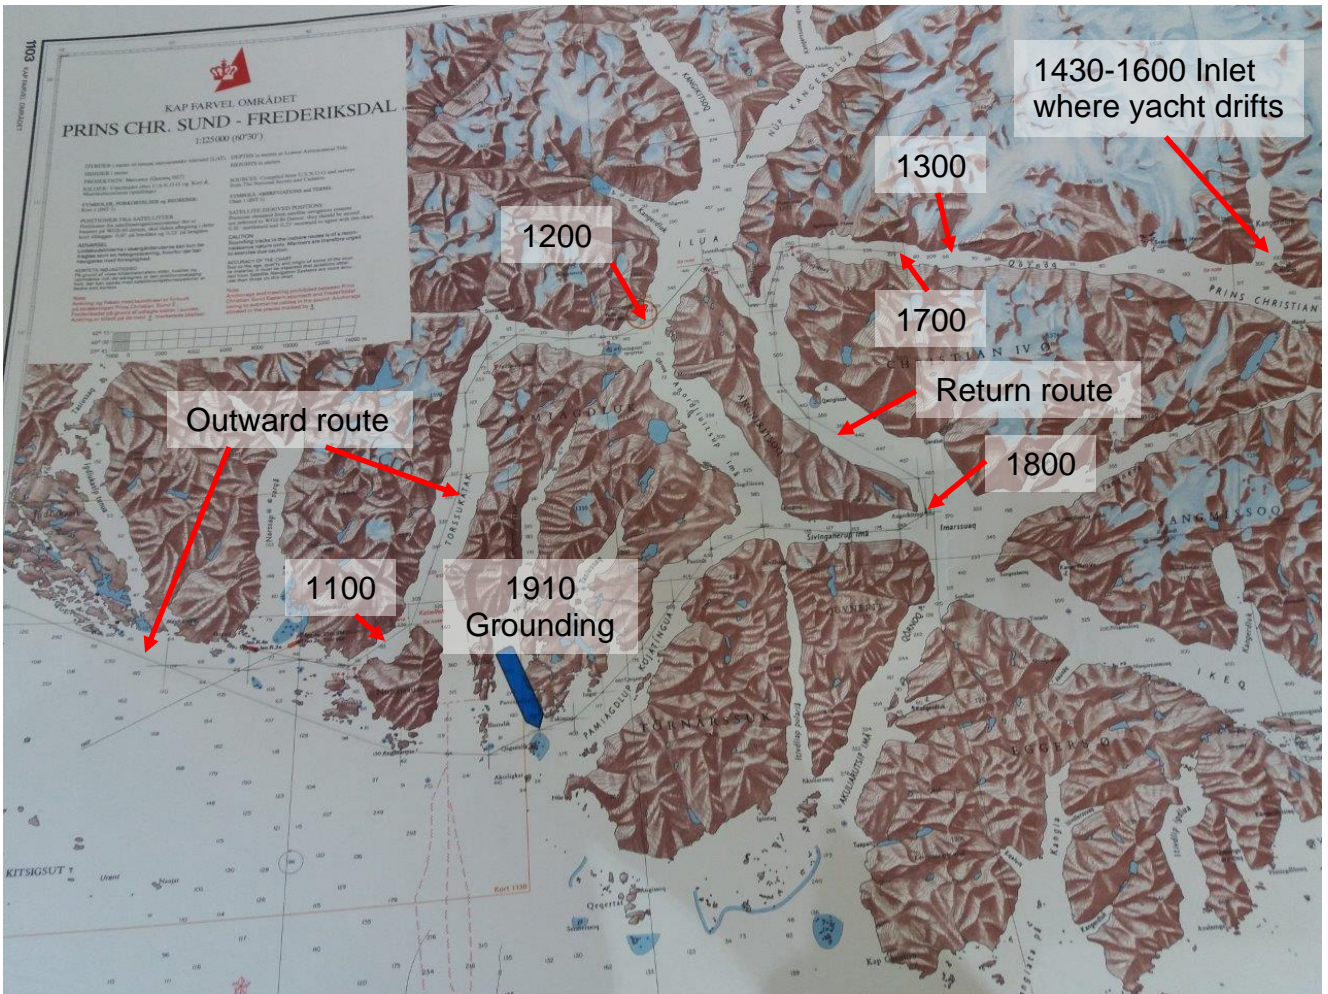
Source: Greenland Chart - 1103 Cape Farvel Area. Prince Christian Sund – Frederiksdal-Danish Geodata Agency
 [The chart above also shows the course lines drawn in order to plan the Transas ECS waypoints.]

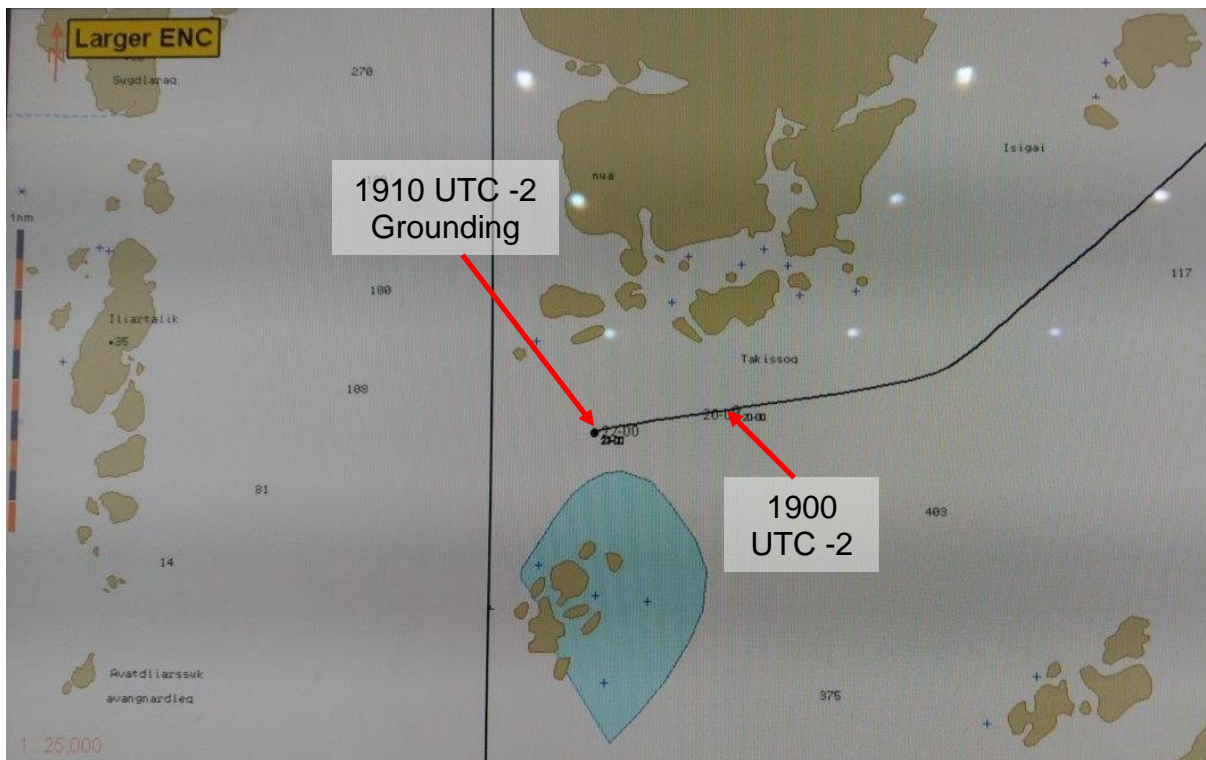
Source: Transas ECS chart 1103

1910 The yacht struck an uncharted rock pinnacle in position 59° 55.638N – 044° 25'.601W at a depth of approximately 2m. The yacht came to an abrupt stop and the crew felt the yacht shuddering and heard "very loud noises" described as banging and scraping. The master stopped the main engines and sounded the general alarm. The yacht quickly listed approximately 15° to port. The master then activated the watertight and fire doors to close from the bridge control panel.

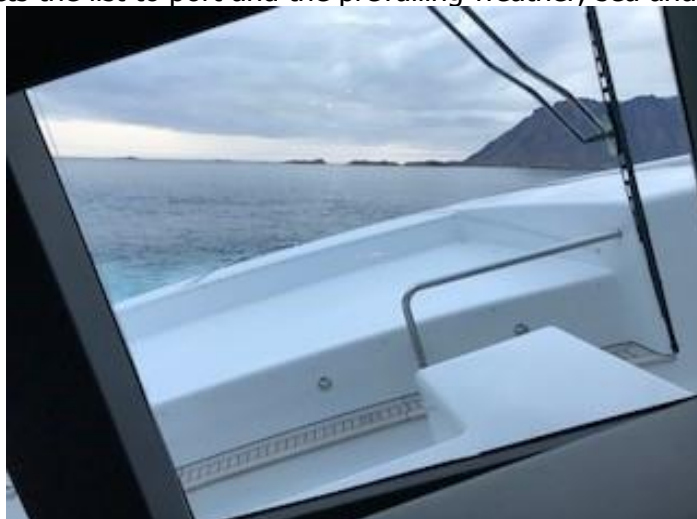
1945 The picture below depicts the list to port and the prevailing weather, sea and light conditions.

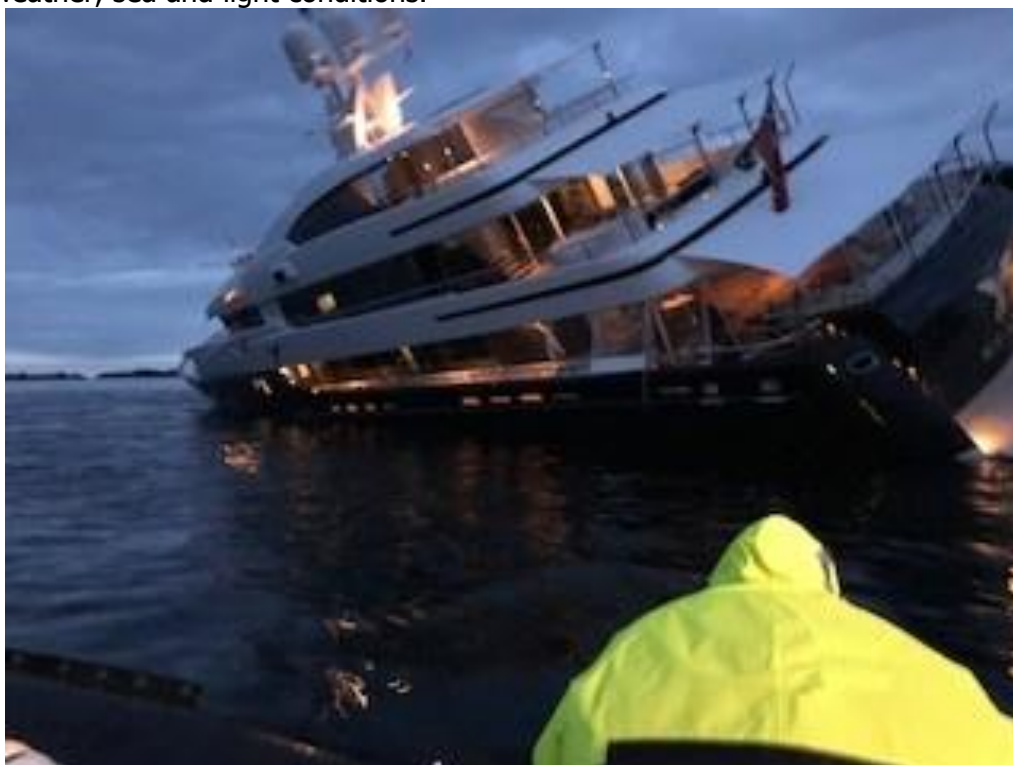
The picture below depicts the list to port observed by the crew from the RIB tender and the prevailing weather, sea and light conditions.

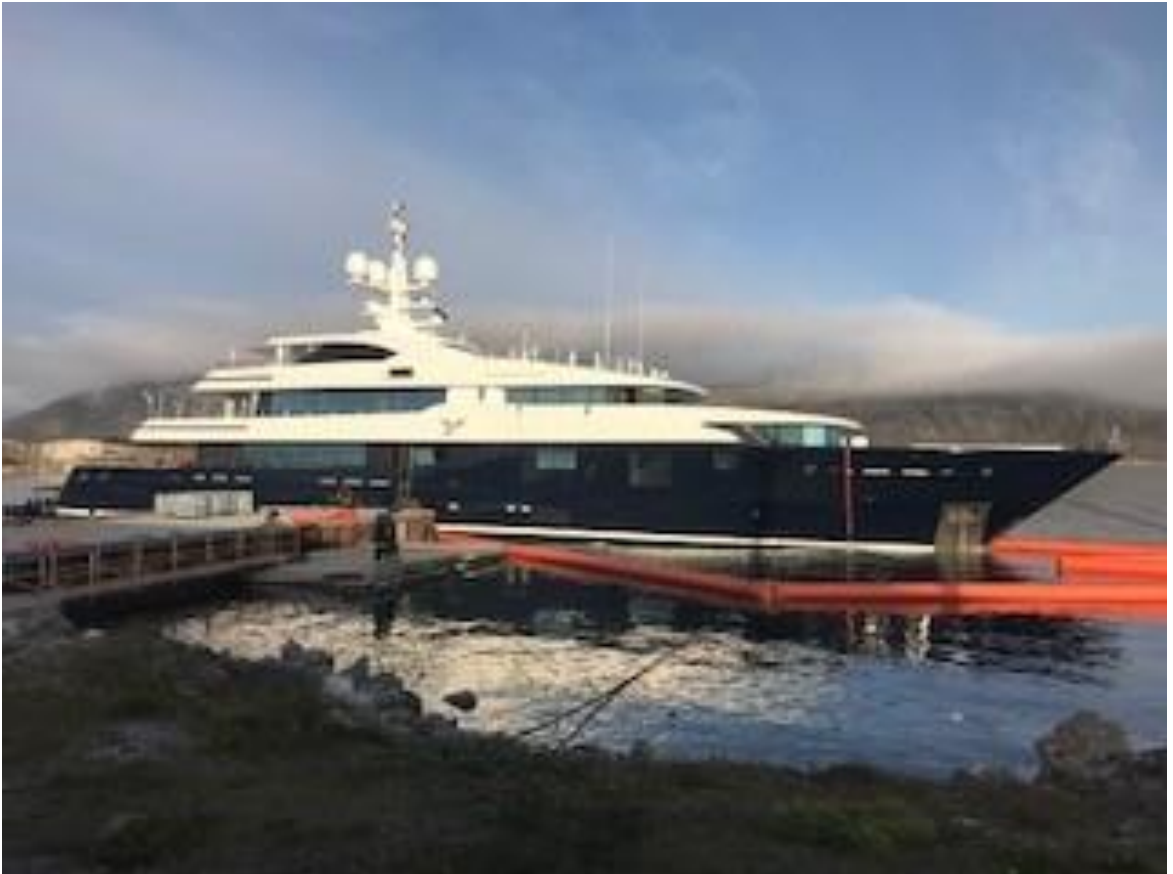
The picture below shows the yacht moored alongside in Nanortalik with anti-pollution booms placed around the yacht.

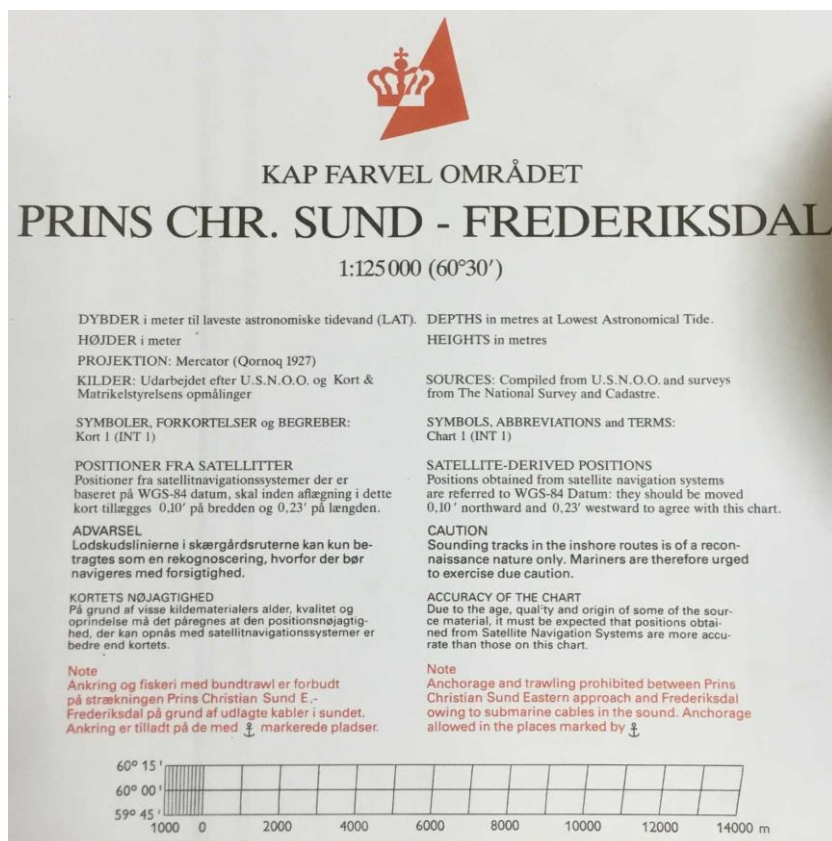
The chart data for Greenland chart 1103 was compiled in 1927.

As can be seen from the chart legend (left) the legend contains notes and cautions mariners regarding satellite derived positions, sounding tracks and the accuracy of the chart.

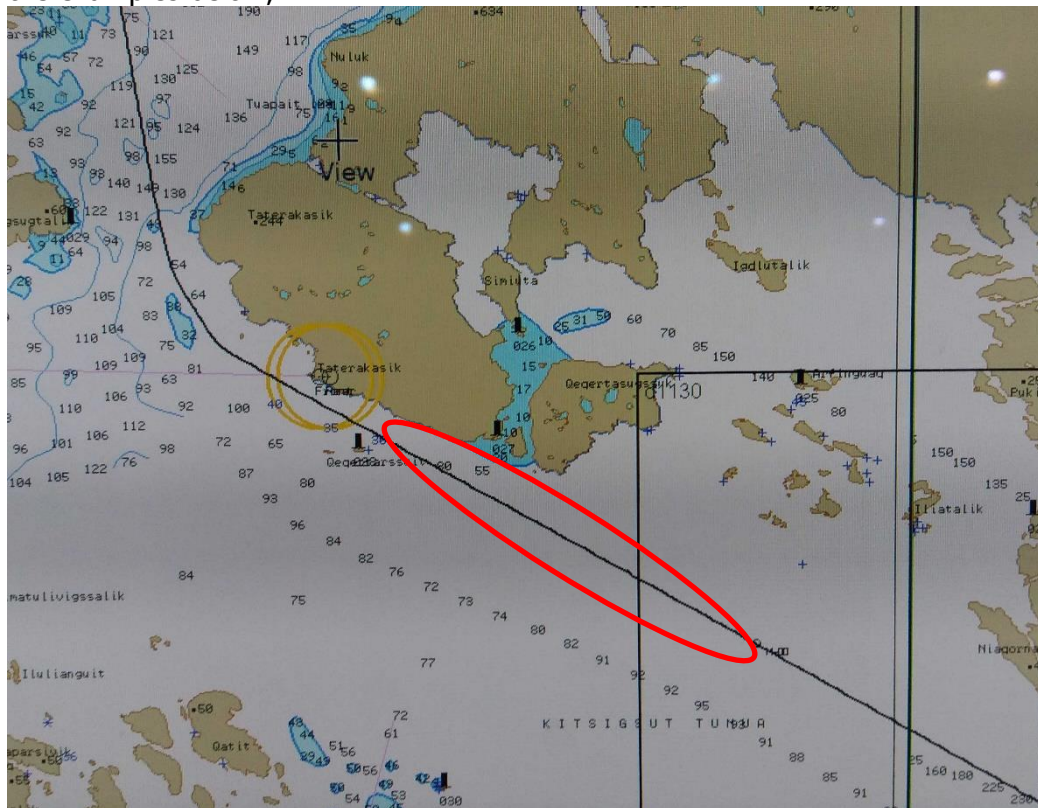
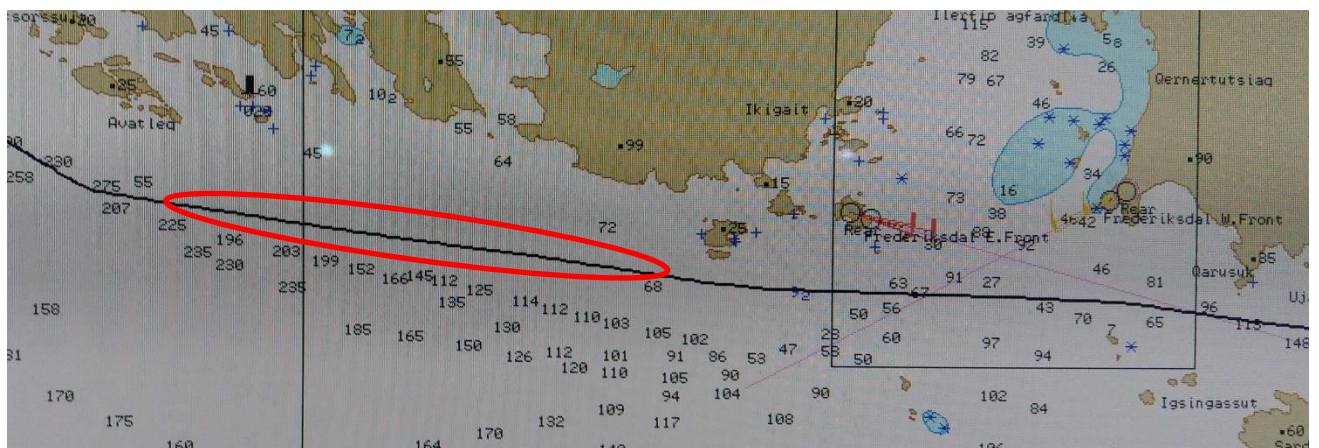
As the yacht was making way, the bridge team at times deviated the yacht off the planned track in order to save time and distance and for sightseeing. The 'white areas' on the paper chart and ENC charts were all considered navigable. The deviations took the yacht through areas of no soundings as indicated in the examples below;

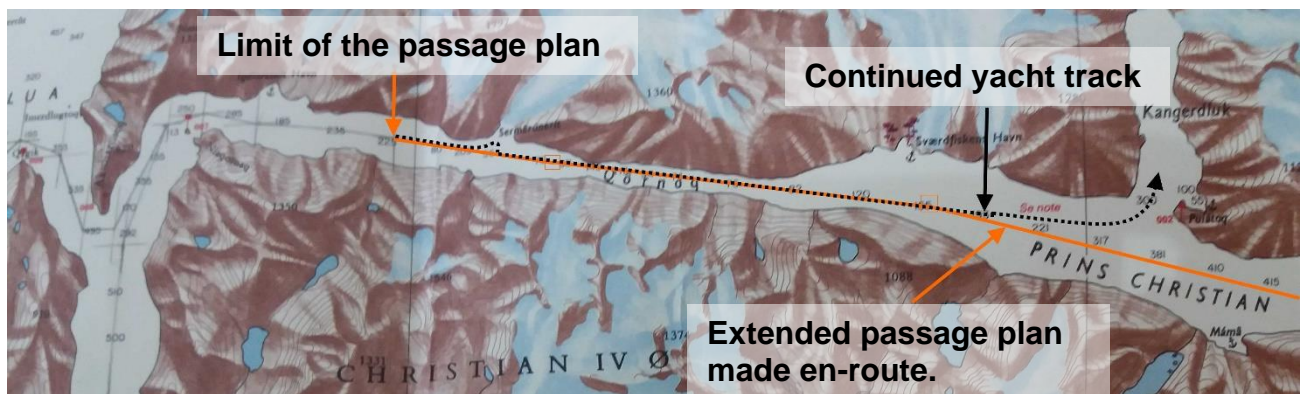
Whilst on passage, the master decided to extend the passage plan further. The additional waypoints were determined from the Transas ECS.

The extended passage plan to the Kangerdluk inlet added approximately 24nm to the planned track and 4 hours to the overall passage including the time taken for the Kangerdluk inlet excursion.

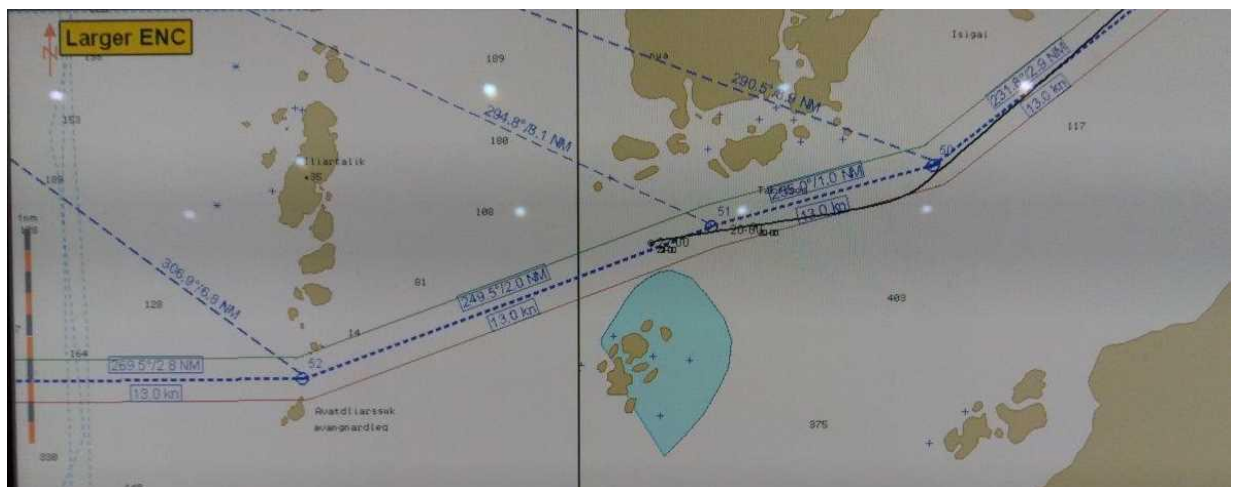
The yacht grounded in waters with no soundings (between waypoints 51 and 52 shown below) in the vicinity of shallow waters and islands whilst following the planned route displayed on the Transas ECS below as indicated below;

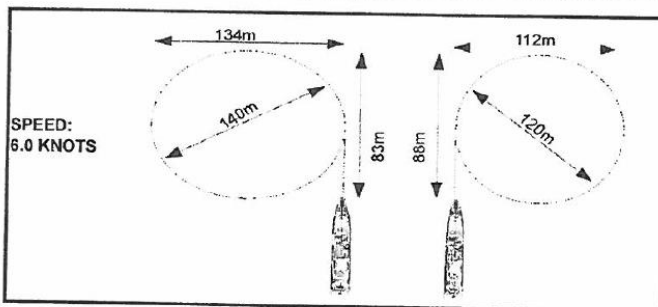
As shown left the yacht was provided manoeuvring data for a speed of 6 knots.

The yacht was making way at a cruising speed of approximately 14.5 knots when it grounded. At this speed the stopping distances and turning circles is greater than that stated on the manoeuvring data.

The greater the yacht's speed the greater the chance of significant damage to the yacht when striking a sub-marine obstacle.

Therefore, a slower speed in areas of poor hydrography may result in greater opportunity to manoeuvre clear or less damage incurred resulting from a collision.
