**ISLE OF MAN GOVERNMENT**

**CASUALTY INVESTIGATION REPORT CA77**

**FAR SERVICE**

**MACHINERY SPACE FIRE - SHORE FATALITY**

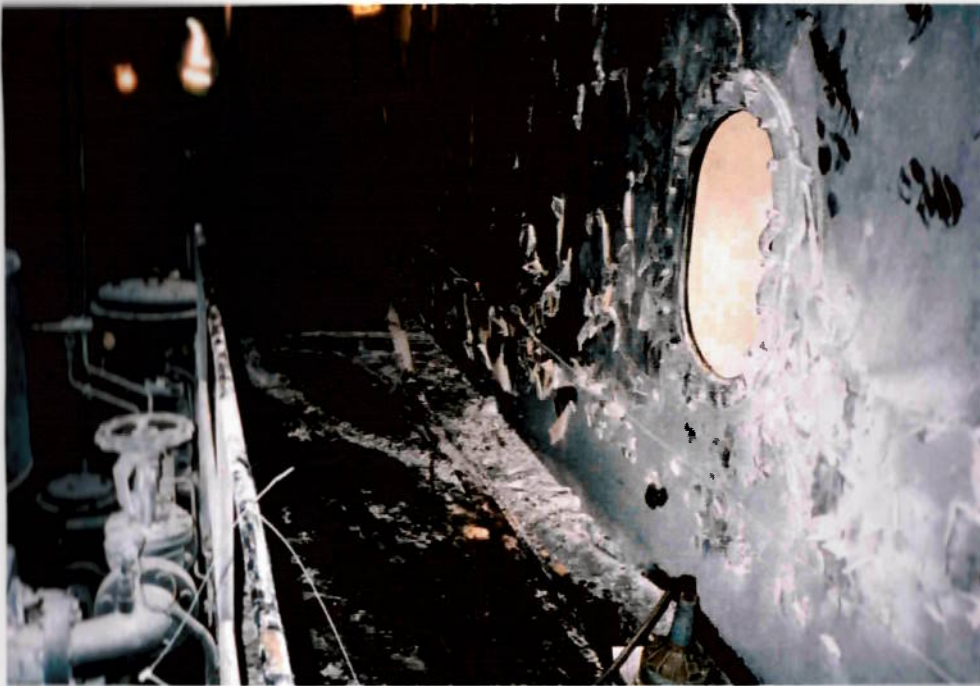
- (i) On the starboard side of the engine room severe fire damage to machinery and electrical wiring and fittings in the area of the starboard main engine and exhaust generally at cylinder head level, the most severe damage being forward of the main engine, the main area of fire damage being concentrated between the main engine turbocharger and ladder to the control room, where base oil was noted spilling out from the hose. Adjacent auxiliary machinery at 2<sup>nd</sup> deck and tank top levels was also fire damaged

Fire damage at walkway by base oil tank manhole at outer starboard side of starboard main engine

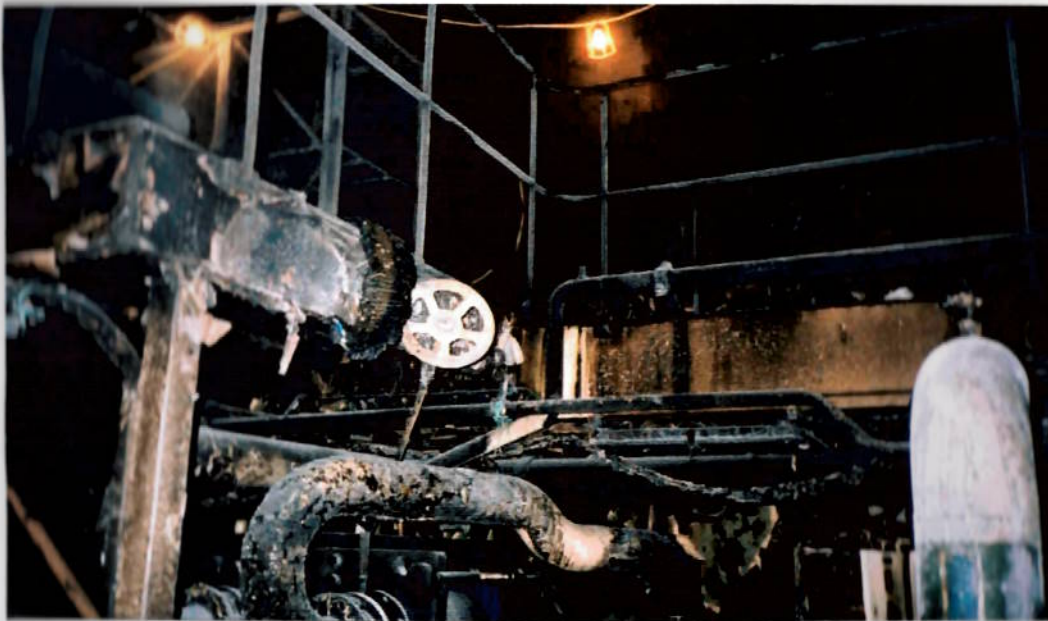
General fire damage

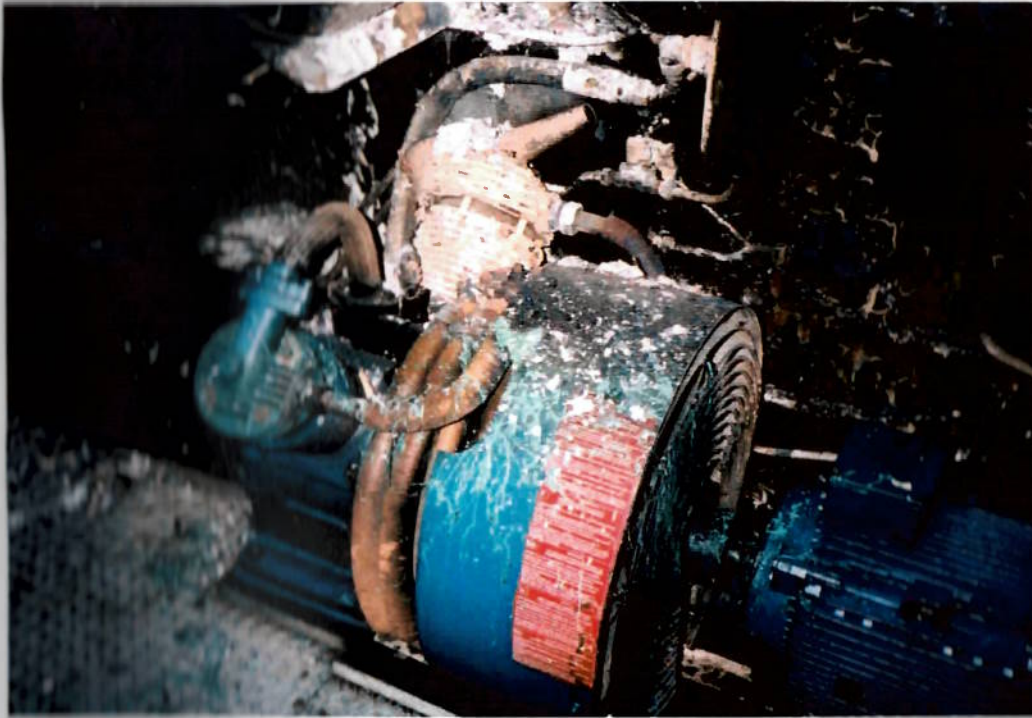
General fire damage

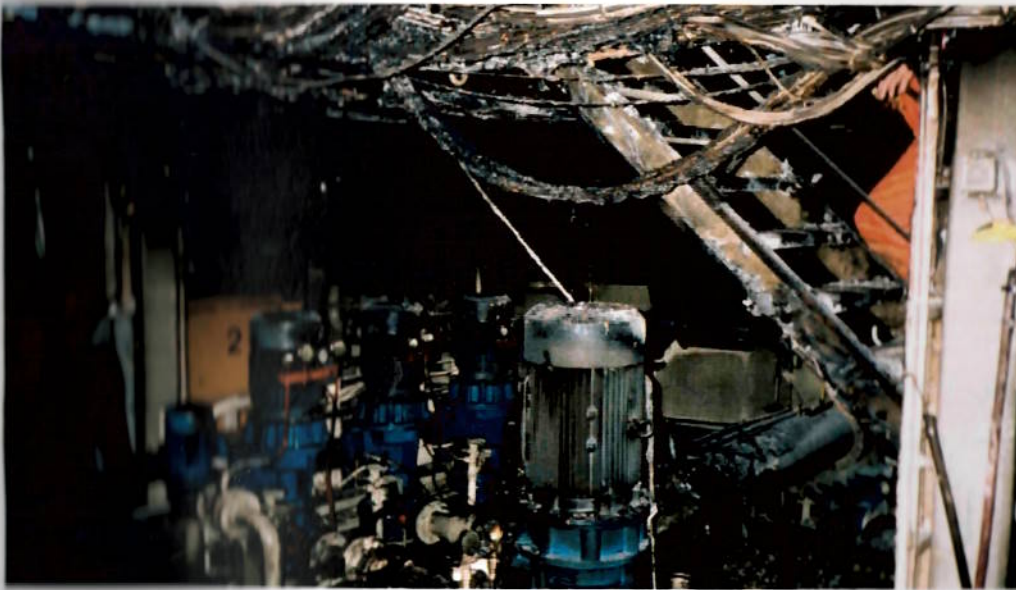
Fire damage to electrical fittings and wiring

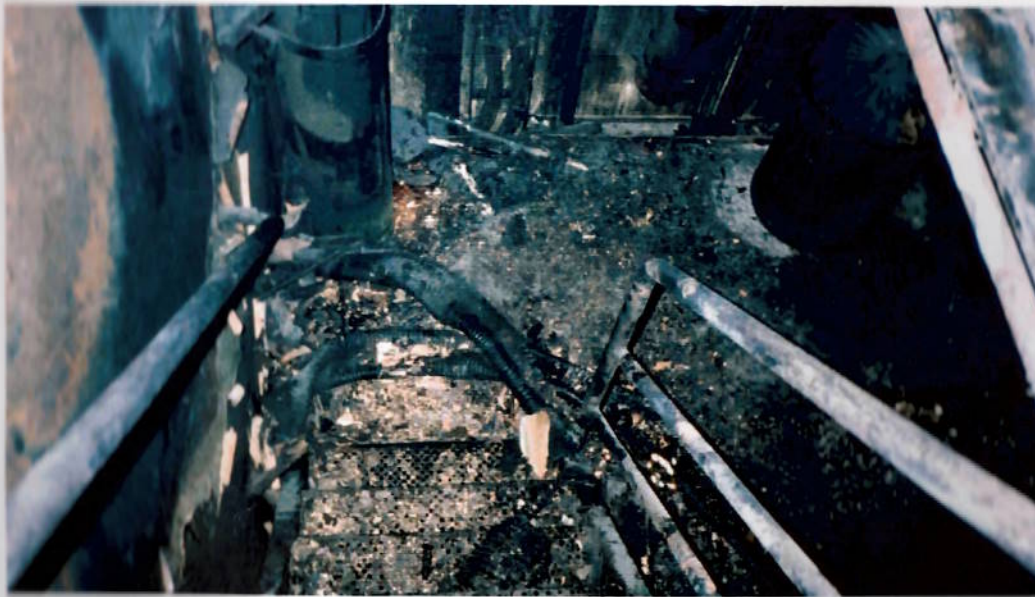
- (iv) Severe fire damage to steel structure, paintwork, electrical wiring and fittings within stairwell leading from engine room 2<sup>nd</sup> deck level at starboard side to aft weather deck

Fire damage at stairwell access from engine room to deck

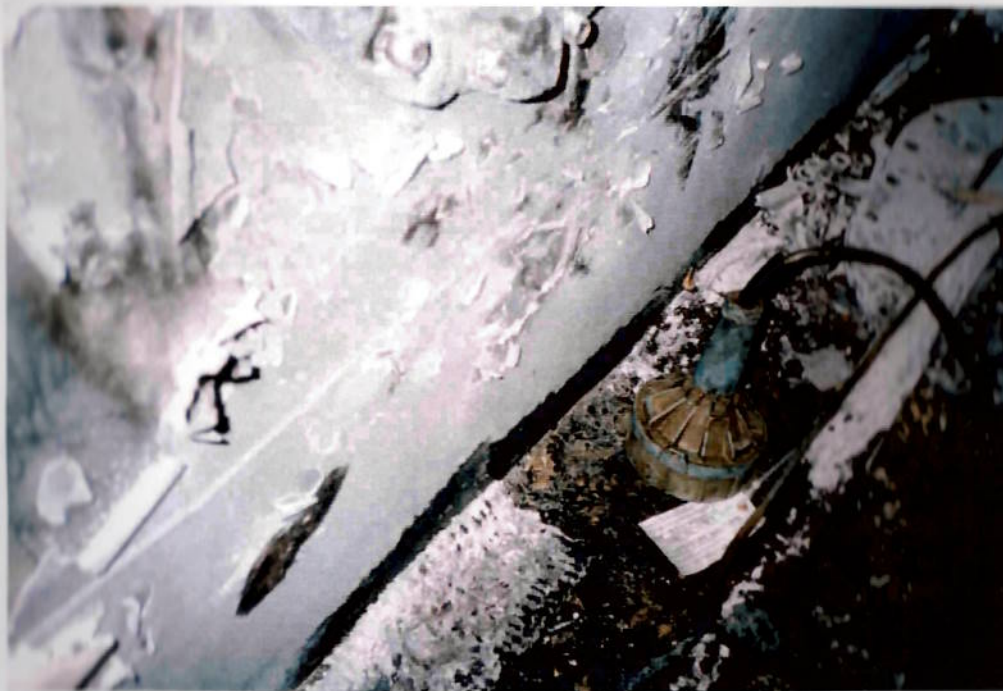
- (ix) A portable electric light close to the base oil tank manhole
- (x) Distorted steelwork on starboard side main engine casing and funnel at all levels

Contractor's portable light

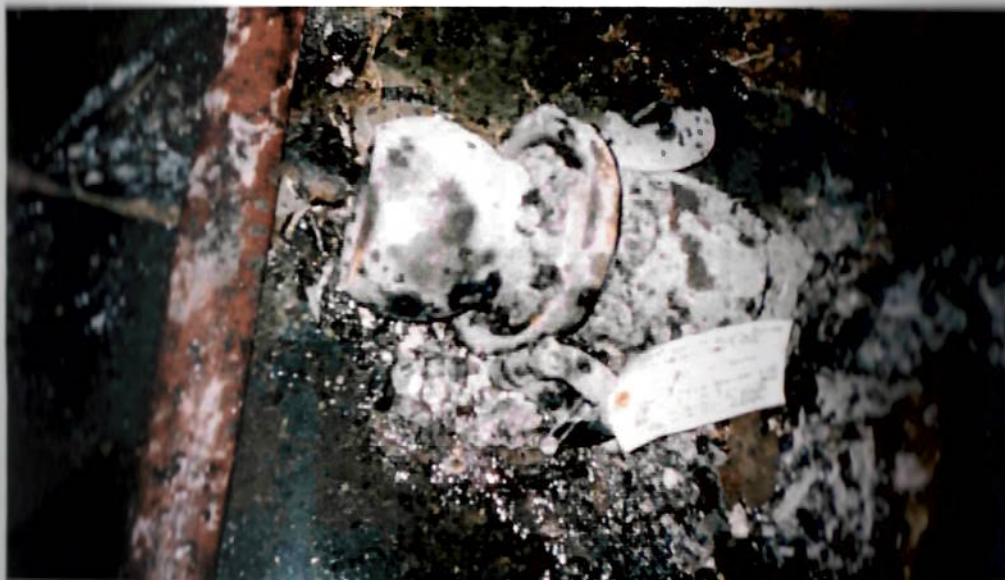
Base oil hose connection

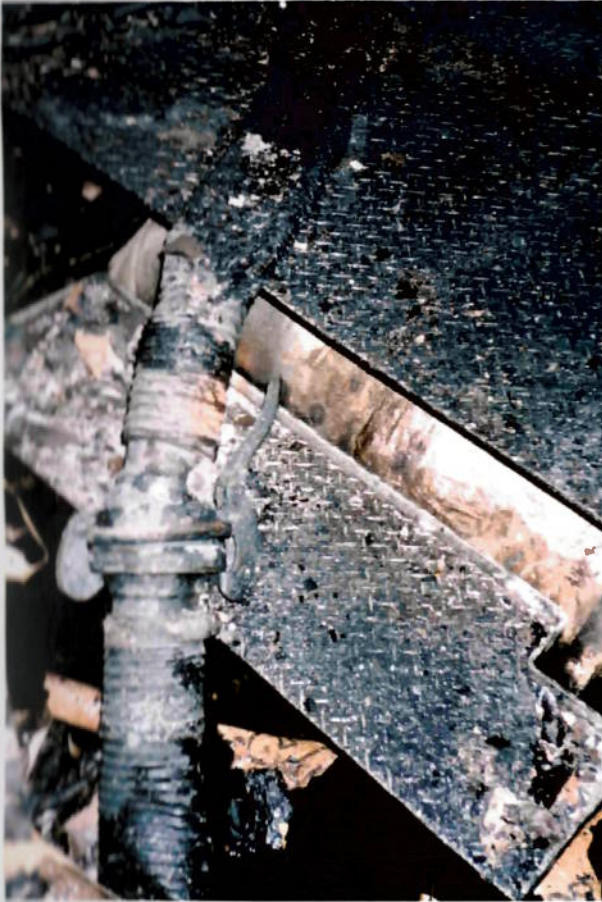
- (viii) The remains of a fire damaged hose (approx. 4" diameter) and couplings in the engine room starboard side at 2<sup>nd</sup> deck level leading from the base oil tank manhole running for'd to the stairwell and upwards towards the aft weather deck

Base oil hose remains with connections at bottom of deck stairwell
