Isle of Man Ship Registry

Casualty Investigation Report No. CA 137

Fishing Vessel FREY (CT 137)

Engine Room Fire

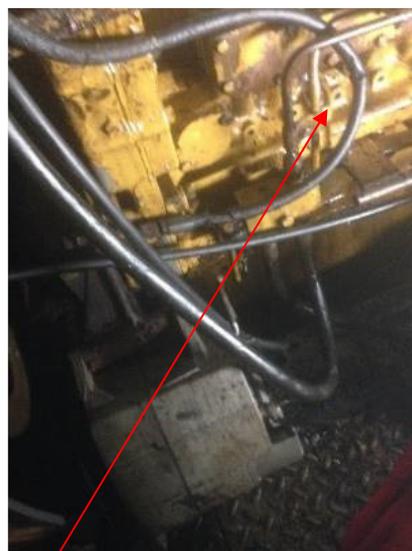
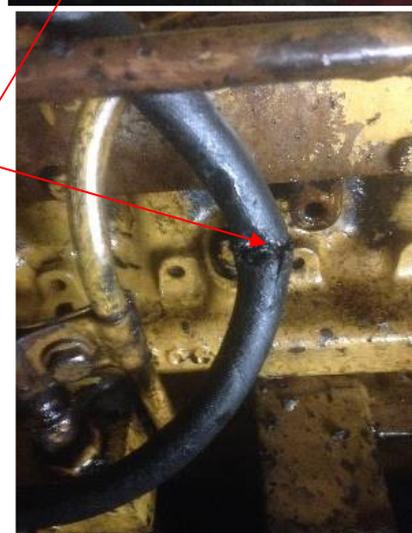
Upon closer inspection and reconstruction of the scene, the cause of the fire was in fact the breach/split caused by a 'kink' in the flexible LO pipe running back upon itself, from the LO pump to the LO gauge. This released the heated LO running from the LO pump to the LO gauge into the engine room space

It is suggested that the LO pipe's direction had been kinked over time before the breach in the line occurred and with the LO under considerable pressure; containing heat from the engine sump; the effects allowed a high-pressure vapour of heated LO to be sprayed into the engine room and on to the heated engine and alternator.

1. That flexible LO and other heat carrying and/or pressure pipe-lines to gauges from plant and machinery as fitted on the Frey are to be replaced by solid steel or stainless steel pipe-work in order to prevent similar situations recurring.
2. During any fire on board that the engine must be stopped to enable full attention to the incident especially during an engine room fire (Code 93).
3. The FV industry to be reminded of the obligation to report to the IOMSR any accidents and incidents.
4. The FV industry is to be reminded to resist the removal of crucial evidence where such evidence is required and remain to be provided for investigative purposes.
5. FV owners/skippers and crews to be notified of this fire-incident to prevent recurrence.

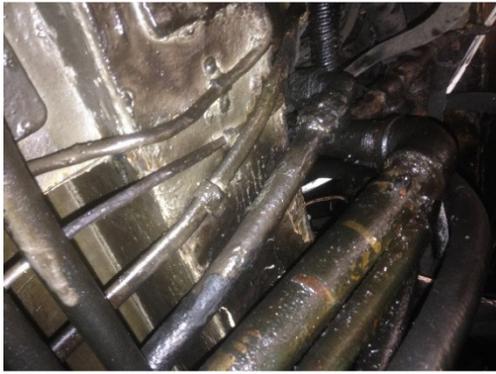
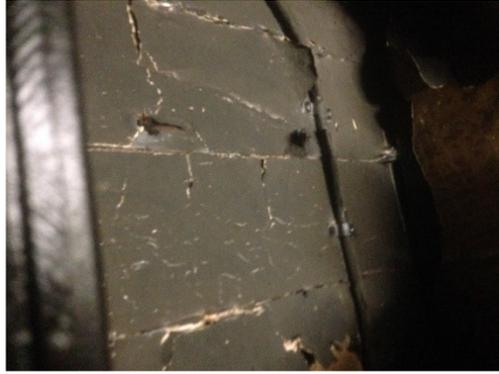
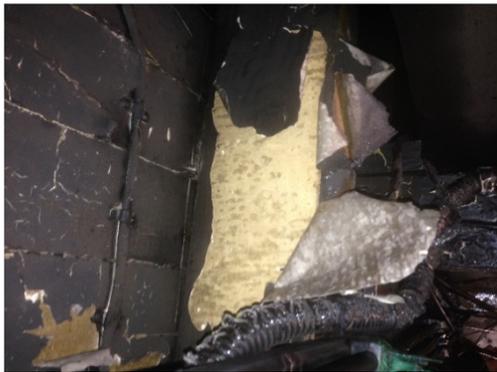
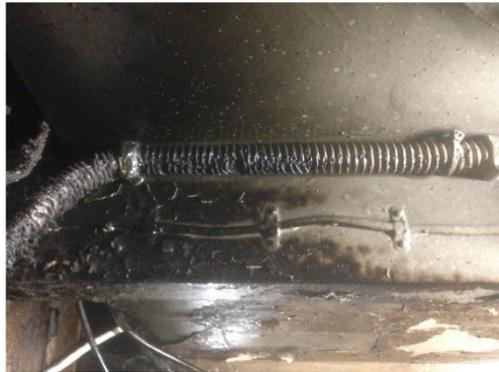
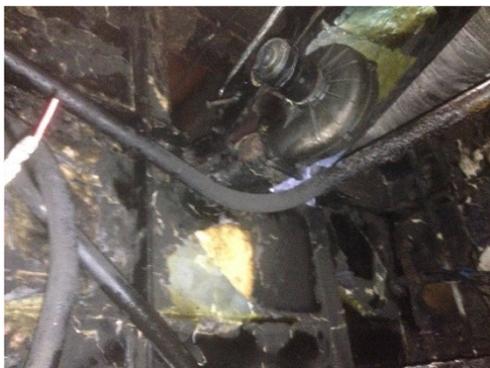
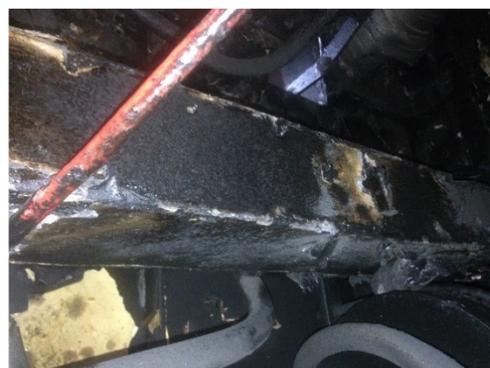
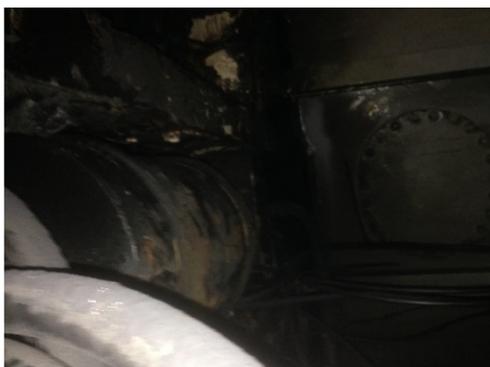
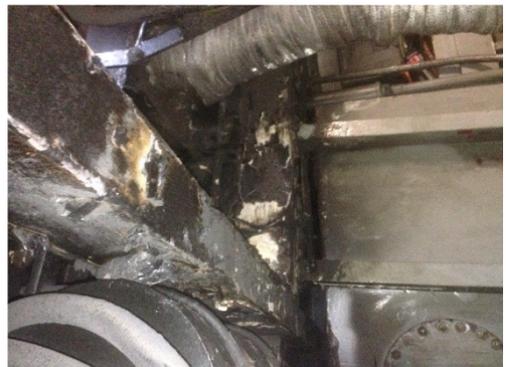
The ER was found to have suffered initial fire damage to electrical cables; melted heat detector; wooden structure and steel tanks charred and paint damage; damage to electrical engine control box; LO and temperature gauge assembly; other areas had smoke damage to under side of the ER; soot residue on most of the portside of the engine itself and other areas concentrated in and around the portside bottom plates.

Pictures of the ER smoke damage after the fire.

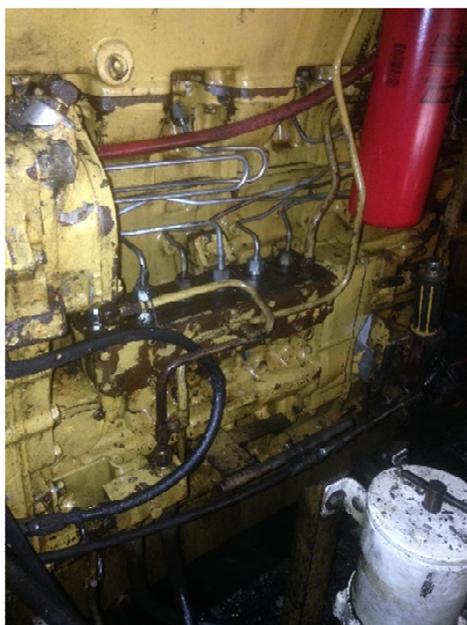
LO Line at Portside Engine

The braided LO hose fitted between the LO pump and the LO gauge was constructed of an inner rubber sleeve and surrounded by a steel braid for protection from heat with a final cover and is deemed not as suitable for heated LO and under pressure nor as a 'suitable material' for the purpose for which it serves.
