Isle of Man Ship Registry Port State Control Notice

July 2023 PSC Analysis

Issued: 14 August 2023

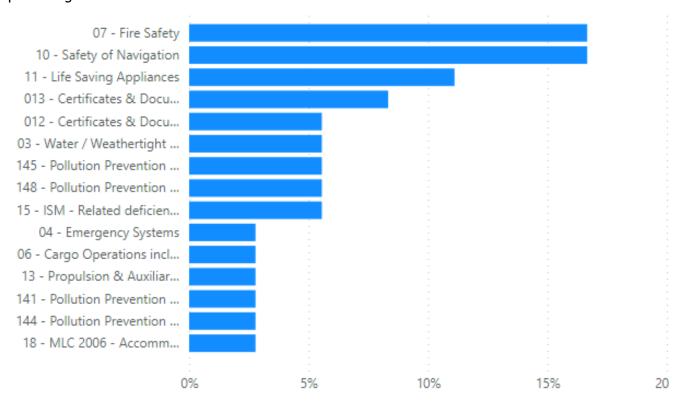
The following chart shows deficiency areas requiring corrective action raised in all MoU Regions as a percentage of total deficiencies recorded:
