Casualty Investigation Report CA 094

CEC PACIFIC

Crane Failure on 26th July 2005 at Zanzibar

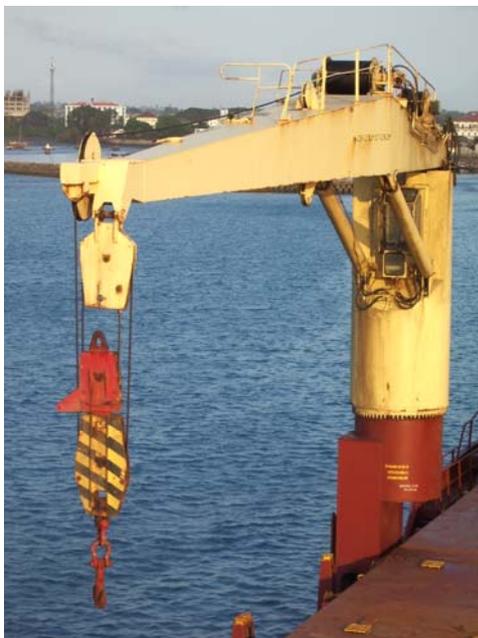
Number 1. Crane

- 3.5 The CEC Pacific is designed for the type of weight as presented. The vessels maximum lifting capacity is 100 tonnes when the cranes are twinned and the lift remains within the 50 tonnes SWL radius, but for this lift it was not possible to remain within the 9.25 metre radius. The barge was outside the limits for the reach of the cranes to remain within the 50TONNES limit which, as the weight was presented, would not have caused any concerns.

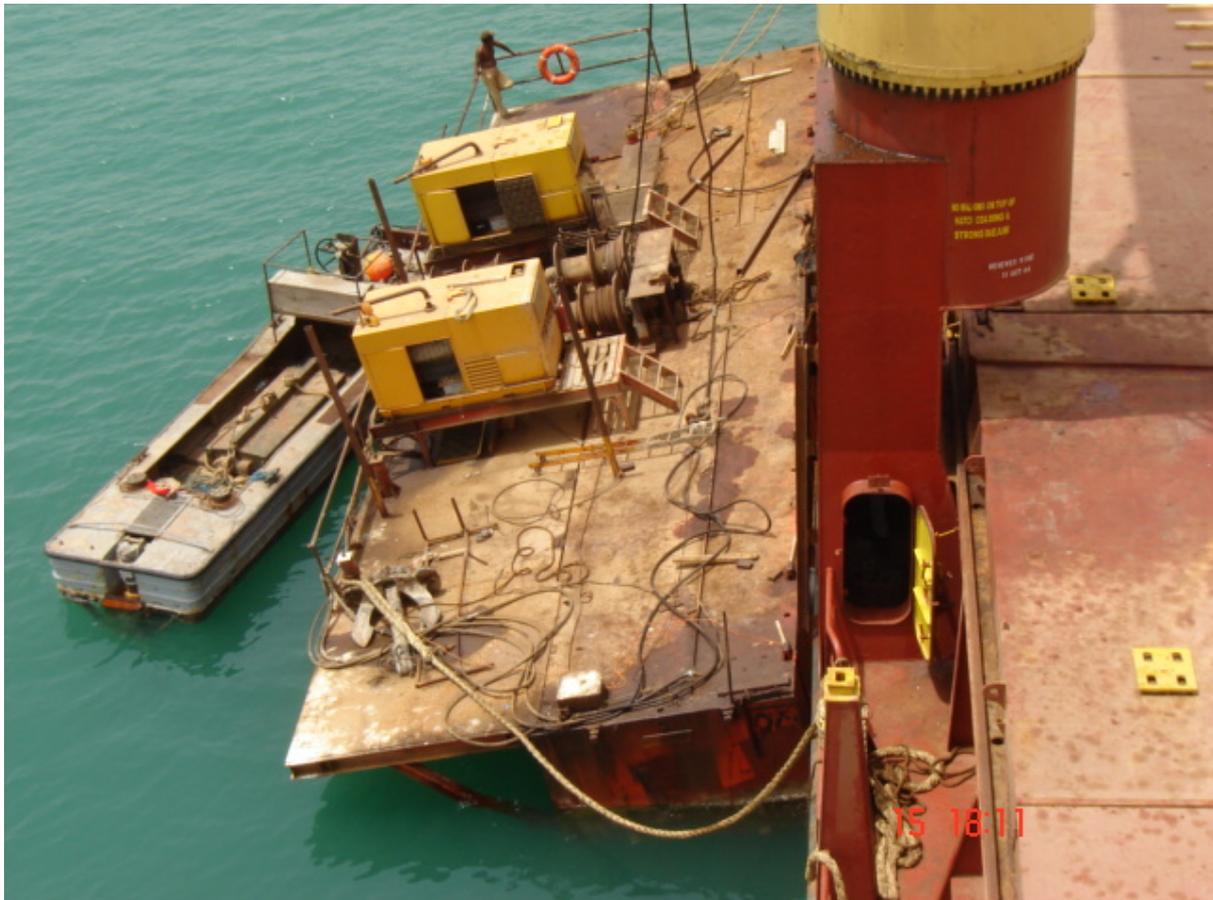
- 5.1 The cranes were rigged in 50 tonne mode and plumbed over the barge ready for a dual lift. On the information supplied by the charterers' the ships staff were working on the weight of the barge being 43.9 tonnes. This would mean that each crane would bear a weight of approximately 22 tonnes and all stability calculations were based on this. As the barge had no marked centre of gravity or weight marked on it, it was only an assumption that the barge's weight would be evenly distributed between the two cranes.
- 5.2 On top of the barge there were two hydraulic power packs, a winch, two steel extension plates and an anchor as can be seen on the picture following, taken at the load port of Tio prior to lifting it on board.

Barge alongside vessel at Tio prior to being loaded

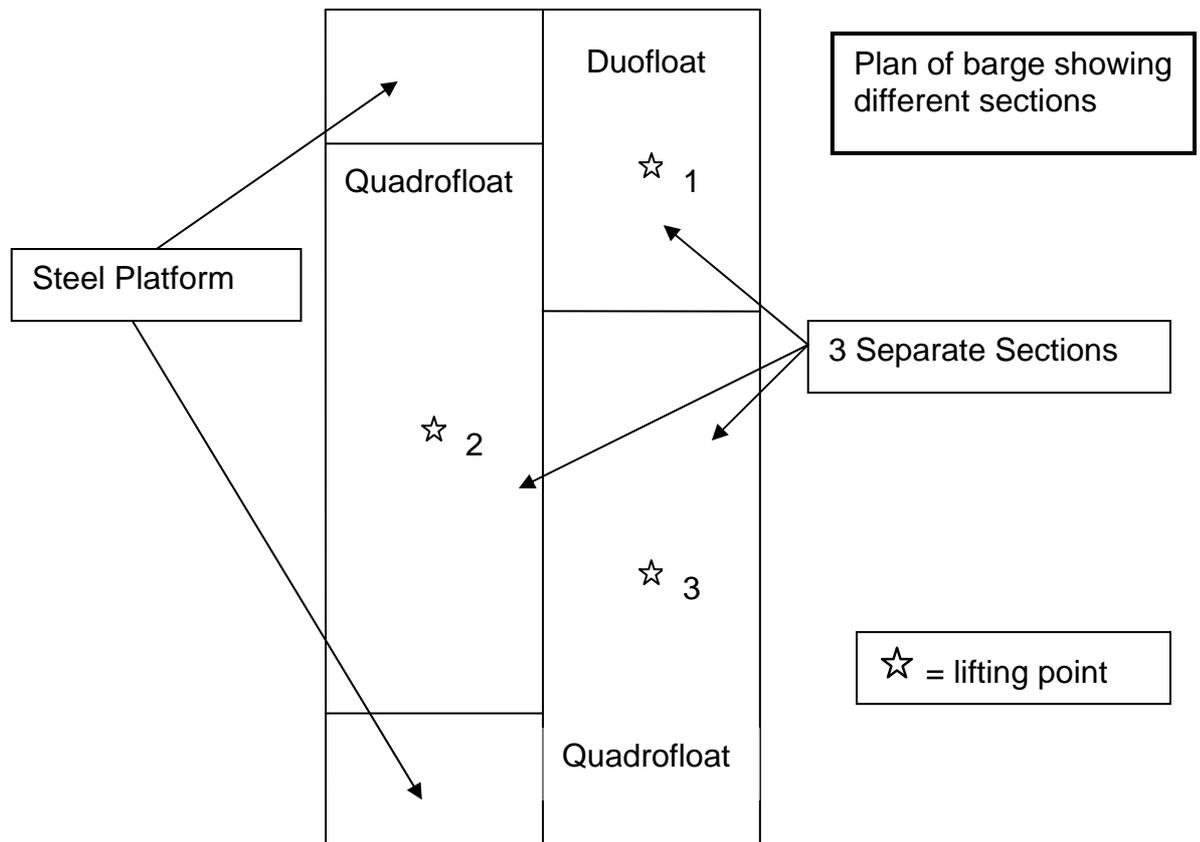
- 5.4 The barge was lifted direct from the sea using the only available lifting points while it was against the ships side as the image overleaf.

Crane No. 1 was attached by a double strop to lifting point 1 (See diagram above for locations) while Crane No. 2 was attached using two strops to lifting points 2 and 3. The barge listed to port when lifted so it was decided to rearrange the strops.

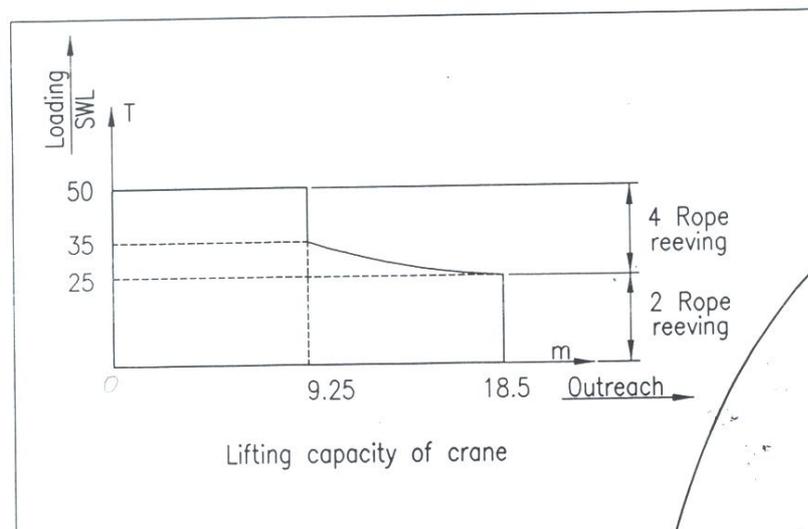
SWL Scale

- 5.13 Using the manufacturer's scale from the crane handbook above:
- No. 1 crane outreach 12.5 m. SWL at this point = 29 tonnes.
Actual weight on crane = 34.8 tonnes. **20% overload.**
 - No. 2 crane outreach 15.8m. SWL at this point = 26 tonnes.
Actual weight on crane = 33.9 tonnes. **30% overload.**
- 5.14 After three attempts at lifting the load there should have been enough evidence for the crew to suspect that the barge was over weight and beyond the limits of the cranes. However, any concerns the crew may have had about the weight of the barge were not acted upon or followed up. In planning for the discharge of the barge no consideration appears to have been taken about the barge being over the declared weight, and possibly outside the limit of the cranes.
