# **Isle of Man Ship Registry**

Casualty Investigation  
Report No. CA103

**Isle of Man Registered "FICUS"**

Grounding

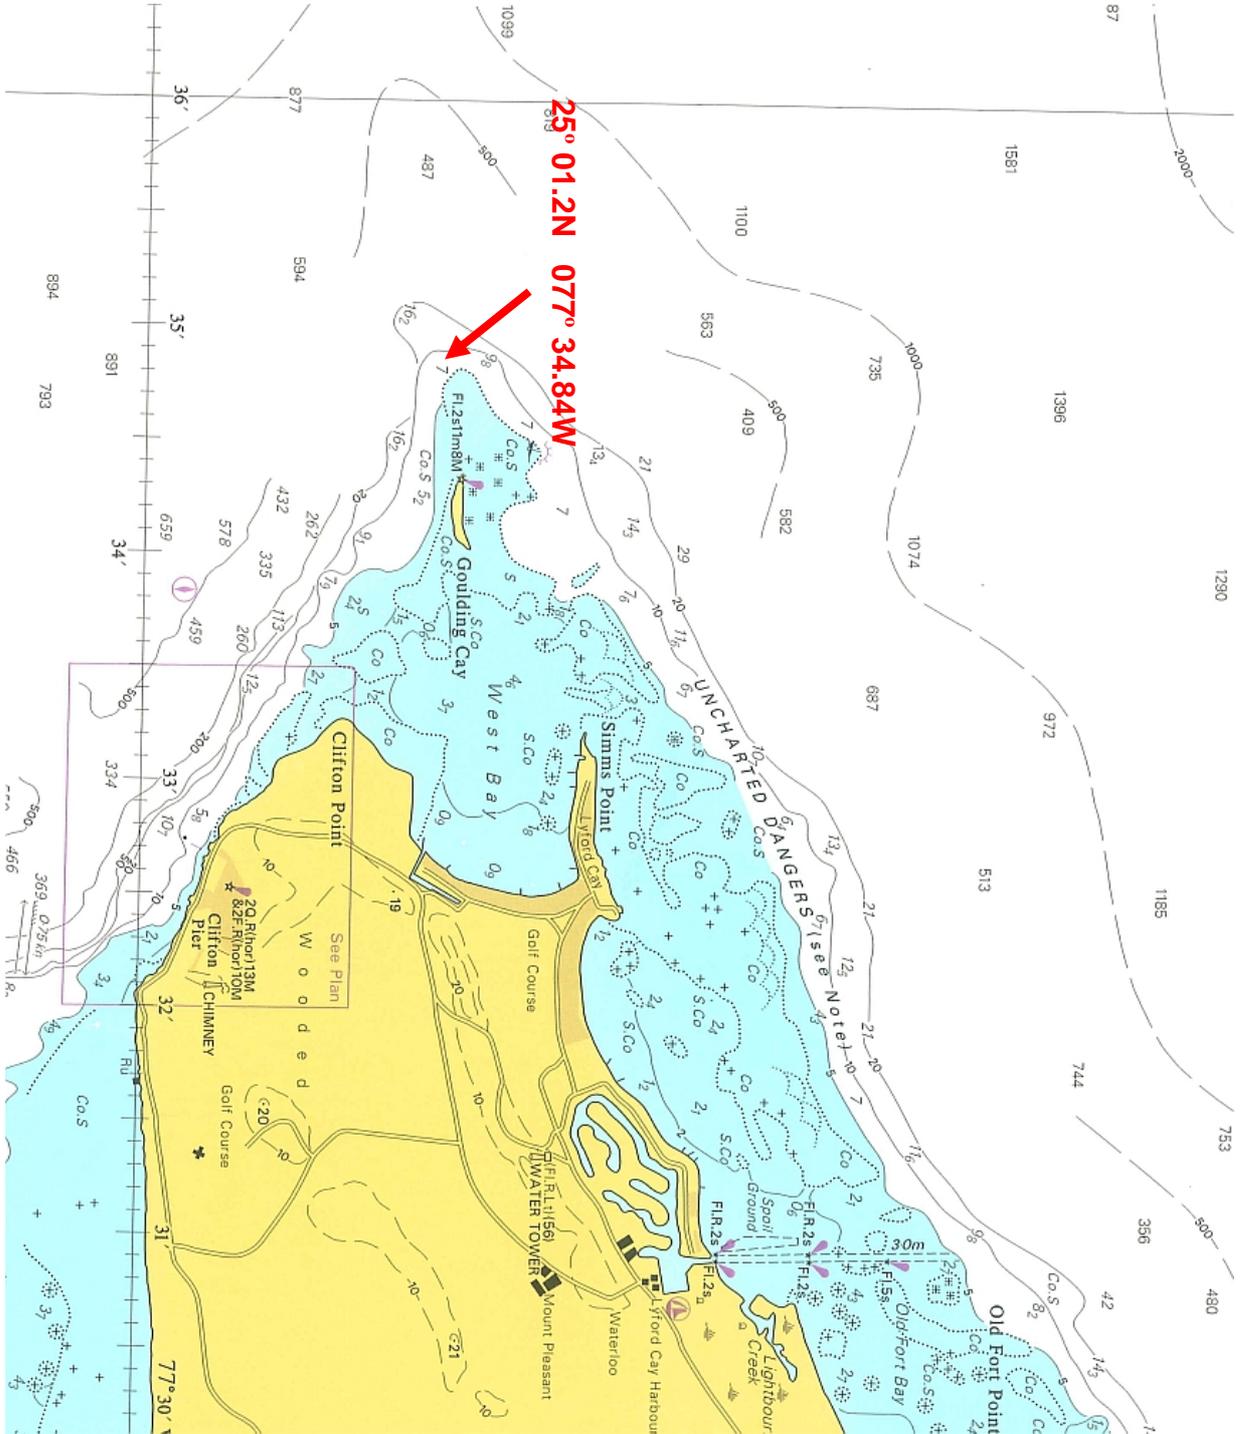
## 1.1 Location of Grounding

Section of Chart BA 1489 – "New Providence Island". Reproduced by kind permission from the UK Hydrographic Office

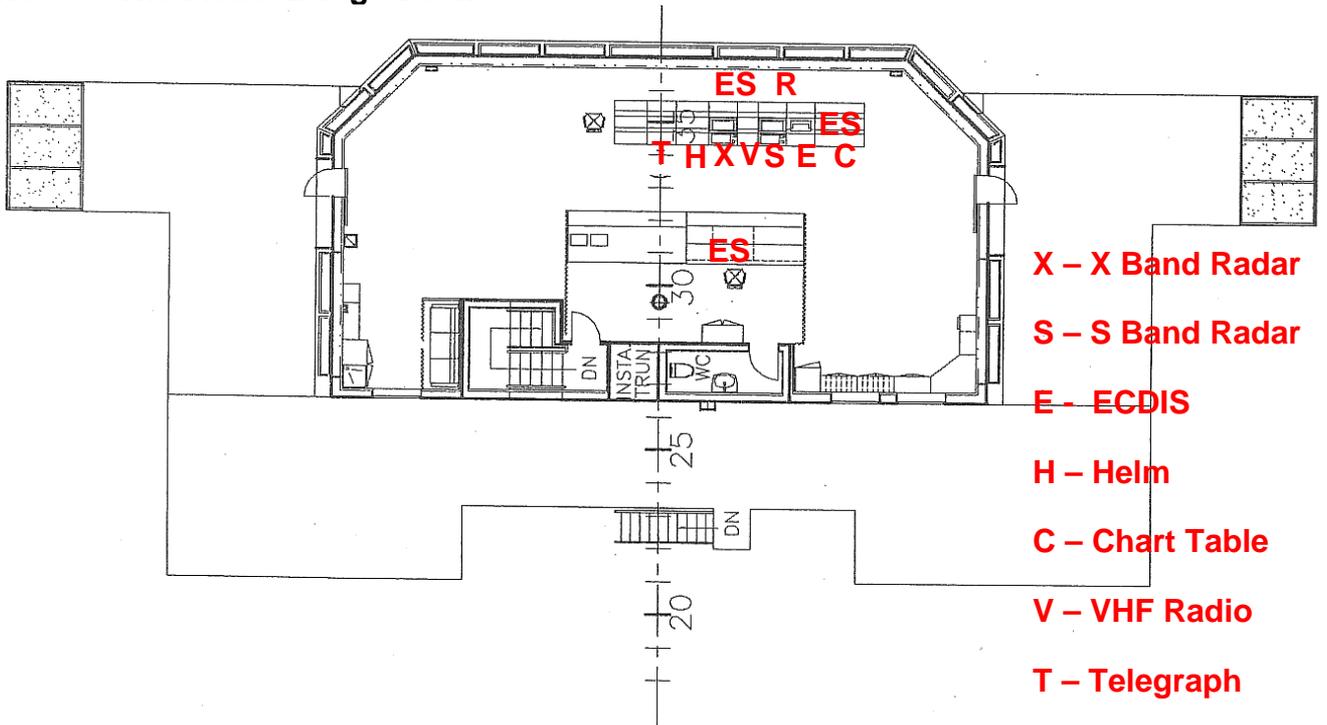
1.3 The Ficus' Bridge Deck

- X – X Band Radar
- S – S Band Radar
- E – ECDIS
- H – Helm
- C – Chart Table
- V – VHF Radio
- T – Telegraph
- R – RoT Indicator  
(on deck head)
- ES - Echo Sounder

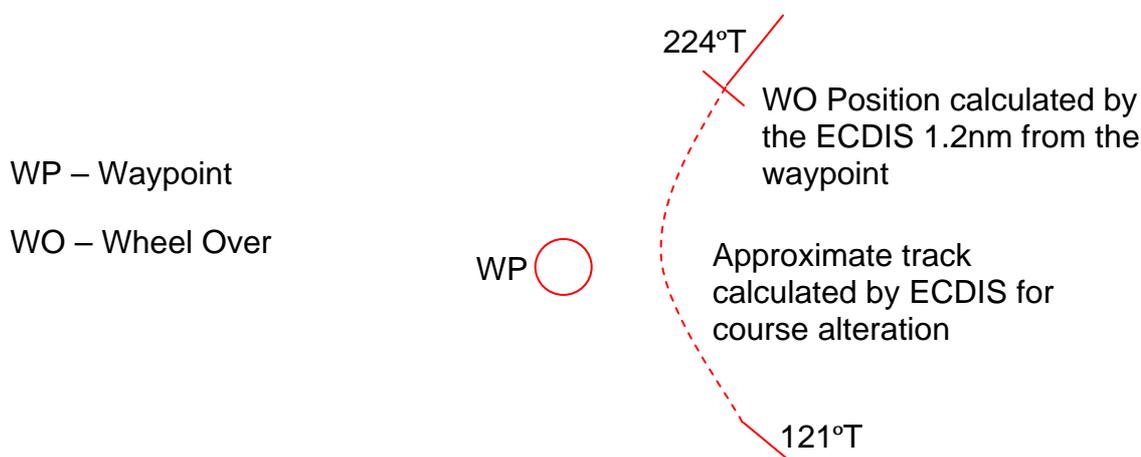
course from 224°T to 121°G. The curved track, represented by the dashed line, is calculated by the ECDIS based on a set turn radius and represents the track the steering system would follow for the course alteration if selected by the OOW. Having decided to alter course manually the OOW(8-12) alters course 1 minute before the calculated Wheel Over Position, his intention being that by applying 'Port 5' Rudder the vessel will come slowly round approximately on the dashed line displayed to him on the radar screen.

The OOW(8-12) is aware the next course is 121°T and confirms this with helmsman by stating “our next course is 121”. As the vessel’s heading changes to port the OOW(8-12) orders “midships” to the Helmsman when the vessel’s heading is 192°G approximately 78 seconds after giving the “Port 5” order. The helmsman places the helm position zero and confirms to the OOW(8-12) by stating “midships now” once the rudder angle indicator signifies “0” four seconds later. This is an attempt not to allow the rate of turn to increase (possibly decrease) and to allow the vessel to change heading under her own momentum.

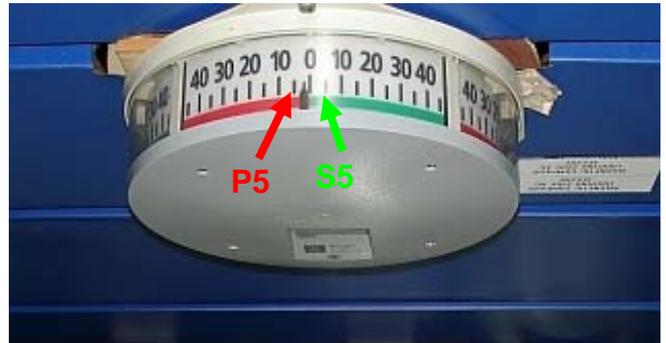
Annex 2B  
Rudder Angle Indicator

TP – Trackpilot control  
MH – Manual Helm control

P5 – Port 5 indicated  
S5 – Starboard 5 indicated
