Casualty Investigation Report CA 91  
Loss of the Isle of Man registered Ship  
Jökulfell

On 7<sup>th</sup> February 2005

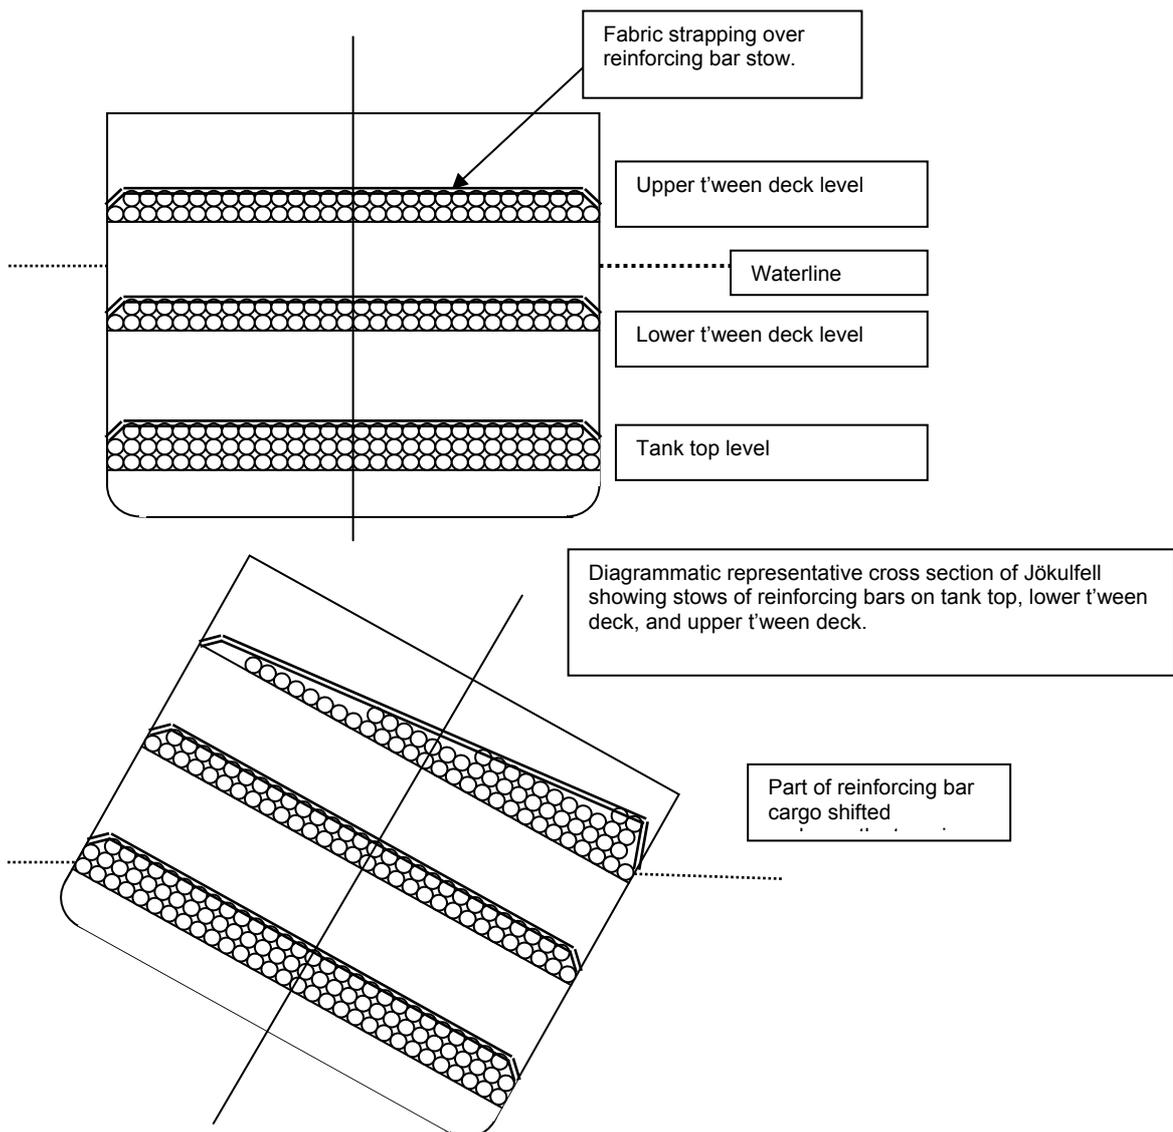
3.40. The characteristic of the webbing straps to elongate under load means that they can provide even less downforce in the centre of the span than might be provided by a wire lashing. Research through expert sources suggests that webbing lashings are not recommended for this cargo. While even a wire lashing will stretch to a degree in a long span it will do so less than the webbing straps and it is concluded that the webbing lashings were not in accordance with good practice for securing this cargo.

3.41. Of greater importance is the manner in which the stows of reinforcing bars were secured rather than the material used. A simple “across the deck” lashing as was used, can clearly be seen from the photograph on page 27 to provide virtually no downward force whatsoever on the centre part of the stow. The effect if the ship is heeled enough to start any bundles moving is to stress the centre of the lashing span, lifting it and allowing bundles to roll underneath the lashing and move to the low side.
