Isle of Man Ship Registry

Casualty Investigation
Report No. CA121

**Isle of Man Registered “Sally Ann C”
Enclosed Space Fatalities and Near Fatality**

13th March 2015

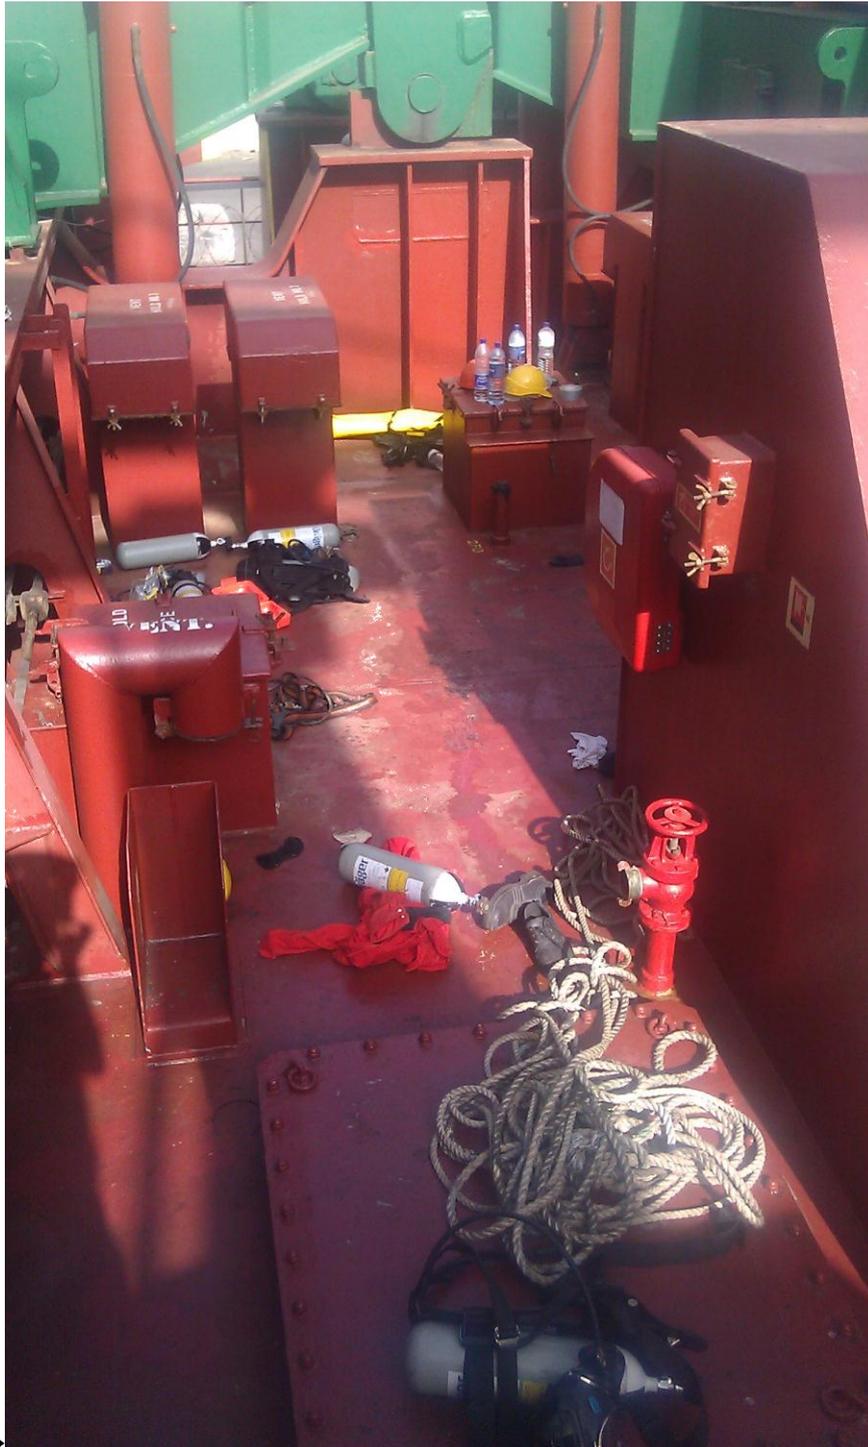
Sally Ann C – No.2 / 3 Cargo Hold Recess & Entrance to No.3 Cargo Hold Access Hatch

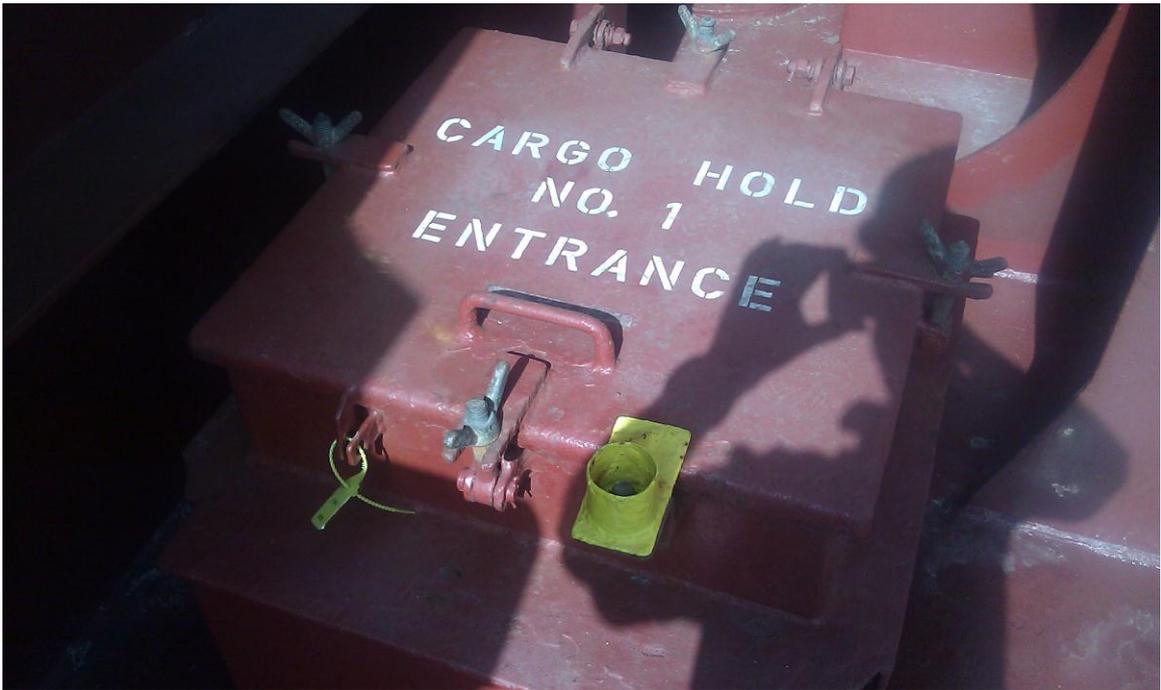
Each ship's access point is secured by its own securing "dogs". Additionally cargo hold accesses are secured by a further securing nut requiring a special key that is normally held in the ship's office. Each cargo hold access also has a plastic security tag with a unique numbering system. The sequence and numbering is recorded in a log book.

It was verified during the investigation that all plastic securing tags were in place and the recorded numbering system was correct. The only missing tag was that for No.3 cargo hold access. A subsequent search of the area around the cargo hold recess between No.2 and 3 hatches and Chief Officer's clothing has not revealed the whereabouts of this security tag.

An example of a secured cargo hold access

The ship's Master eventually gained access to No.3 cargo hold during the discharging of cargo and a broken security tag was found hidden amongst the dunnage lying on platform 1 at the base of the vertical ladder. It was subsequently identified as the missing security tag number 3008.
