Isle of Man Marine Administration
Oaseirys Lhuingys

Casualty Investigation Report CA 89

“Mirabella V”

Grounding

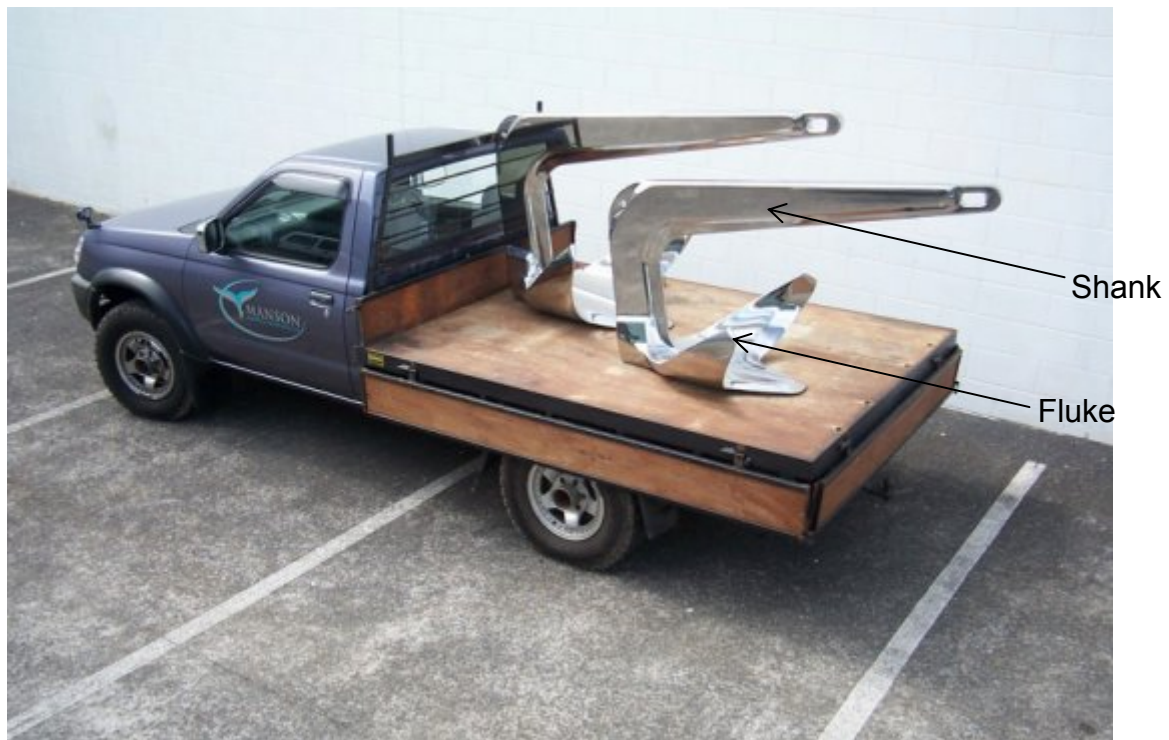
Anchors fitted to the Mirabella V

- 2.2.6 It is concluded that the tendency of this yacht to swing at anchor, coupled with a short scope of cable deployed, in all probability caused a lateral load on the anchor shank.

2.3.4 After the incident the anchor shank was found bent.
