Casualty Investigation Report CA 86

Sinking of Isle of Man registered fishing vessel

PL 17 "TETSUKO"

Isle of Man Government Marine Administration

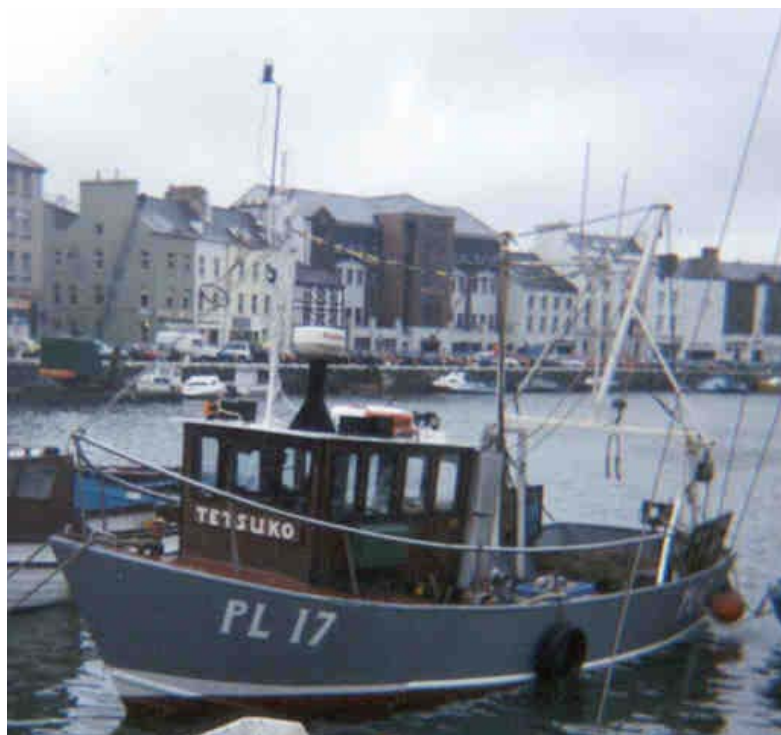
Tetsuko, converted to stern trawler 1998-2003

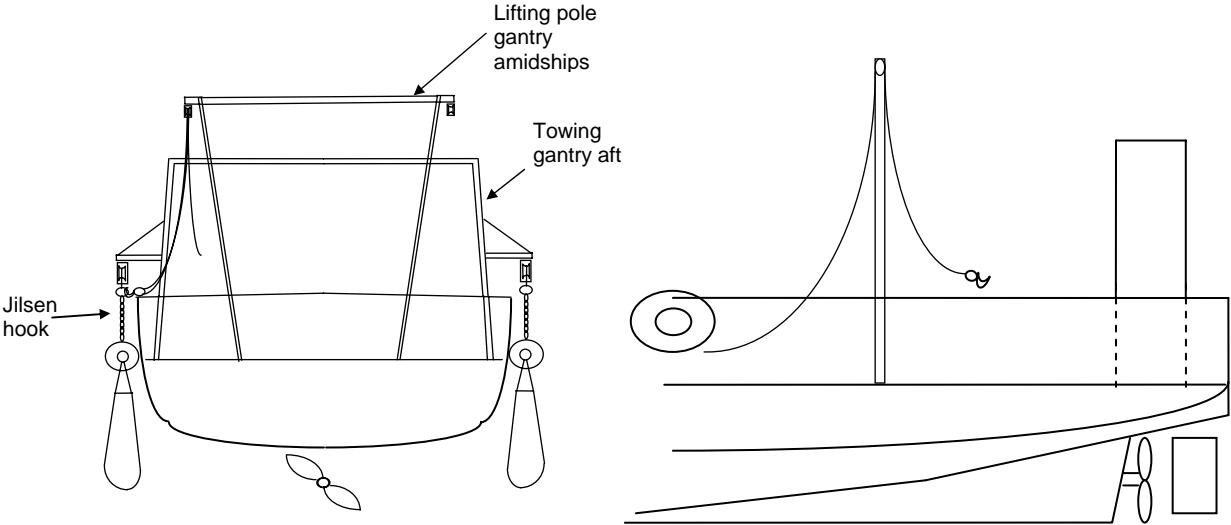
Conventional arrangement with lifting points (P&S) further towards amidships

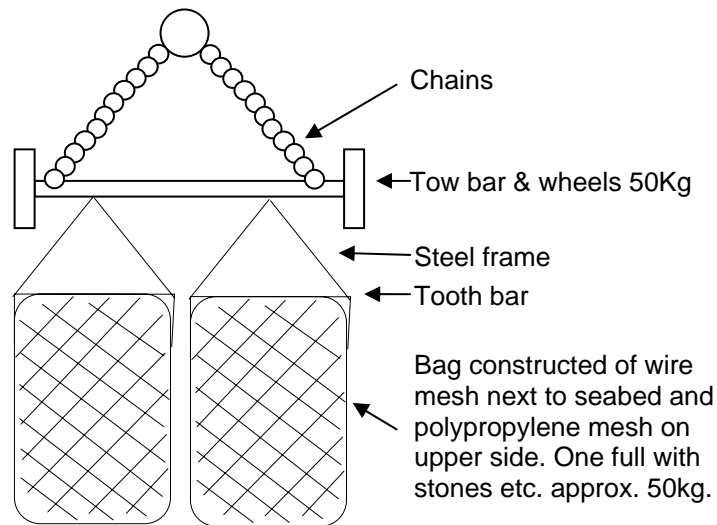
Chains + frames + tooth bars = approx 50kg
Dredge Total Weight = 200kg approx

This weight of 200kg per side would have a significant effect on the stability of the *Tetsuko*, especially when suspended from a height.

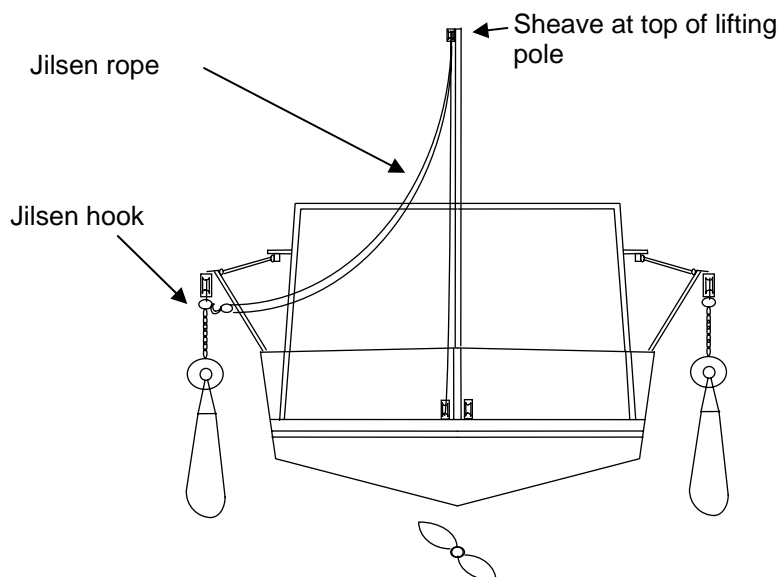
- 2.3.2.7 The jilsen rope turns were reversed around the port capstan. The winch control lever was put in lower mode (anti-clockwise), to hoist the port dredge, whilst the starboard dredge was slowly lowered.
- 2.3.2.8 To manoeuvre the dredge bar onto the top of the transom gunwale the skipper would have had to walk aft with the tail of the jilsen rope turned round the winch capstan head. This indicates that the skipper would have to leave the winch controls for a significant time.
- 2.3.2.9 As the weight of the portside dredge was taken up on the jilsen rope & lifting pole, the dredge moved across the stern towards the centreline directly under the lifting pole.

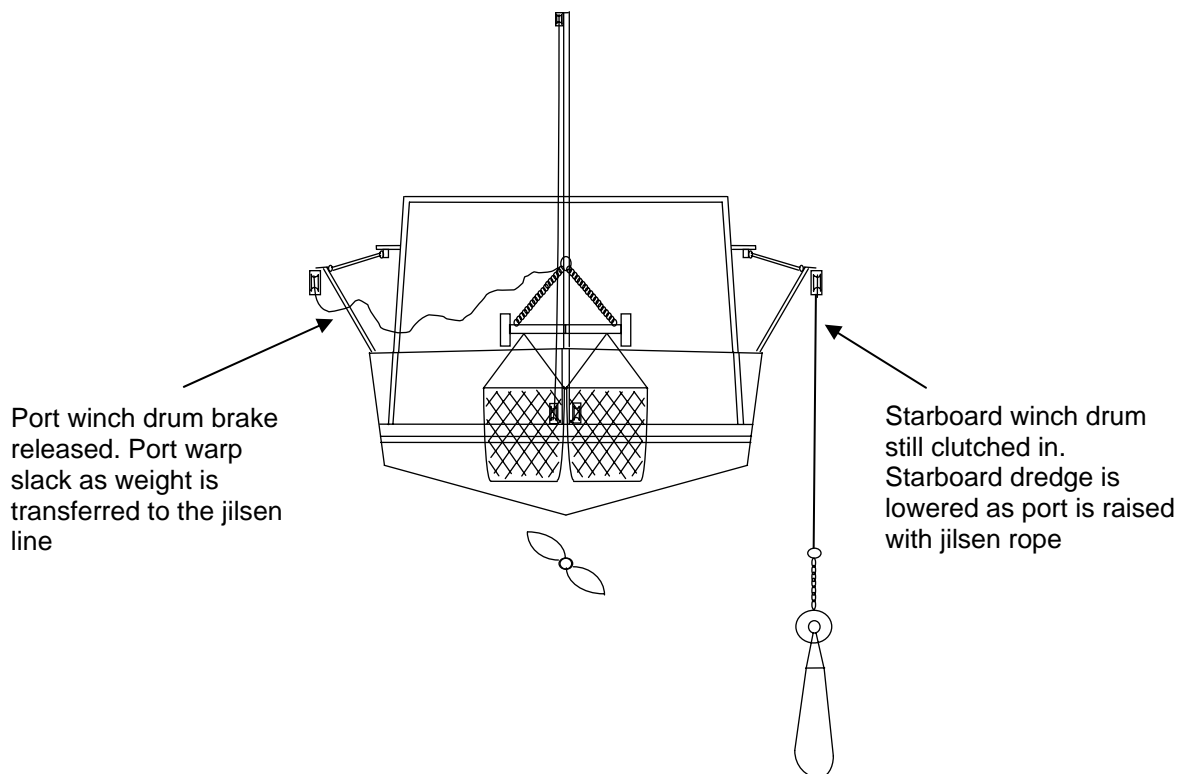
- 2.3.2.10 The vessel at this time started to heel to starboard.
- 2.3.2.11 It is probable that in an attempt to bring the *Tetsuko* upright, the rope on the port dredge was released with the hope that it would free run back to the sea-bed and free the excess weight from the head of the lifting pole. This could have possibly recovered the situation.
- 2.3.2.12 The jilsen rope had been spliced along part of its length and became jammed in the block at the top of the lifting pole, suspending approximately 7.7 metres of rope with the dredge attached under water (see Figure 2, Page 20).

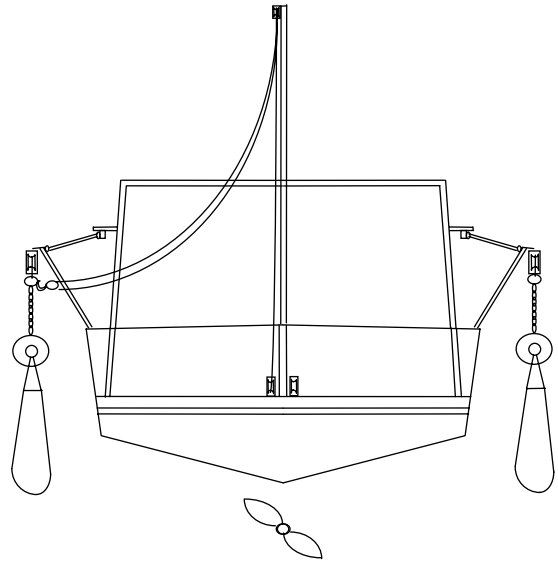
TETSUKO HAULING SEQUENCE

Procedure for the TETSUKO is much the same except that she is only fitted with one lifting pole at the aft end, the top of which is directly above the aft end of the transom. When the jilsen hook is attached, the dredge is moved around to the ***aft end***. When the dredge is in this position it would swing like a pendulum from the top of the lifting pole, as the vessel rolls.

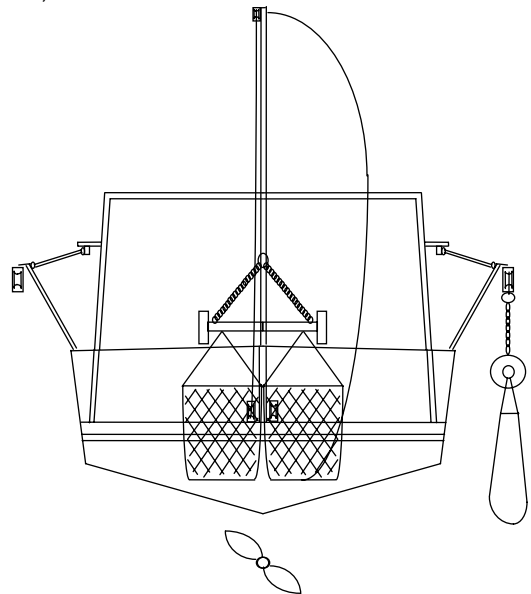
The tow bar is brought up to the gunnel of the ***transom*** and then the bag is tipped into the aft end of the vessel.

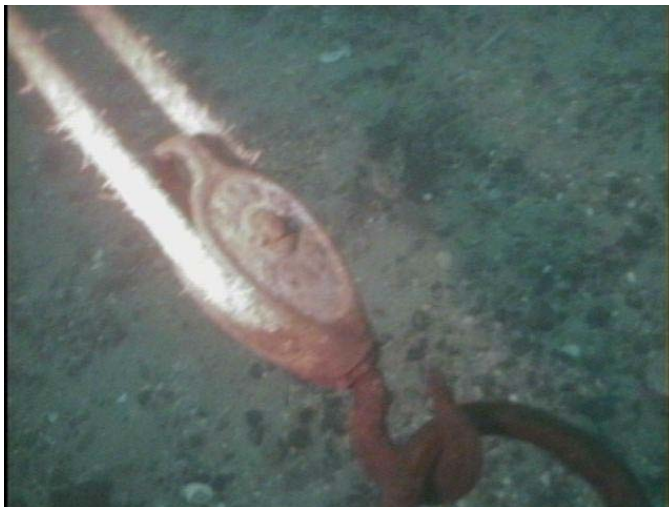
Photo 3
Jilsen hook

2.3.2.6 The jilsen hook and rope were connected to the port dredge.

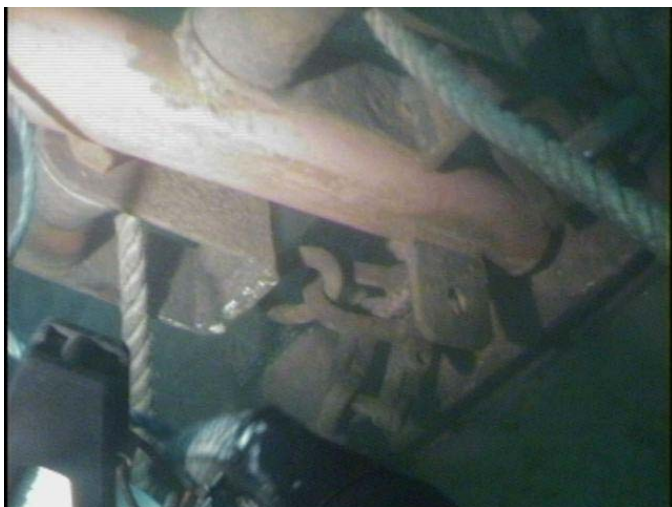
Photo 9
Lifting pole base

Tetsuko fitted with single aft central Lifting Pole 4.5m high

The height of the lifting pole for the recovery of fishing gear was 4.5m above the deck. This is far in excess of that required to lift the scallop dredges on board. Once the weight is taken on the pole then the centre of gravity effectively moves to the point of suspension, at the top of the pole, with consequent rise in the vessel's centre of gravity and a reduction in stability. In addition, such a large weight suspended from such a height would swing like a pendulum, adding dynamic loading as the vessel rolls.
