Isle of Man Ship Registry Port State Control Notice

May - July 2025 PSC Analysis

Ref: 03-2025
Issued: 12 August 2025

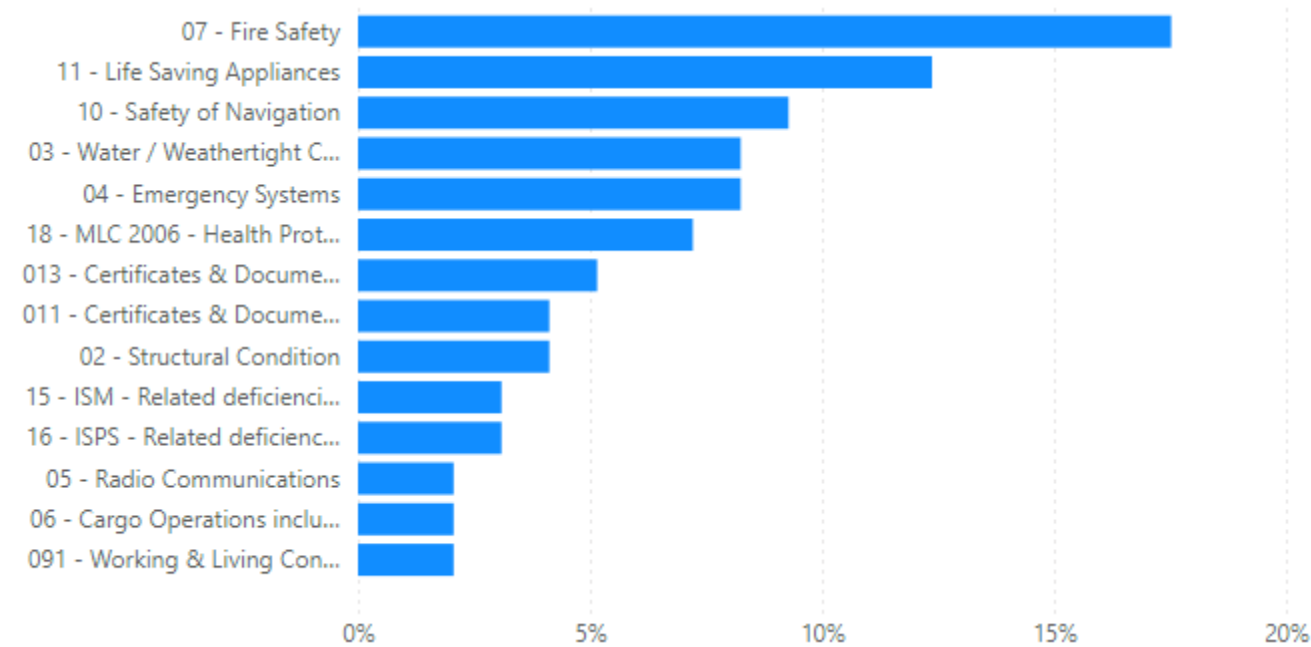
The following chart shows deficiency areas requiring corrective action raised in all MoU Regions as a percentage of total deficiencies recorded:
